The Failure of the Bouzey Dam in 1895

NORMAN A.F. SMITH

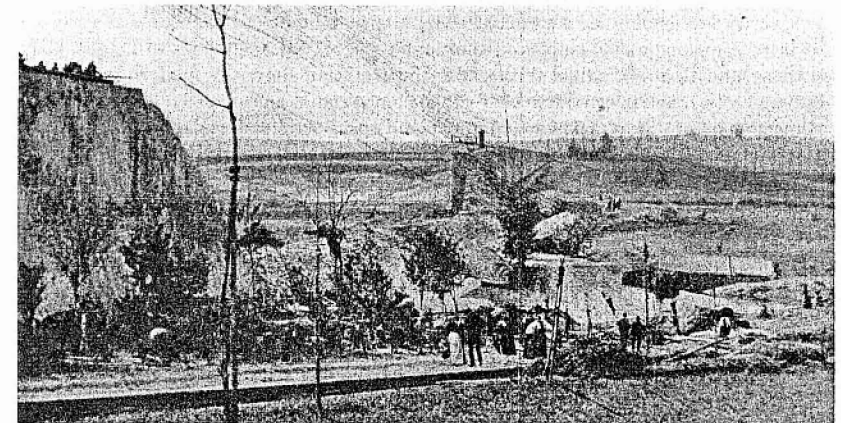
The Bouzey dam near Epinal in Eastern France failed almost exactly 100 years ago, on Saturday 27th April 1895 at 5-45 in the morning (Fig. 1). The ensuing flood-wave, pouring northwards along the valley of the Aivière (Fig. 2) to the Moselle, drowned 85 people and extensively damaged canal works, railway structures, bridges, villages and farms. By the standards of dam disasters it was a serious accident although not so destructive of life as the Dale Dyke dam failure¹ near Sheffield in March 1864, which killed 244 people, and nothing like as terrible as the death-toll of over 2200 in Johnstown, Pennsylvania when the South Fork dam collapsed in May 1889². For comparison, 75 people were killed in the famous Tay Bridge railway disaster of 1878.

Fig 1: A general view of the breach looking southwest and into the reservoir (from Louis Geisler, 15 Vues Photographiques de la Vallée de l'Aivière après la Catastrophe de Bouzey, Roan-l'Étape, 1895)

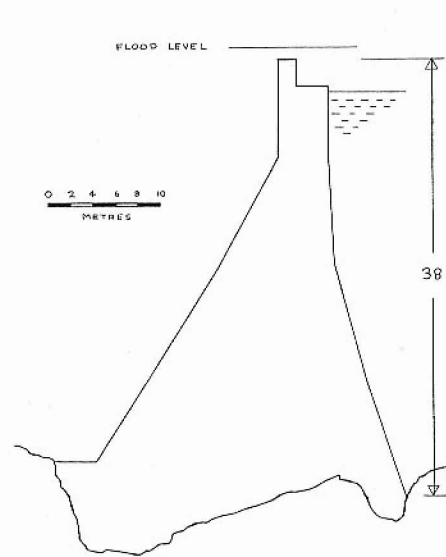
Fig 10: The Habra Dam

A famous failure of this type befell the Habra dam (Fig. 10) in Algeria in 1881¹⁴. Massive runoff after storms and huge flood flows produced an overflow at the dam of, at its maximum, as much as 5000m³/sec. Not only was the spillway, such as it was, overwhelmed, but so too was the dam itself. The crest was overtopped to a depth of nearly 1m and the normal operational reservoir level was exceeded by about 4m. Proportionately, the increase in water pressure was not all that significant near the base of the dam, but it most certainly was at the top. At a depth of some 10m below the crest the horizontal section was being subjected to *twice* the designed thrust. Consequently, tensile stresses must have developed at the water-face and the masonry presumed to have cracked. Such cracking would have allowed the

penetration of water as a result of which a new force came into action. It was an uplift force acting vertically within the crack. In effect, it augmented the horizontal water pressure in overturning the dam section above crack level.

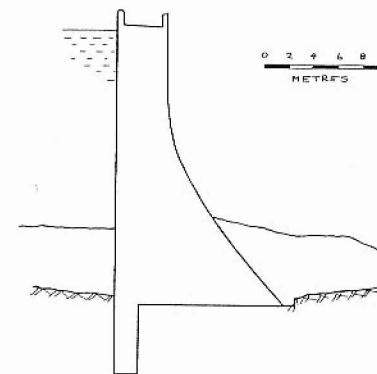
The Bouzey dam was completed right at the end of 1880 and filling of the reservoir began late in 1881. The reservoir's capacity was 7 million cubic metres, it covered 128 hectares, and could feed something of the order of 45,000m³ of water to the canal each day. The dam itself was straight, quite long at 525m, but not exceptionally high at 22.7m. The masonry and mortar used to build the dam had an overall specific gravity of 2, a low value but not of itself a cause for concern. In order to counter the fissured nature of the foundations, a cut-off wall was built reaching down as much as 5m below the base of the dam on the upstream side. As built the Bouzey dam's cross-section was the one shown in Fig. 11.

Fig 11: The Bouzey Dam as built

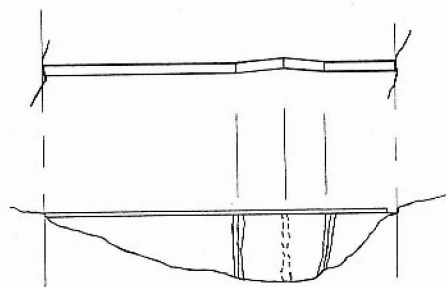
Fig 12: Plan and elevation of the failure of 1884 (not to scale)

the reservoir level had reached 15.5m, that is to say about two-thirds the maximum, and at this moment the water-supply to the reservoir was augmented very substantially by the completion of a 43km-long aqueduct bringing Moselle water from Remiremont. By March 1884 the reservoir was 18.6m deep; the leaks had grown only a fraction to 70 l/sec. The level rose a further 80cm. And then, on the 14th of March, just before noon, 135m of the dam slipped forward into the V-formation indicated in Fig. 12. The maximum displacement was 35cm and the break occurred at foundation level (Fig. 13).¹⁶

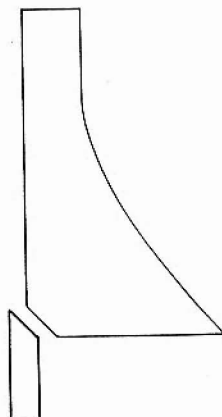
The reservoir was drained in the autumn of 1885. Not surprisingly groups of vertical cracks were found at each end of the displaced section and at its centre. They, quite evidently, were the result of bending fractures, tension cracks in a broken "horizontal beam". Underneath the dam it was found that the cut-off wall had no means protected the poor rock immediately under the structure. Fissured and permeable beds reaching well into the reservoir area had not been sealed by the cut-off wall, and the formations under the dam were dislocated and saturated to a depth of 2-3m. Something which all the pioneer analysts of dams had thought about but never really believed could happen, in fact had. A dam had slid on its foundations, an effect probably exacerbated by a considerable uplift pressure under the dam, although that factor was not fully debated until a later date.

Fig 13: The nature of the fracture

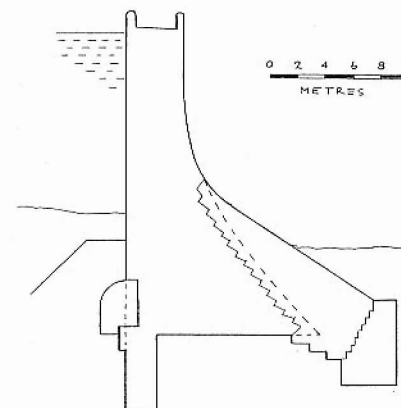
Fig 14: The Bouzey Dam rebuilt (the old dam is shown by the broken line)

the manner of the measures taken at the dams of Grosbois and Chazilly.¹⁹ In view of what was to happen in 1895 the decision *not* to build "contreforts" was another chance missed. In the event, the chosen solution was a massive buttress "toothed" into the original masonry and bearing against a deep level abutment. The intention was to prevent further sliding. But no strengthening was provided for the upper half of the dam and that was where the ultimate disaster was lurking. Drains were installed at the base of the dam to take away any water percolating underneath. The vertical cracks were filled with cement mortar or grout. The bore-hole used to investigate conditions on the lower side of the original dam was retained as a basis for monitoring water-pressures beneath the modified structure. The rebuilt cross-section is shown in Fig. 14.

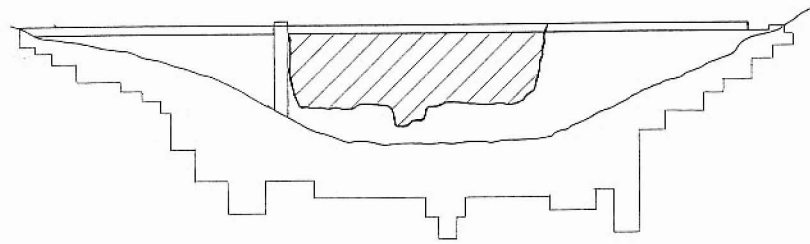
Fig 15: The failure of 1895, viewed from upstream. The vertical scale is 5x the horizontal; the stepped line shows, approximately, the bottom of the cut-off wall

There were three witnesses to the collapse on the 27th April 1895. Early that morning a workman called Thiriat was crossing the dam and he stopped, 160m short of the spillway at the eastern end, the right bank, to talk to a mason working below. As they talked the dam began to break up. M. Thiriat had to jump over a 10cm crack in his dash to safety. The mason he had been chatting with was the first victim of the disaster. The third eyewitness was the innkeeper M. Gihin who was watering his horse in the village of Bouzey, 300m downstream. He was able to provide a useful account of the failure sequence which comprised two phases: an initial break near the crest in the middle of the structure over a length of 20m, followed by the main collapse of 180m of the dam to a depth of about 10m. Both Thiriat and Gihin commented on the noise. The failed dam is shown diagrammatically in Fig. 15.

The cross-section of the failed dam is instructive (Figs 15-17). The break runs horizontally through about half the section and then drops away. Unwin was struck by the fact that there was no evidence of failure by crushing, that "The mass was torn out along a nearly level plane of fracture without any obvious cracking or splintering of the stones along the down-stream edge of the fracture. The mass filling the gap appeared rather to have slid or overturned."²⁵

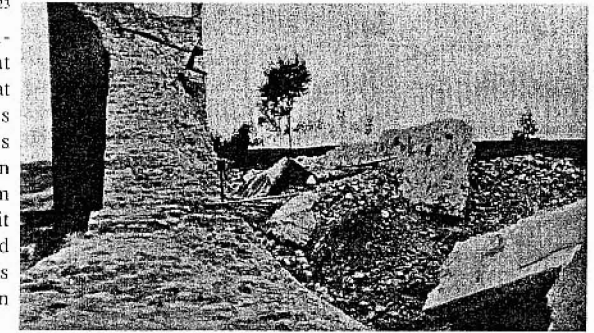
Fig 16: A close-up view of the break (from a photograph by Professor W.C. Unwin)

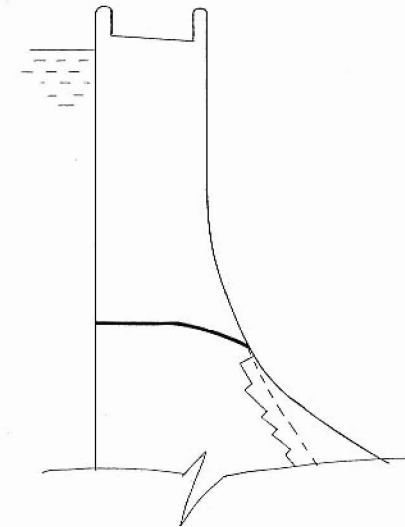
Fig 17: The typical shape and position of the failed section

At a depth of 10 m of water we can now construct a third stress diagram, III (Fig 18); it applies to the surviving 3.3m length of the section and, of course, it includes a new element of tension – 3.8 kg/cm² at maximum – which, if it is relieved by cracking, allows an even larger uplift force and leaves a decreased length of section intact. It is hardly necessary to emphasise the progressive nature of the failure now underway, except to point out again that at the final stage, overturning about the downstream edge would most likely give way, if that is the phrase, to shear fracture. Such a fracture would be along a surface that falls away towards the air-face, as indeed the ruins of the dam confirmed (Fig 17). A similar surface of failure had been observed in the Habra dam.

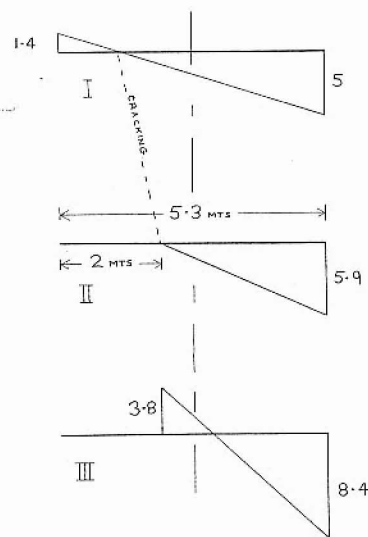
Fig 18: Successful states of stress (in kg/cm²) and cracking across the critical section

since neither was of first class quality. The crucial defect was that the bond between the masonry and mortar was very poor and should not have been relied upon in any case.²⁸ It was quite incapable of resisting the tension which developed with a full reservoir and so the Bouzey dam cracked.

Referring to the stress diagram I in Fig 18 we can show that if the tension of 1.4 kg/cm² was relieved by cracking, the crack would penetrate 2m and the next stress diagram, II, would then apply, the minimum stress now becoming zero and the new maximum being a compression of 5.9 kg/cm². So far the dam is still not over-stressed, exactly as de Sazilly, Delocre and their followers were willing to allow. However, as soon as water pressure penetrated the tension crack a new vertical force came into play, the uplift force we were considering in the case of the Habra dam, cracked in that case by a chronic hydraulic overload. The uplift *U* within the cracked Bouzey dam significantly increased the overturning moment and the magnitude of the effect is readily calculated (Fig 19).

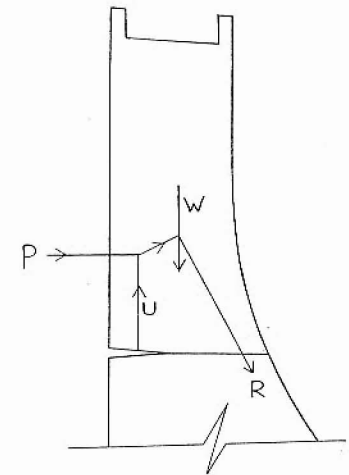
Fig 19: System of forces with uplift
