Traditional Construction Techniques of the Newars at the Itum Baha Monastery in Kathmandu

Matthias Beckh

This paper discusses traditional construction methods of *Newar* architecture in the Kathmandu Valley. The first part considers traditional construction and design details as well as typical structural problems associated with this kind of construction. The second part deals with construction principles and techniques as associated with the restoration of the Itum Baha monastery in Kathmandu.

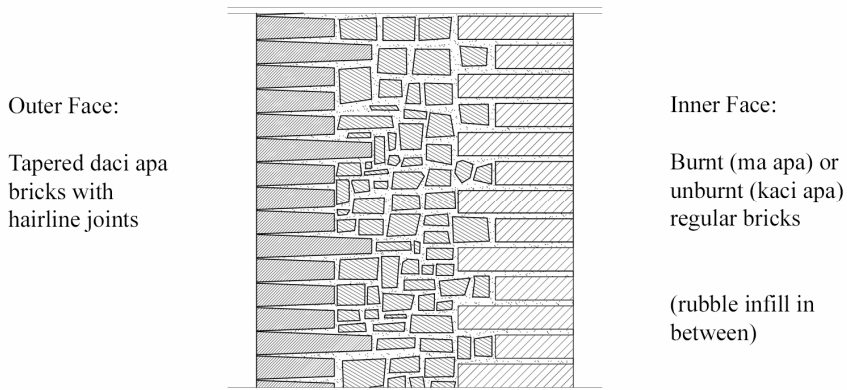
Figure 1. Typical wall cross section

The inner face of the wall is made of one wythe of burnt or even unburnt brickwork (*kaci apa*). Only rarely do those thick walls consist of continuous solid brickwork. More often they consist of a core of brick rubble infill set between an outer faces of brick (**fig.1**). The bricks are traditionally laid in mud mortar. In the 19th century lime mortar was introduced by masons from Lucknow, but only used at rare occasions until the rebuilding after the 1934 earthquake. Commonly, all bricks of the outer face are laid as runners, so that there is no or only little bonding between the different leafs. Cross walls are often simply butt jointed with no interlocking at all.

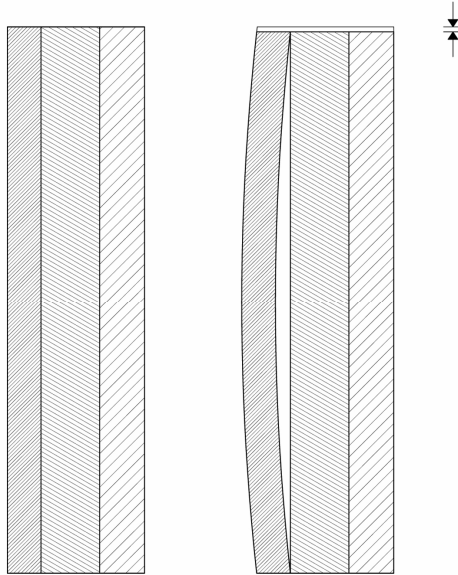
- Water infiltration accounts for most damage to the buildings: Rain from the heavy monsoon downpours easily finds its way past dislodged roof tiles into the mud bed, causing wet rot of the roof structure.
- Damages due to rising damp: the lack of any moisture barrier above foundation level in this very humid environment causes widespread damage at the brickwork and associated timber elements.
- Delamination of the multi-layered walls: The lack of sufficient bond between the outer shells and the rubble infill often causes degradation of the walls.
- Bulging of the veneer-like *daci apa* front face: the different amount of soft mud mortar between the *daci apa* shell and the inner shell results in different stiffness. Due to this, differential settlement is frequent under larger gravity loads, which sometimes causes the bulging or deformation of the stiffer façade shell. (fig.2)

Figure 2. Bulging of the stiffer face brick shell

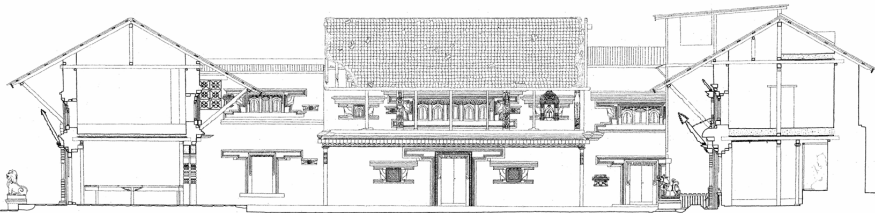
Figure 5. South Wing Façade: existing and proposed restoration (Drawing by Bijay Basukala)

The restoration started with the south wing of the building, which was in an extremely bad state of repair (**fig.5**). A lack of maintenance had led to the partial collapse of the roof structure and the ingress of water had damaged beyond repair all the rafters and most of the joists. At the second floor level, many of the joists were rotten and severely affected by wet rot, fungus and insect infestation. Many of the timber windows on the second floor level showed boreholes caused by insects that had led to partial decomposition of the wood.

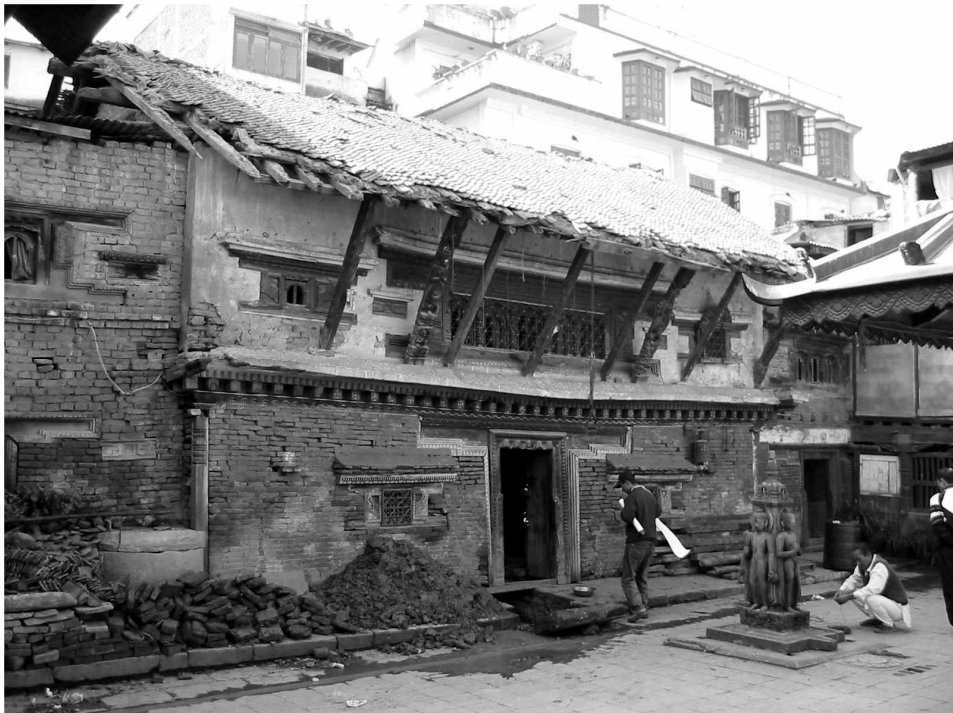
The load bearing walls consist of locally produced fired brick – *ma apa* - laid in mud mortar, with the typical three-layered cross section. Most parts of the brickwork were in poor condition. The rear wall brickwork had suffered severely from water ingress through the leaking roof and had been repaired repeatedly with modern bricks and cement in the last decades. Heavily decayed brickwork could be seen along the entire front and rear walls of the south wing. Rising damp had caused spalling of bricks and washed out the mud mortar in the evaporation zone of the wall, between 50 - 180cm above ground level. Below this zone, heavy efflorescence and moss could be witnessed along the walls. The rising water, exacerbated by an unusually high water table, had led to a substantial weakening and decomposition of the structure (**fig.7**).

Figure 6. South wing before restoration

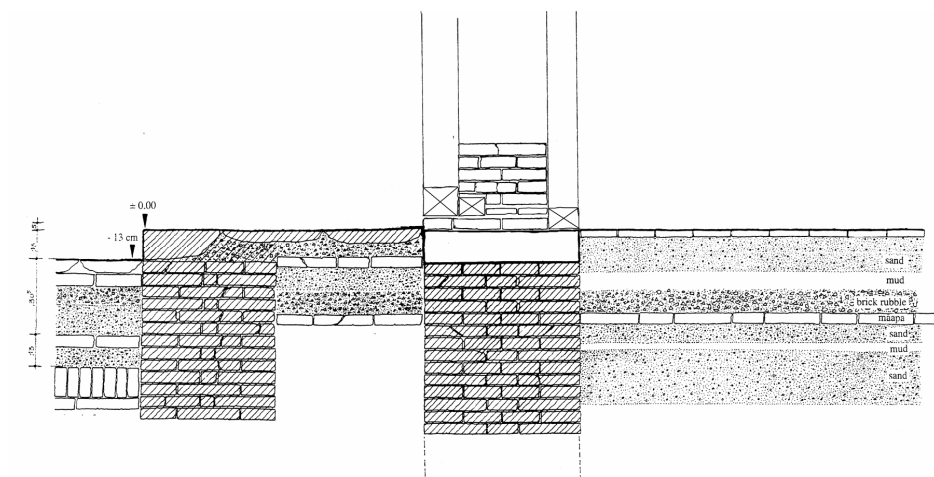
Figure 7. North-south section through the central door of the south wing showing the inserted ring beam (22x65cm)

The lack of authentic brickwork as well as the extremely poor condition of the structural fabric led the design team to the decision to dismantle some parts of the South wing and reconstruct them. To protect the masonry walls from rising water, and to increase the seismic shear resistance of the foundations, it was decided to incorporate a reinforced concrete ring beam just below grade level on top of the existing foundation walls (**fig.7**). The walls were rebuilt on top of the new ring beam in the traditional fashion with mud mortar, using both new and historic bricks. Instead of the typical three-layered wall construction with the rubble infill, a two layered cross section was used, with proper bonding between the face brick and the *ma apa* bricks behind. The new *ma apa* bricks were specially ordered to match the historic dimensions of 4 x 13.5 x 20cm. To this day bricks are still hand made using traditional wooden moulds and wood-fired kilns (**fig.8**).

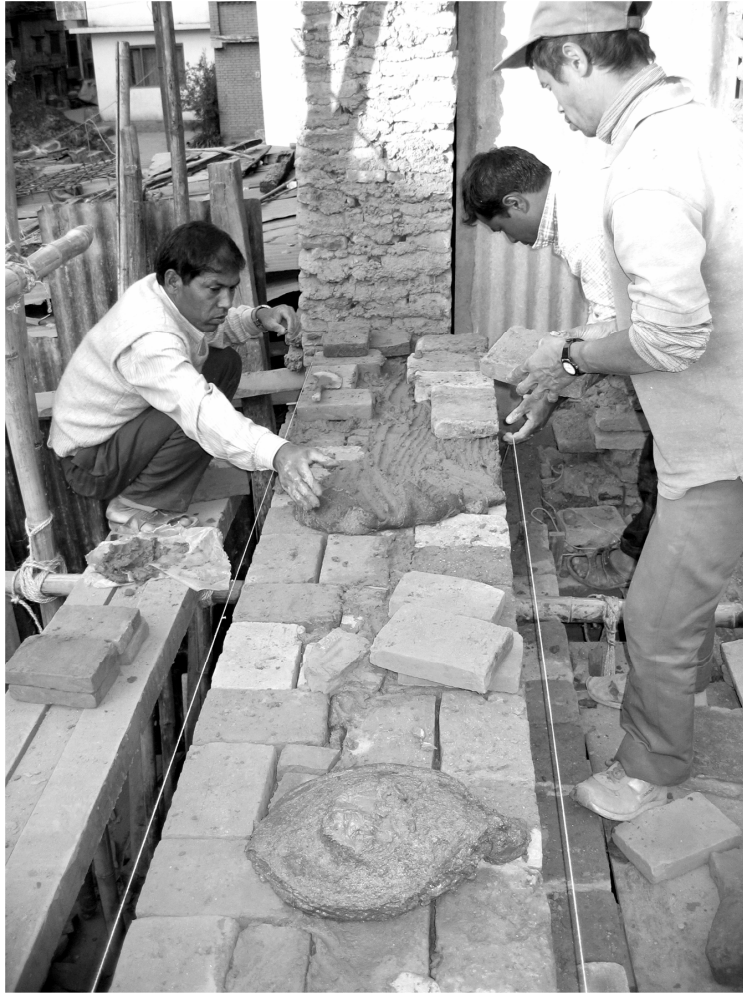
Figure 8. Rebuilding a part of the South wing rear wall

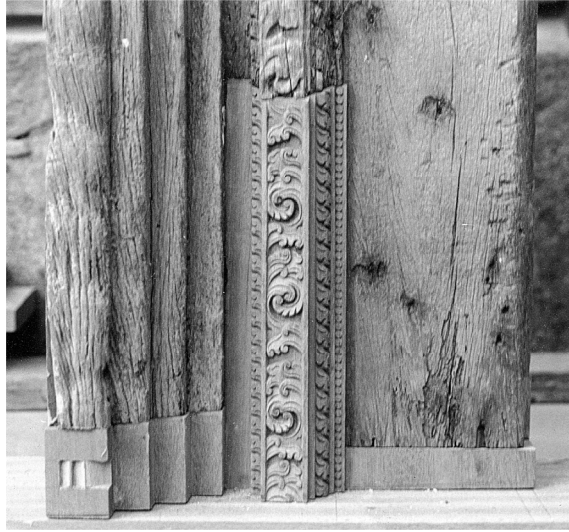
Figure 9. Detail of restored doorframe at south wing (Photograph Niels Gutschow)

Wooden doors and window elements were preassembled by wood carvers and carpenters. Where it was absolutely necessary, damaged parts were carefully replaced by new wooden components. (The master carvers still use the same tools and techniques as their fathers and forefathers to work with the wood.) Lost parts were skilfully reconstructed with the help of historic documentation and meticulously integrated into the historic parts. After having finished the assembly of the door or window frames, the complete frames were set on the brickwork with the masonry later wrapping around them. (figs. 9, 10)

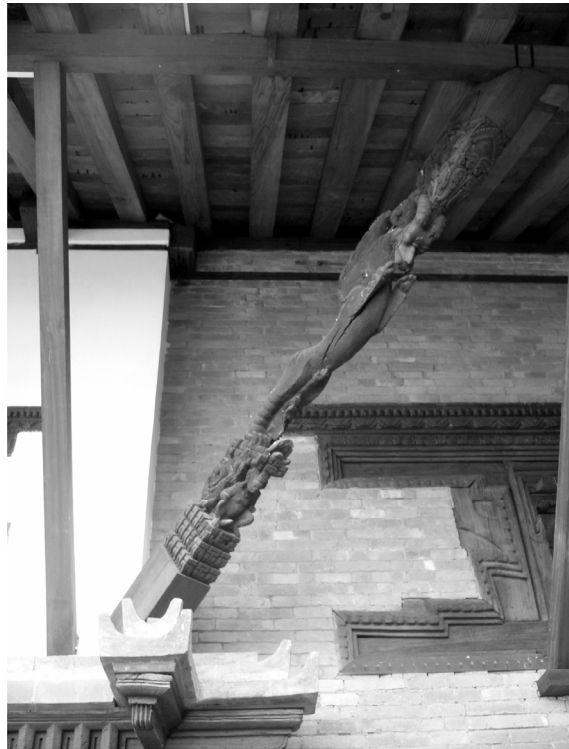
Figure 10. Restored historic roof strut. Missing parts were carefully replaced (head).

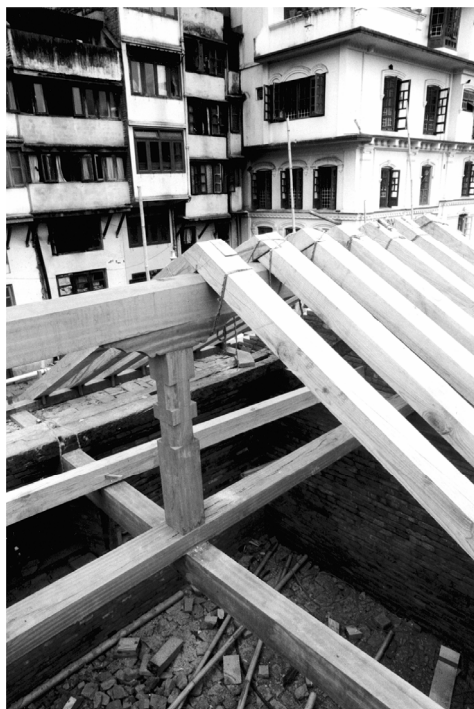
Figure 11. Rebuilding of the roof structure

At the roof level, 2cm thick marine-grade plywood panels, staggered in plan, were mounted on top of the rafters above the building. The panels form a stiff diaphragm and increase the cohesiveness of the roof system. The overhanging part of the roof, which is visible from below, was covered with traditional terra cotta tiles. To protect the roof from infiltrating water, a waterproof membrane was inserted. Sloped battens were installed to prevent the mud layer from sliding. Finally, the traditional, palm-sized roof shingles were pressed into the mud bed. **(fig 11-13)**

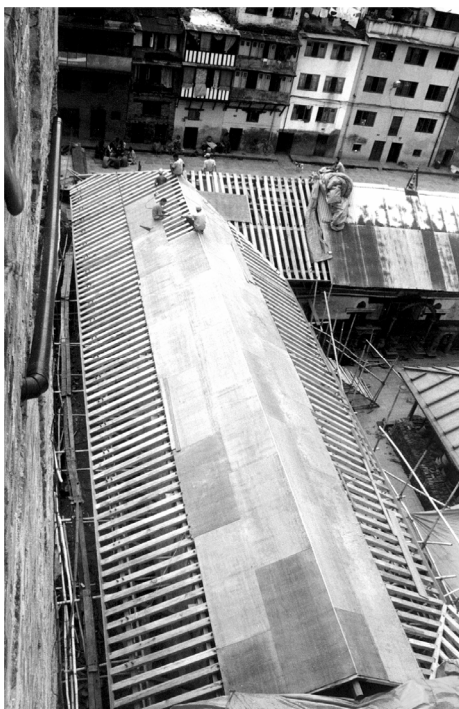
Figure 12. Rebuilding of the roof structure and stiffening of the roof with staggered plywood panels

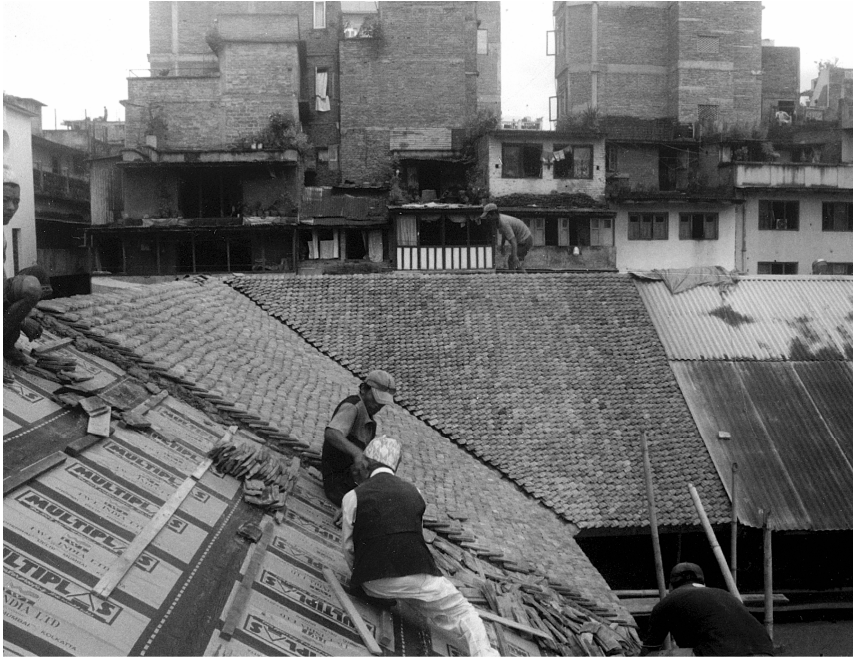
Figure 13. Installation of the mud bed and the roof tiles
