Nineteenth-Century Iron Suspension Footbridges in Flanders (Belgium)

Ine Wouters, Michael de Bouw and George G. Nieuwmeijer

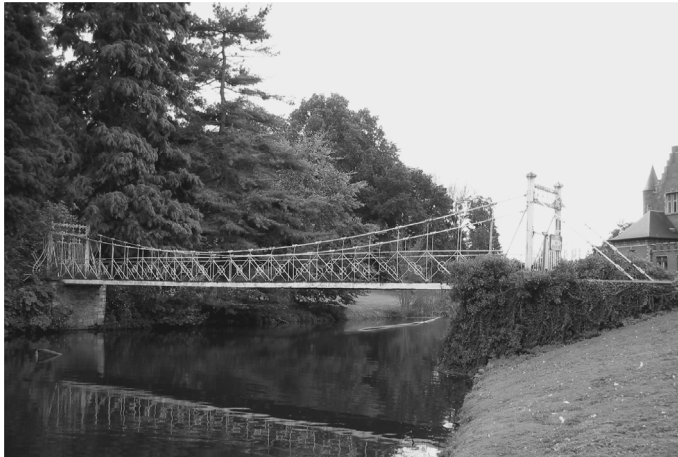
The load-bearing capacity of the bridge is very low. Although the bridge is light (0.73 kN/m²), the self weight of the bridge leads already to stresses as high as 115 N/mm² in the chain and 125 N/mm² in the tension ties. In the current configuration, not the stress in the chain, but the connection between the chains is the weakest element and a live load of 0.10 kN/m² is the maximum. When ignoring the combination coefficients of 1.35 on the self weight and 1.5 on the live load, we come to a permissible live load of 0.40 kN/m². This means that a maximum of 18 people can walk on the bridge. It is hard to imagine that this number has not been exceeded in the past, even when it was in use as a private castle bridge.

But times have changed. Since 1989, the council of Kruibeke rents the castle and the park to open them to the public. As a consequence, the bridge will have to undergo much higher loads. The discussion about the acceptable load-bearing capacity of the bridge has not yet been opened, since the bridge was in such a bad condition that it was closed to the public since 1990.

Figure 1. Side view. Iron suspension footbridge in Bazel at the castle of Wissekerke. 1824.

replacing the original bolts, and accepting a stress of 200 N/mm^2 in the tension ties, a live load of 0.85 kN/m^2 (or 37 people) is acceptable. Is this load high enough for a public bridge? When strengthening the tension ties, we are faced with the maximum strength of the main cable leading to a live load of 1.00 kN/m^2 (or 44 people). To reach a higher capacity, the main cable will have to be altered as well. As the bridge has been classified as a historical monument since 1981, the crux presents itself if this is acceptable from a historical point of view. Maybe there exist invisible methods of strengthening, or maybe the answers can be found in a limitation of access, or a reduction of the deck?

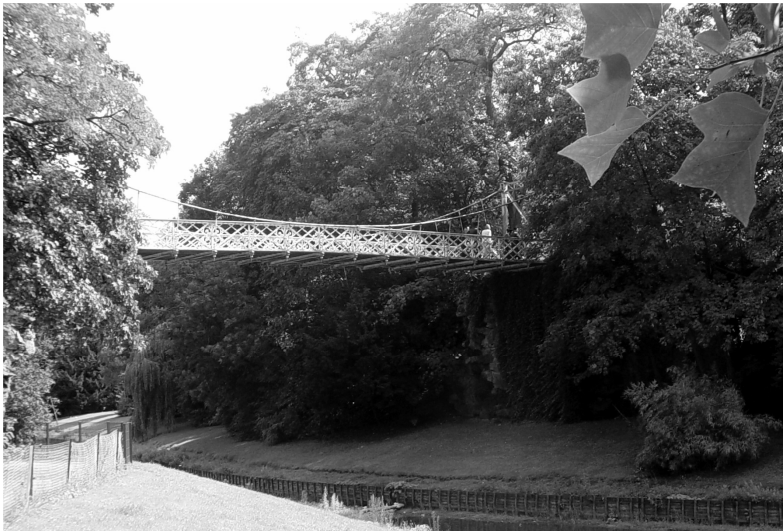
In 1971, after a period of 100 years, the bridge was closed to the public because one of the main cables was corroded up to 50 %. Further inspection showed that there was severe corrosion on the cross beams and the railing too. The wooden deck had to be replaced. The council submitted a request for protection of the bridge as a historical monument and started the renovation. In 1976 the bridge was dismantled, the cable, railings and deck replaced.

Figure 4. Side view. Iron suspension bridge in the public park in Antwerp, 1869.

still, the renovation tends more to a *rebuilding* of the bridge: the wire cable was replaced by a new steel cable (capacity 2500 kN), just like the hangers, wind bracing and anchorage bars; the double U-shaped cross beams (UPN180) changed into simple “I” shaped beams (DIN14). Only the columns and the truss in between those are still original parts.

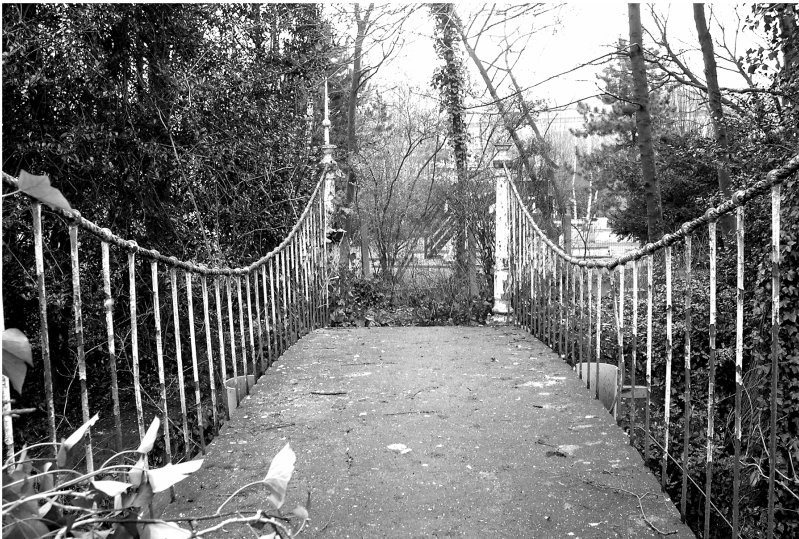
Figure 6. Front view. Iron suspension bridge at the municipal school of Zelzate, 1880-5.

The main wire cable spans from column to column. The part between the column and anchorage is missing! The cable goes through the eyes of the hangers, which have a double function: they carry the deck and, placed every 240 mm, serve as a railing. Two beams span from bank to bank and support the wooden deck. Later on, this has been covered with a concrete plate. The iron wire cable is corroded. The abutments have subsided. The bridge is not in use.

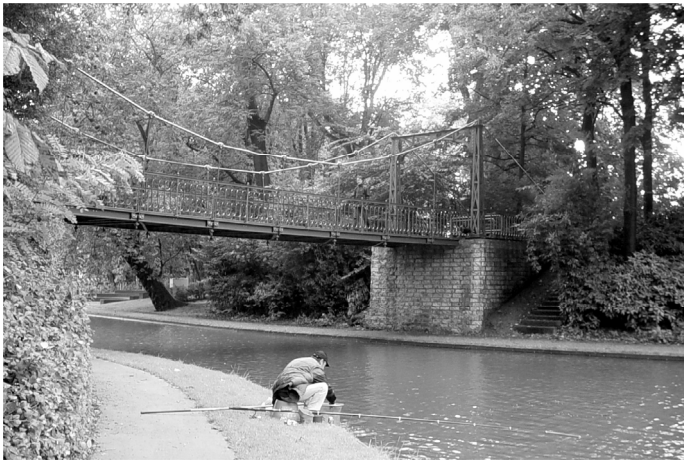
The original cable was already replaced in the 1970s. In 2000 the bridge has undergone a thorough renovation. The “I” profiles of the deck were badly corroded, particularly where the wind bracing was connected to the main “I” profiles, since moisture and dirt accumulated onto the gusset plates. The abutments have subsided. At this moment, the railing, the truss between the columns, the

Little attention is paid to the durability of the main cable. The cable saddle cap, although drawn on the architectural plans, is not provided. The cable is in direct contact with the ground before entering into the anchorage shaft.

Figure 7. Side view. Iron suspension bridge in the public park of Vilvoorde, 1899.

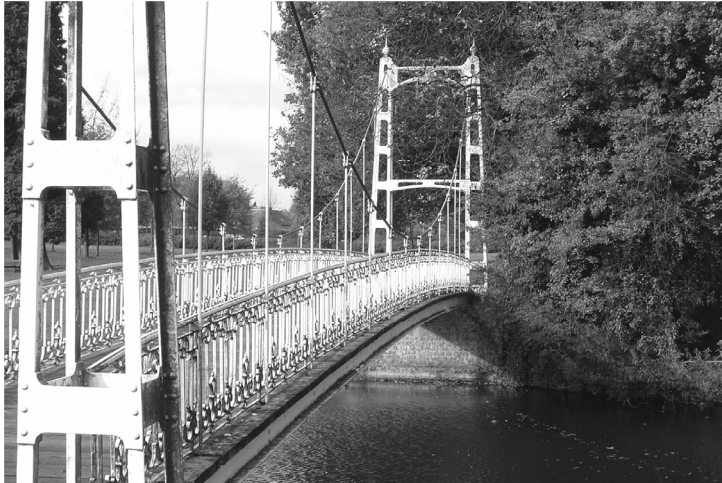
structural elements had to be replaced due to a lack of maintenance. In 1978, the deck of the bridge was renewed. In 1990, after one of the hangers was broken, the stability of the bridge was checked. The following renovation works were carried out: the columns were strengthened by welding new material onto them, the cable was replaced and the railing repaired. As the bridge is very lively and even one person can cause important oscillations, the railing endured serious deformations. The “design” problem of the detailing of the railing was not solved which results, today, in a deformed and buckled railing. Barriers are placed to avoid cars and motor vehicles from crossing the bridge.

Figure 10. Side view of the iron suspension bridge in Beveren, near castle Cortewalle, 1900-05.
