37 WEST STREET, OUNDLE
NORTHAMPTONSHIRE

Historic building recording: Level 3

JULY 2020

TANSY COLLINS
Historic Buildings Survey

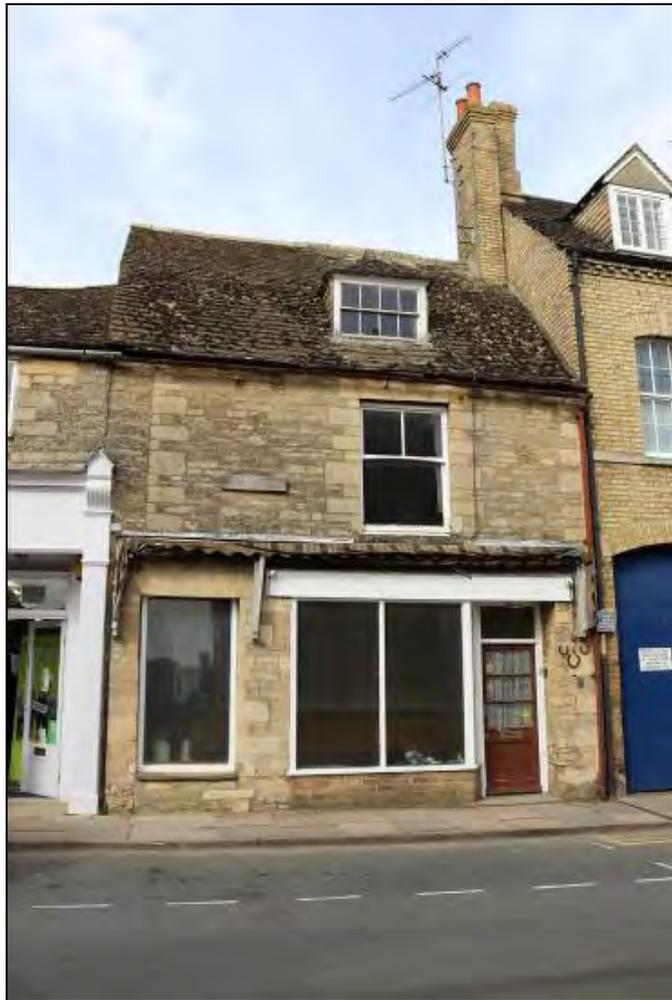
Plate 3 South elevation of No. 37 (Range 1, DP1)

5.3 Range 1 rises over two storeys to a pitched roof which contains an attic room. The south elevation presents an asymmetrical arrangement to the street front and bears some interesting evidence for the evolution of the building. At ground floor level, the elevation has been altered from the typically late Victorian shop front visible in **Plate 1**, although the position of a doorway remains to the west. This shop front was present in 1974 at the time the building was listed (App. 1) but has since been replaced with a central modern shop front comprising a brick apron and two large glass panes above, with a slightly recessed entrance on the east. The threshold here consists of a repositioned large stone slab. It has two small holes, probably for vertical metal poles to railings, while one or two quoins in the east jamb of the doorway have further sockets for lost fixtures. The existing awning is of no great age, certainly post-1974, and extends to the west end of the range to protect a former doorway. This doorway formerly provided entrance to a hallway which gave access to the narrow rear yard, but also would have

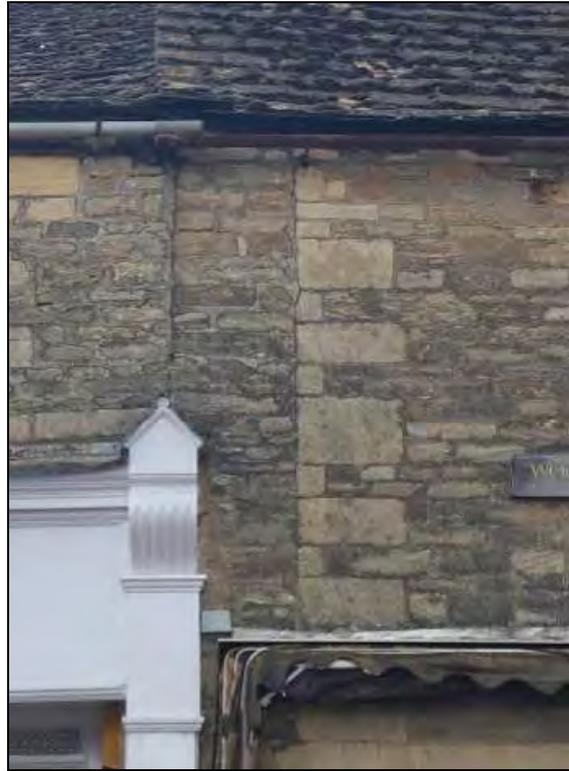
Plate 4 South elevation at first floor level showing depth of original west wall with 18th century rebuilding to the right (Range 1, DP8)

5.4 At first floor level, the elevation reflects a fairly substantial phase of rebuilding so that only a narrow section of the original stonework survives at the west end with fairly small limestone pieces are laid in short courses (**Plate 2**). This defines the depth of the flanking west wall of the range and is marked by a distinct straight joint to the remainder of the elevation, the latter marked by the presence of good squared large and small quoins which is mirrored at the eastern corner. A window aperture is slightly offset from the centre and dressed by ashlar block voussoir and jambs. Otherwise, the stonework comprises rubblestone laid in courses with areas of re-pointing in cement. The window itself is recessed into the stonework and is of two-over-one sash form, the rail of the upper sash being slightly cambered for decorative effect. This window has been altered as noted. To the left is a sign which reads 'WOODENSTONE CIRCA 1600'. Historic research has revealed that the property was named Woodenstone in the mid-19th century. The roof over is clad in

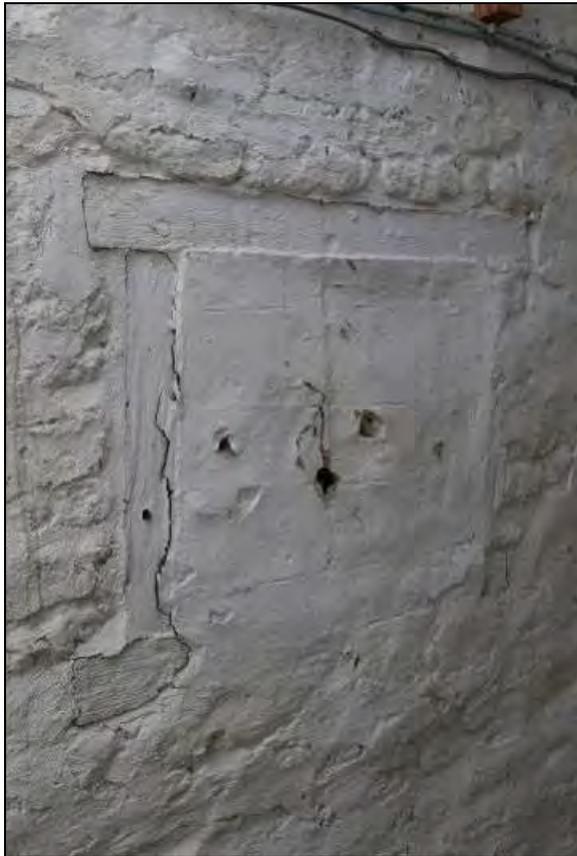
Plate 5 Blocked timber mullion window on the west side of Range 2 (DP24)

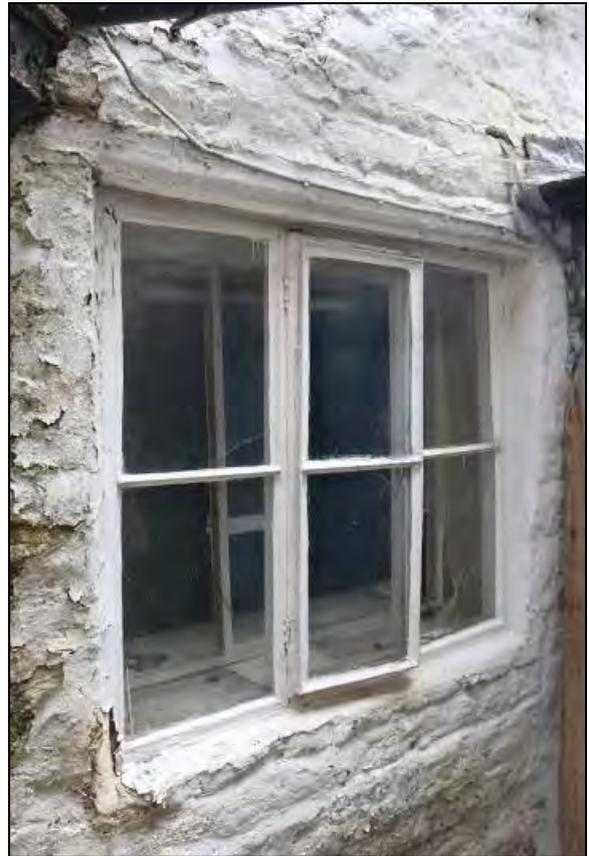
Plate 6 Early 18th century window on the west side of Range 2 (DP21)

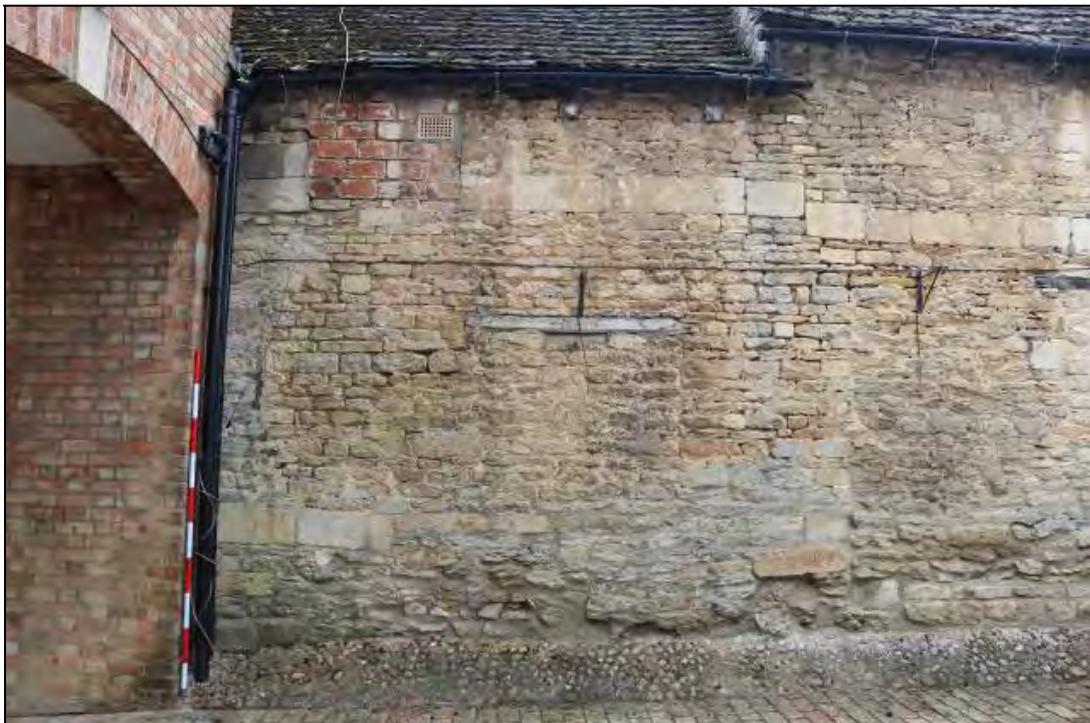
Plate 7 East side of Range 2 showing courses of good squared limestone with blocked apertures on both levels (DP240)

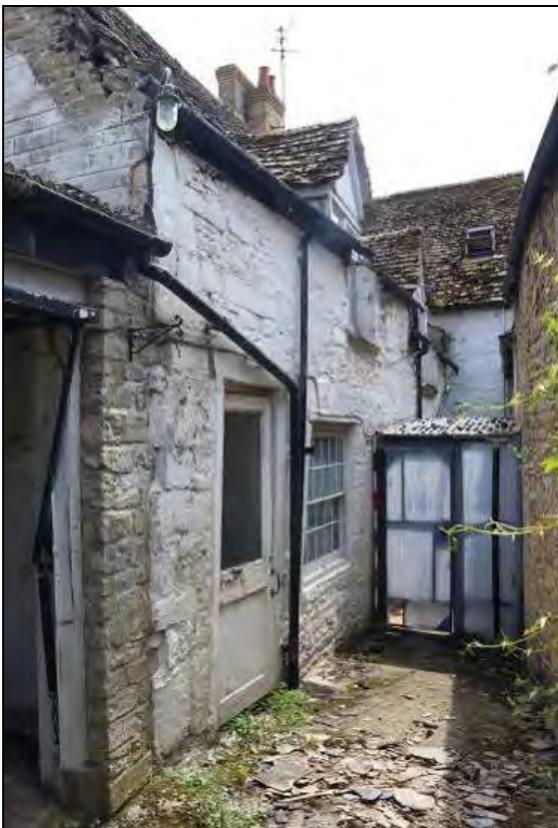
Plate 8 West elevation of Ranges 2-3 (DP14)

5.8 The west elevation (**Plate 8**) continues from Range 2, but the previous application of repeated paint layers means a straight joint is not well defined here though is indicated by the presence of ashlar quoins. Courses of squared stone work extend across the elevation with quoins at the north corner. At the junction with Range 2 lies the back door. It comprises a robust four-panel door with a heavy round knocker. The rear room of the range is lit by a wide ten-over-ten sash window with no horns, and at the end of the range a doorway opens against the flank of a large chimney stack and leads to the cellar. The door itself is modern. At upper level, a further window rises above eaves level as a dormer and contains a modern casement.

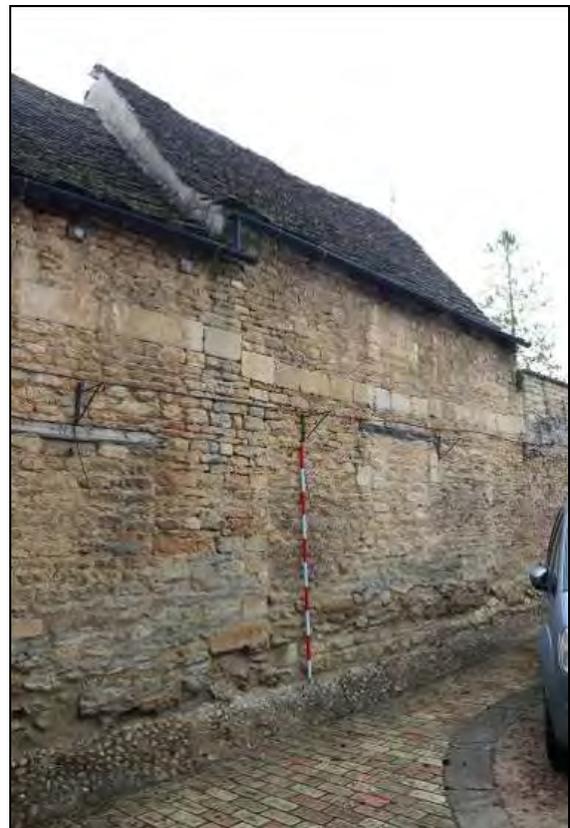
Plate 9 East side of Range 3 showing blocked apertures (DP242)

5.9 The east elevation extends inline from Range 2 where there is an irregular straight joint between the two ranges and bears marked similarities in stonework with a single course of good squared limestone blocks (**Plate 9**). The roof rises slightly higher and a view within the roof space reflects that this range has been built over the north gable end of Range 2. As with Range 1 there are areas of disturbance reflecting modification at various times but the main elements include a window at ground floor level of a similar form to the south with a timber lintel though here with good quoins at the jambs. At upper level a small aperture abuts the eaves and is infilled with brick.

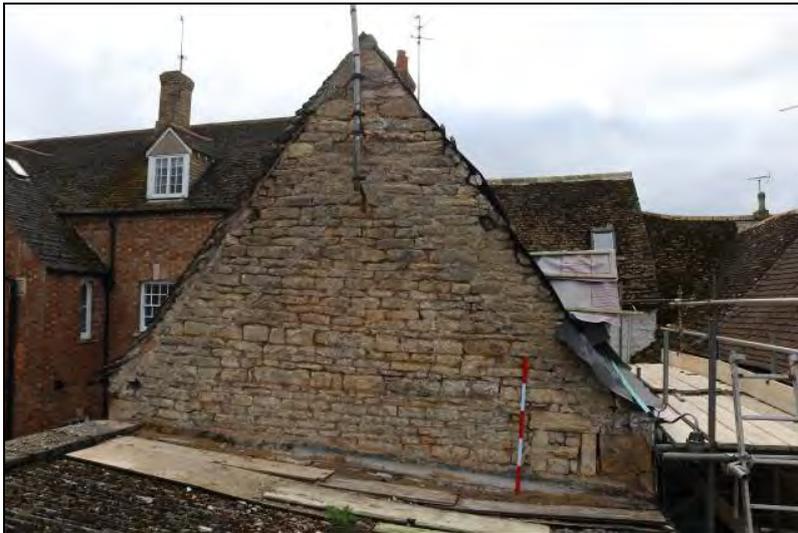
Plate 10 North elevation of Range 3 at upper level showing small blocked aperture to light former staircase and impression of lost roof pitch (DP234)

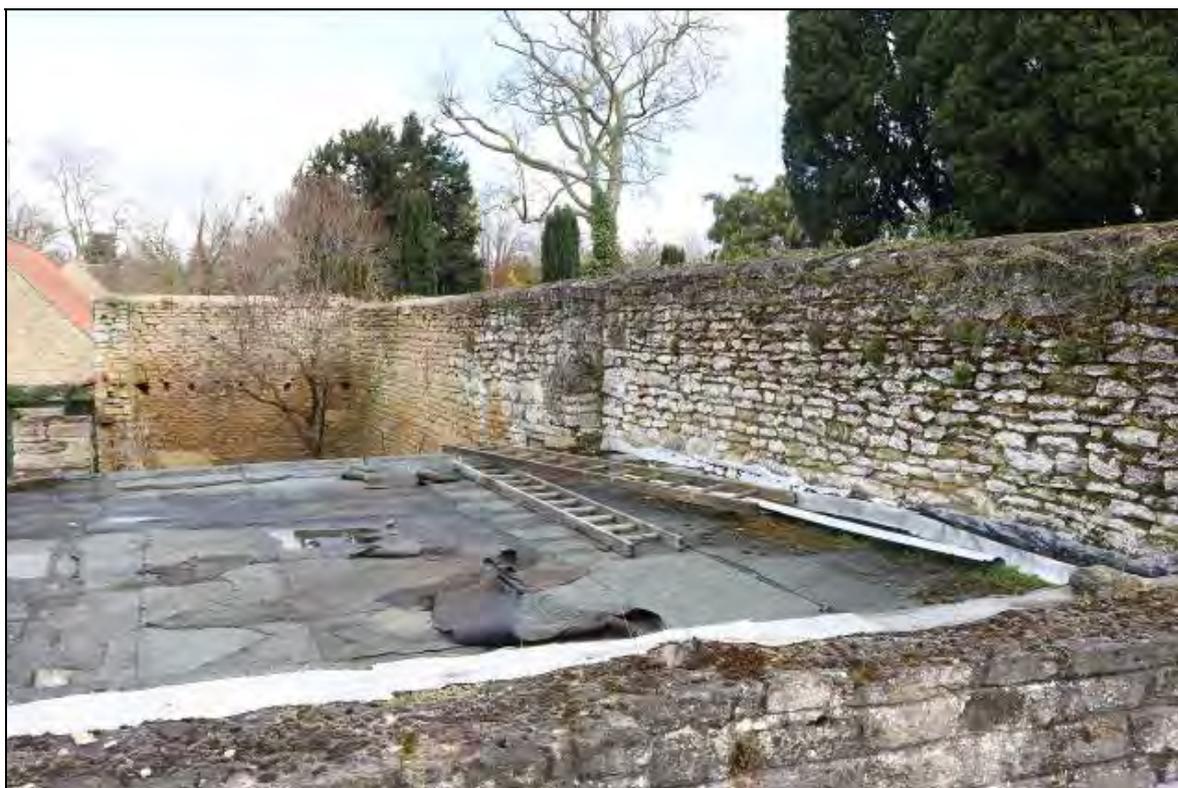
Plate 12 View of the east side of Ranges 5 and 6 at upper level with the remains of outer walls, taken from the south-west (DP235)

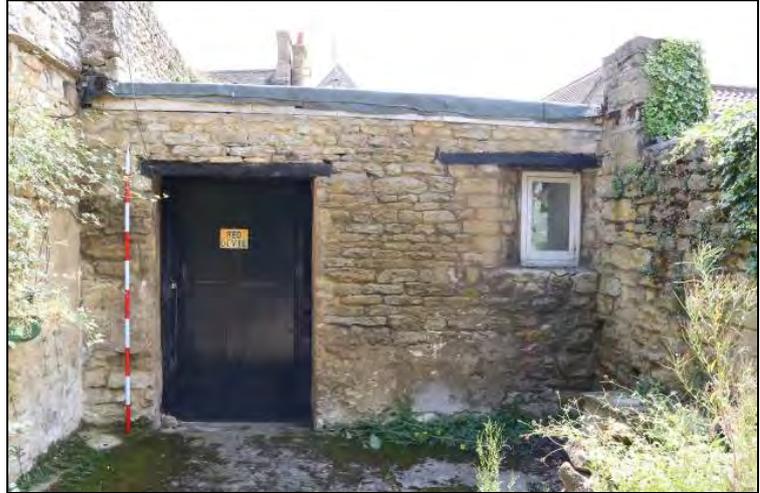
Plate 14 North elevation of Range 5 (formerly internal wall) showing doorway and window aperture with splayed reveal (DP33)

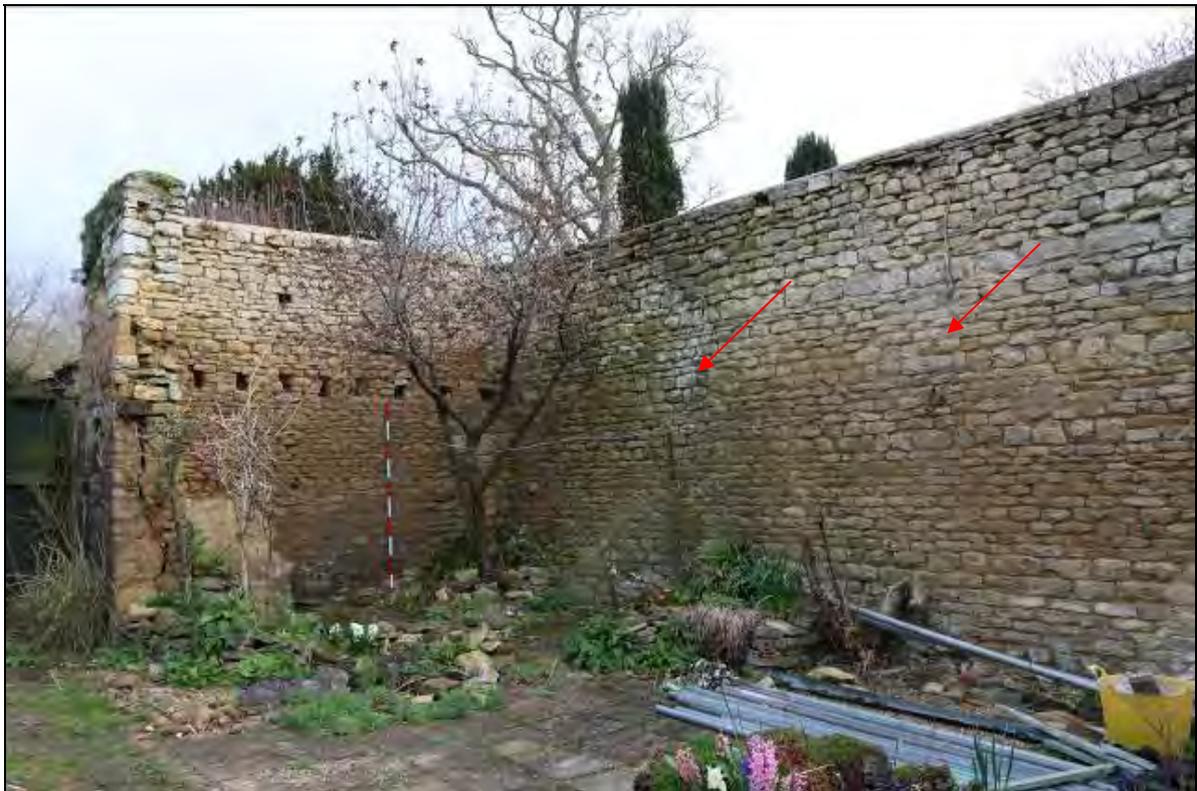
Plate 15 North and east walls of Range 6 showing blocked apertures for lost binding joists (indicated) and sockets for common joists to the left (DP231)

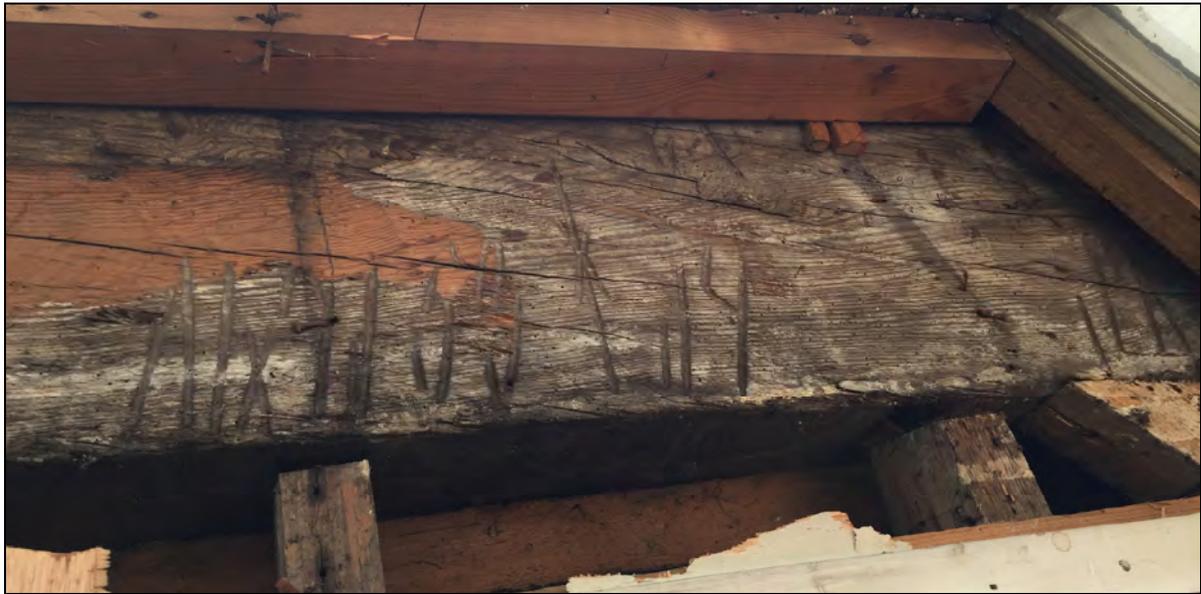
Plate 17 19th century Baltic timber mark on the joist above the modern shop front (GF01) (source: client)

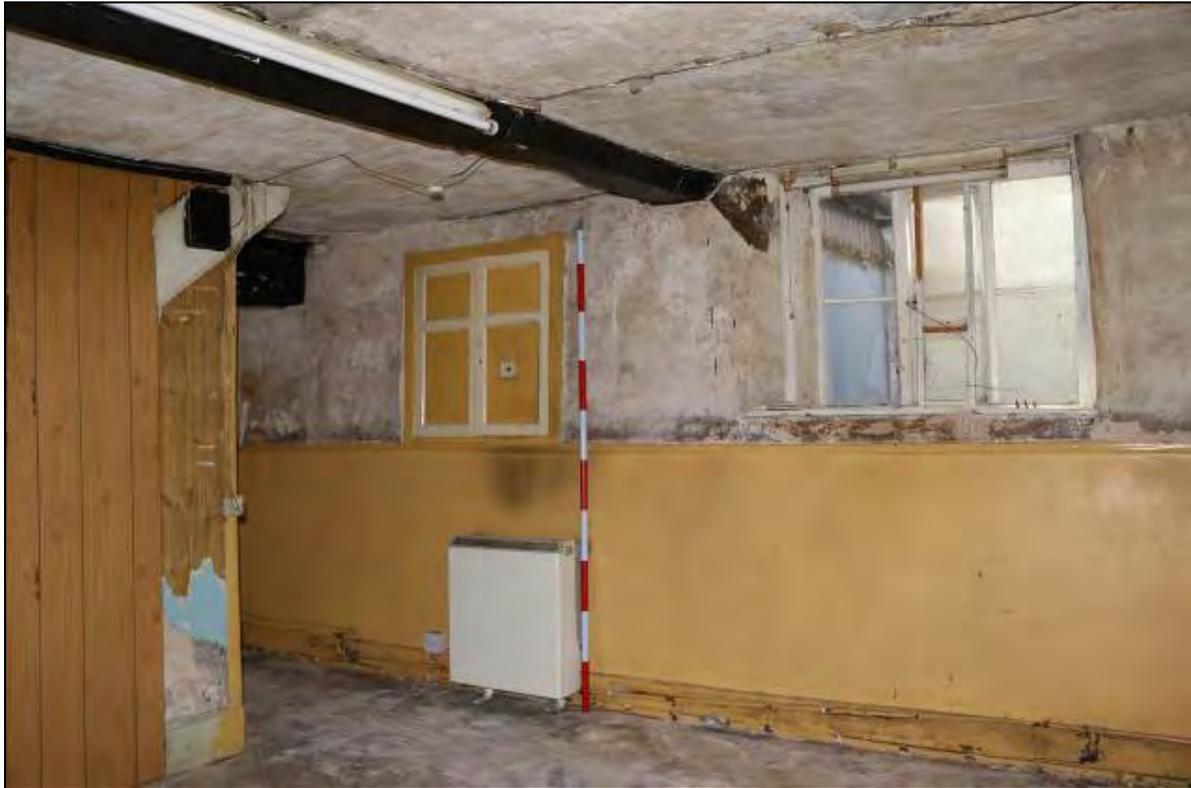
Plate 18 West wall of Room GF02 (Range 2) showing fabric including the late 16th century binding joist and early 18th century cupboard and window (DP83)

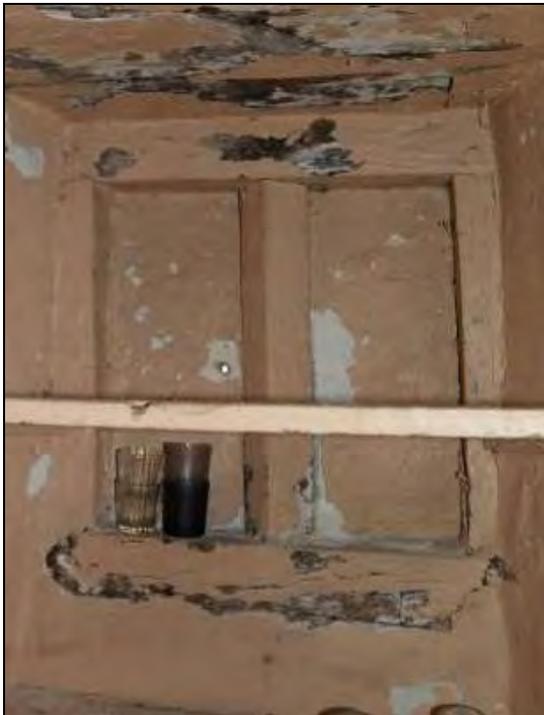
Plate 19 Detail of the blocked mullion window in GF02 (Range 2, DP86)

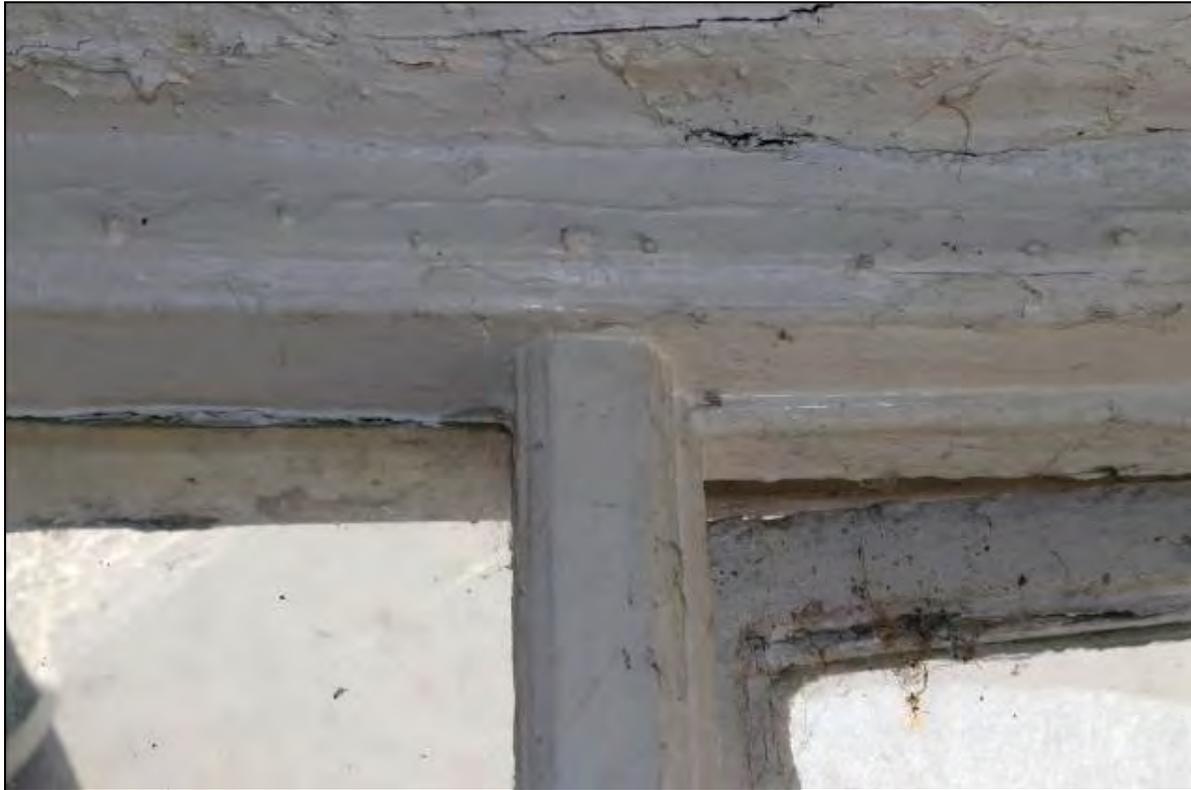
Plate 21 Detail of the moulded mullion on the 18th century three-light casement in GF02 (Range 2) (DP76)

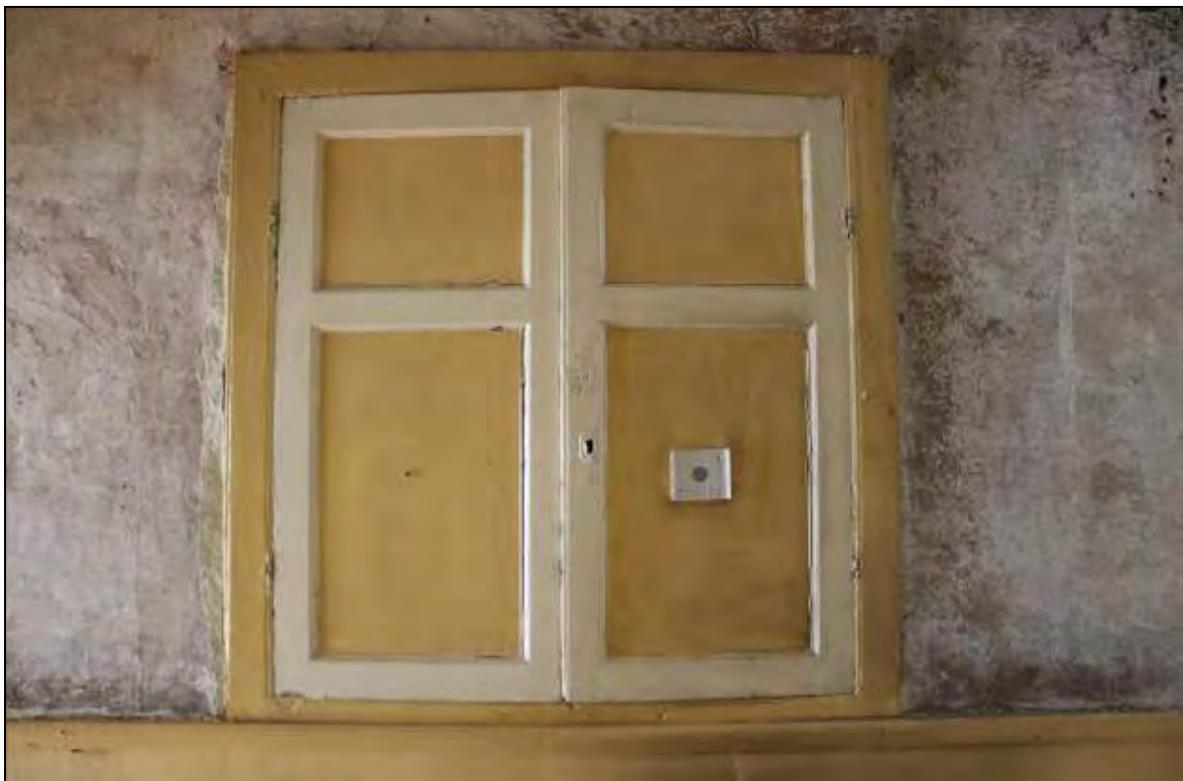
Plate 22 Early 18th century cupboard on the west wall of Room GF02 (Range 2) (DP84)

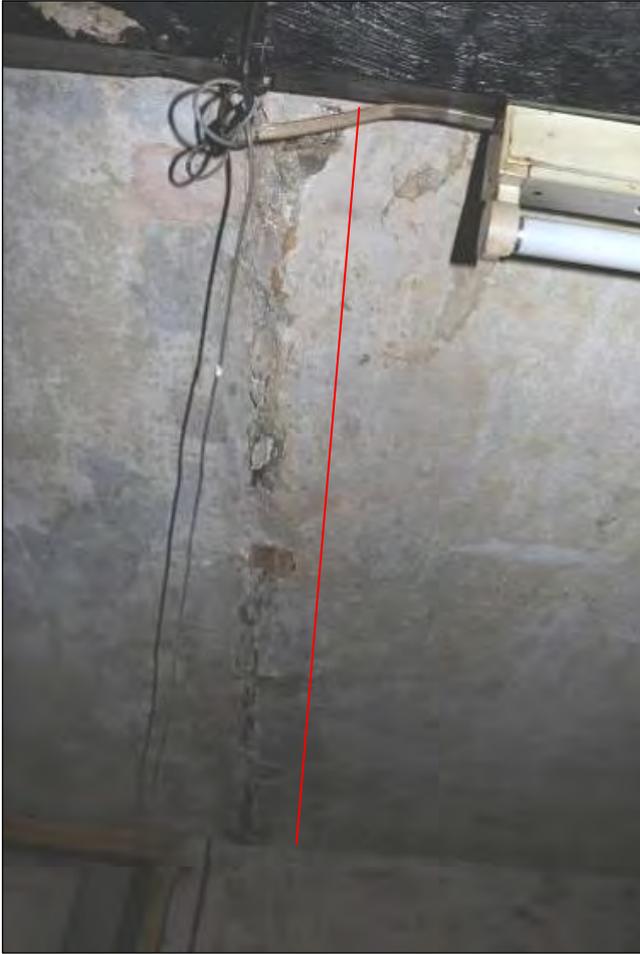
Plate 23 Ceiling in GF02 (Range 2) showing remains of ephemeral partition (indicated) (DP72)

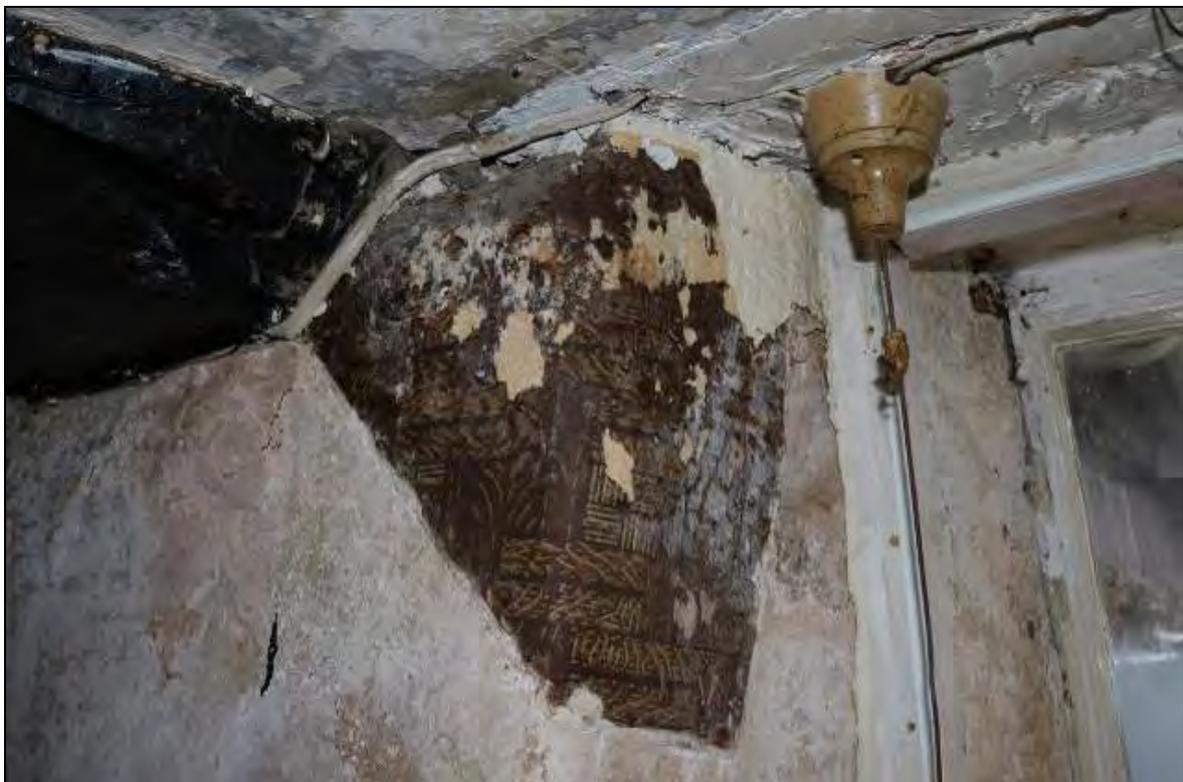
Plate 24 Area to the south of the west window in GF02 (Range 2) showing historic linoleum reused as a repair patch on the wall (DP79)

5.20 A further phase is represented by the insertion of the existing staircase to first floor level, which appears to have coincided with the blocking of the west windows. The staircase is constructed of good timber risers and nosed treads but is currently in a poor state of repair and a slender square newel has been truncated and it is now enclosed from the room by modern fabric. A cupboard occupies the space below the staircase constructed of a simple timber partition clad in riven lath and plasterwork and the floor within is covered in quarry tiles. The door is an 18th century two-panel door with an upper H-L hinge and large rim-lock, but has been repositioned here and the surround has a later moulding. There is too little diagnostic fabric to date the staircase with certainty, though it belongs to a secondary phase; perhaps it has been reconfigured since the 18th century or reflects additional phases within that century. Other features include evidence at ceiling level for a partition on the west side creating a corridor to the rear (**Plate 23**), and a small patch repair adjoining the west window of early linoleum (**Plate 24**).

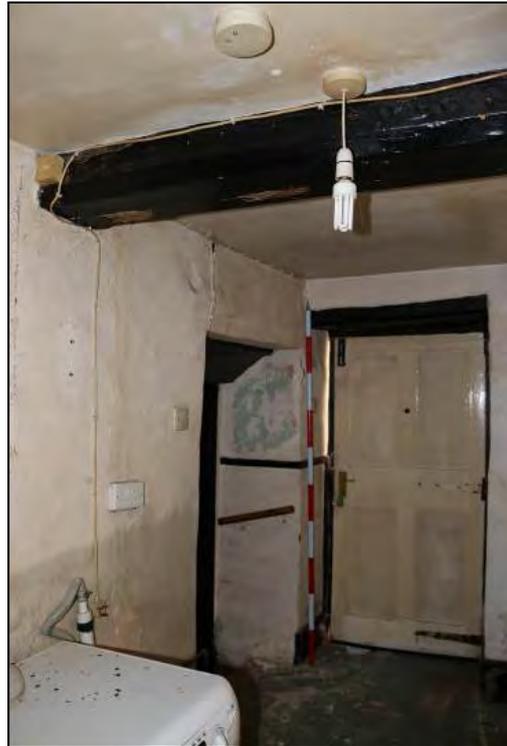
Plate 25 West side of Room GF03 (Range 3) showing external doorway and doorway on the left leading down to Room GF02 (DP68)

5.21 Range 3 has been built against Range 2, utilising and building on the north gable end of that range, but in general is of relatively similar form. The outer walls are of stone but are mostly lined out within and the large chimney stack at the north end was hidden until the recent removal of modern cement render and brickwork. This range is set at slightly higher level so that it is reached via a step up from Room GF02 (**Plate 25**).

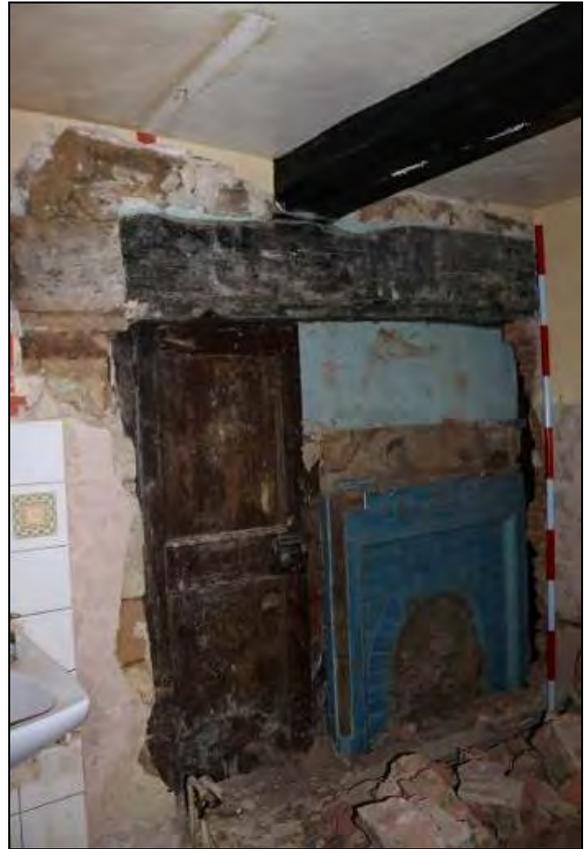
Plate 27 North wall of GF04 (Range 3) showing original inglenook fireplace infilled with 18th century cupboard and early 20th century fireplace (DP205)

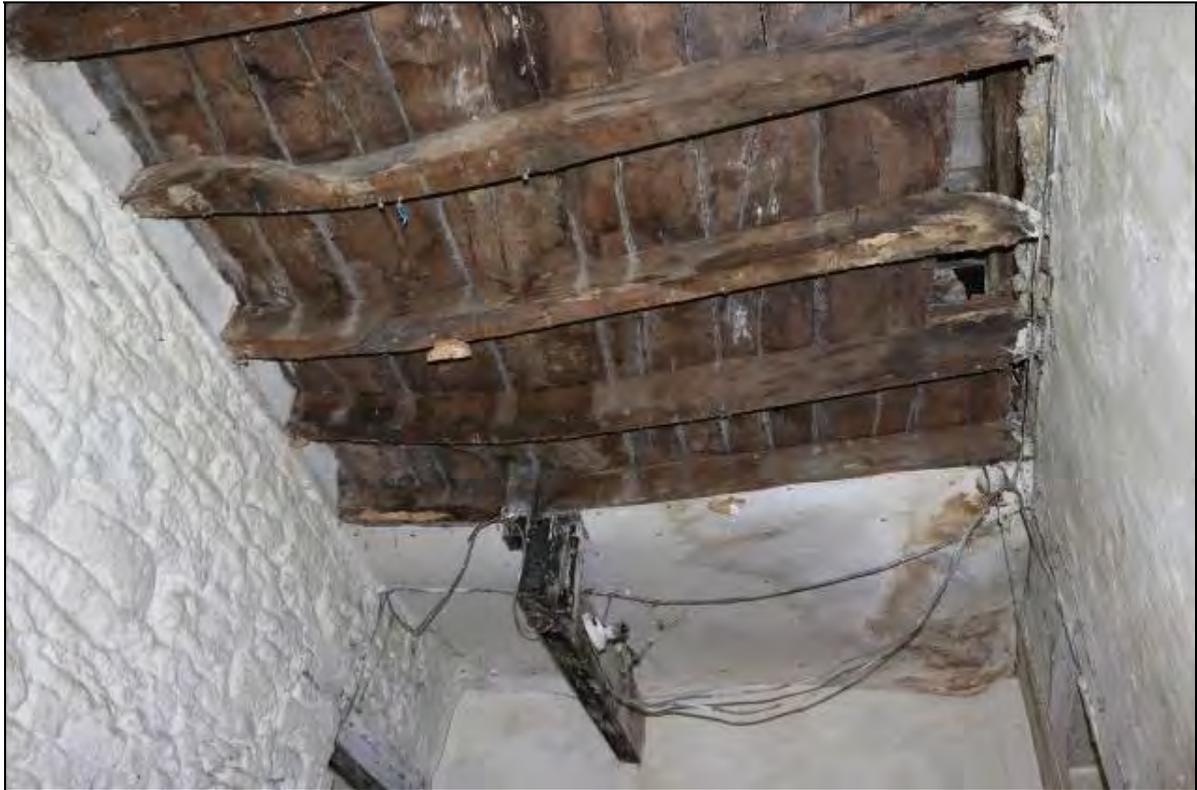
Plate 29 Ceiling of Room GF06 (Range 5) showing waney joists and additional truncated joist to the rear, taken from the west (DP54)

5.26 Range 5 contains two rooms and although much altered and in substantially poor condition, there is some evidence for the previous arrangement. The outer walls are all painted stonework, as is the wall dividing the two rooms, and the floor is of concrete. The south room (GF06) is a small narrow space with a modern door on the west and a doorway on the north side which contains an 18th century two-panel door. This has an original latch but has likely been relocated to this position from the principal ranges. The ceiling structure is formed of a series of slender waney joists extending north-south which are in relatively poor condition, and above these fairly wide floorboards are visible (**Plate 29**). This provides supporting evidence that this range formerly held a second floor. The east end, however, is underdrawn with modern boarding so the area above is not visible, but includes a short section of an east-west thin-section joist set below the ceiling level. Interestingly, a timber jointed at the east end appears to be the base of a rafter, though nothing further is visible and it may have been reused here.

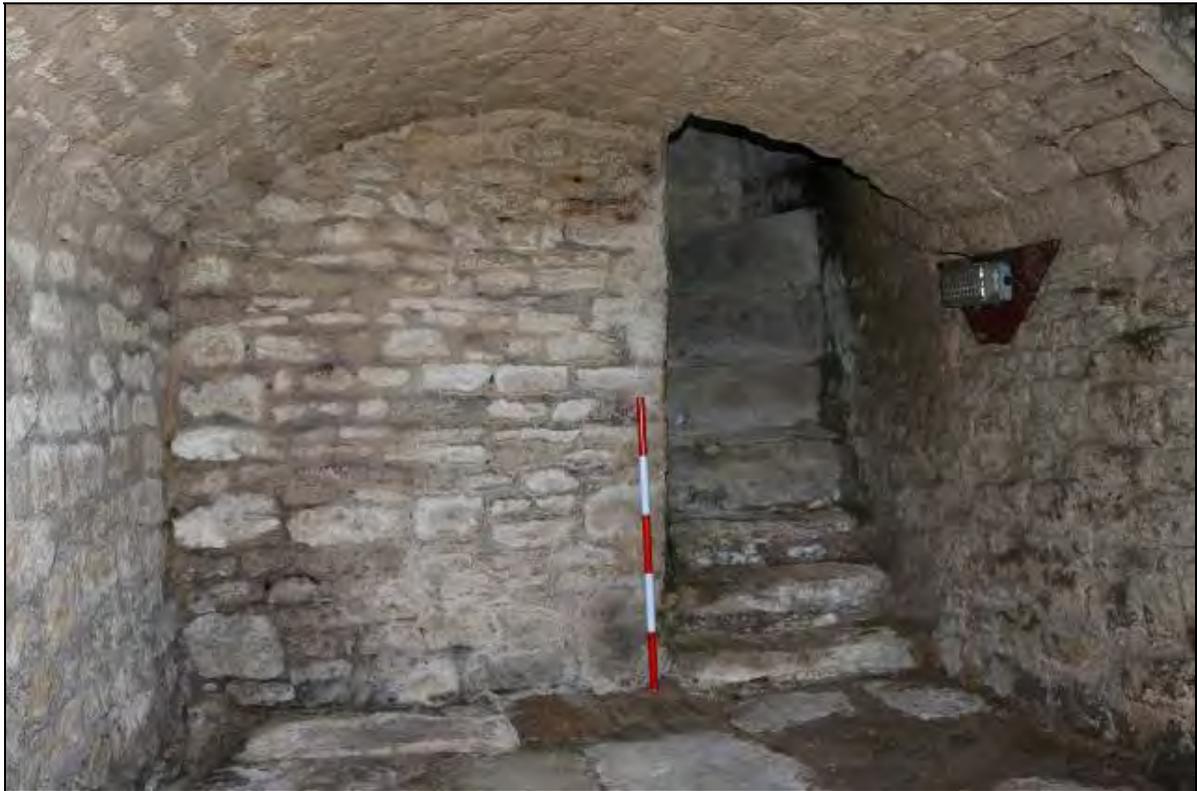
Plate 30 Interior of the barrel-vaulted cellar room CF01 (Range 3) (DP199)

5.29 The basement room forms a small stone-lined space aligned north-south with the outer walls rising to a barrel vault (**Plate 30**). The floor is covered with large stone flags with what appears to be a drain at the south end close to the steps. A cellar light lies on the west, the aperture framed with large limestone blocks. The aperture at ground level above is now covered with a modern hatch cover, but there appears to have been a lower hatch; a metal hook is fixed to the ceiling close by. Small fragments of iron fixings are visible elsewhere but their form is less well expressed.

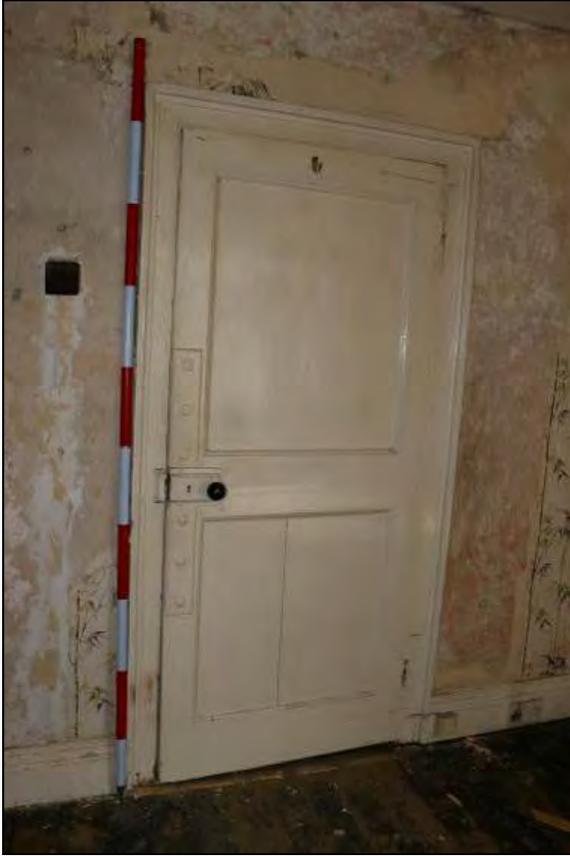
Plate 31 18th century two-panel door on the north side of Room FF01 (Range 1) (DP126)

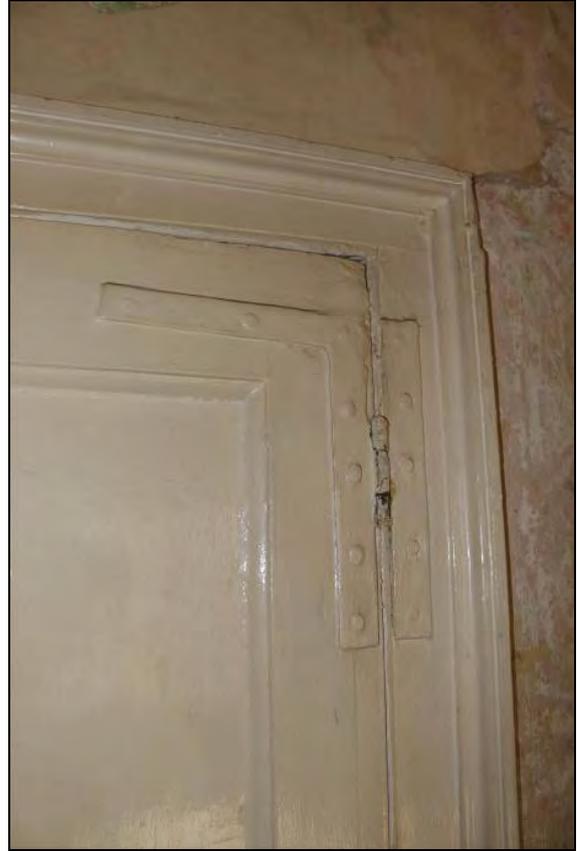
Plate 32 Detail of the H-L hinge on the 18th century two-panel door on the north side of Room FF01 (Range 1) (DP127)

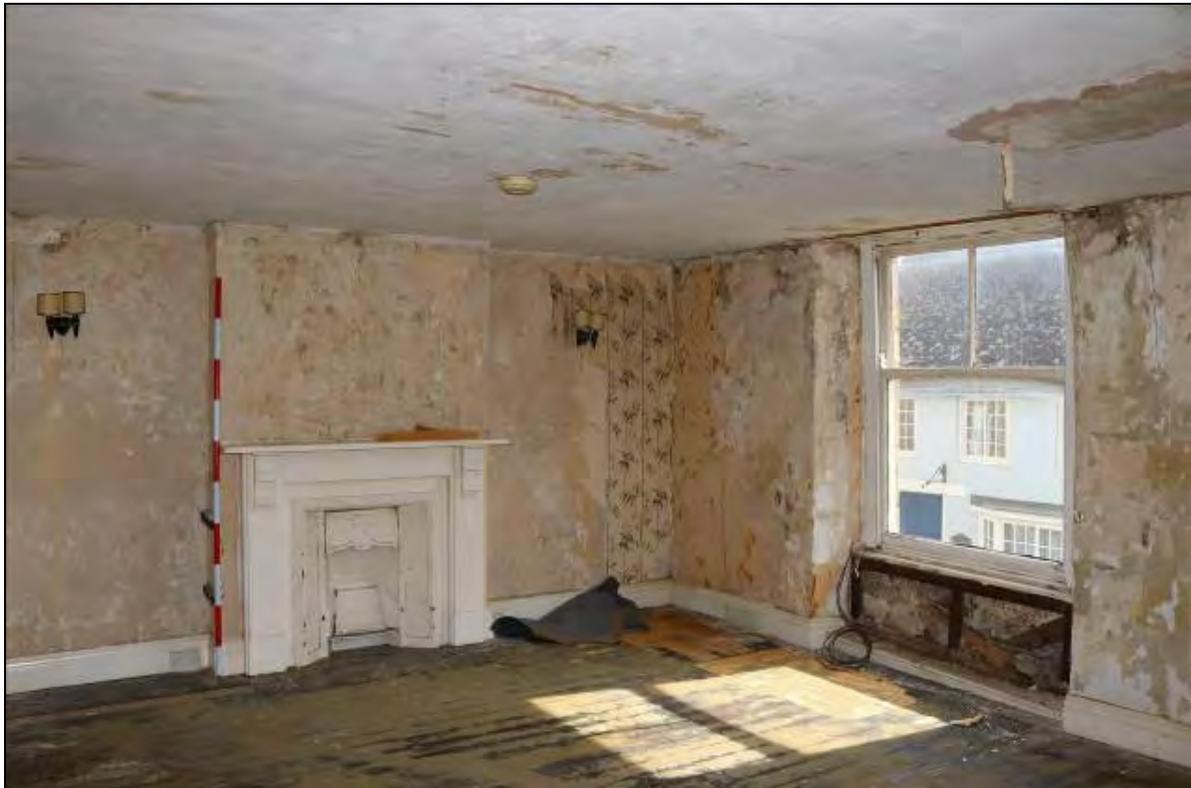
Plate 33 Room FF01 (Range 1) showing fireplace and sash window overlooking the street (DP129)

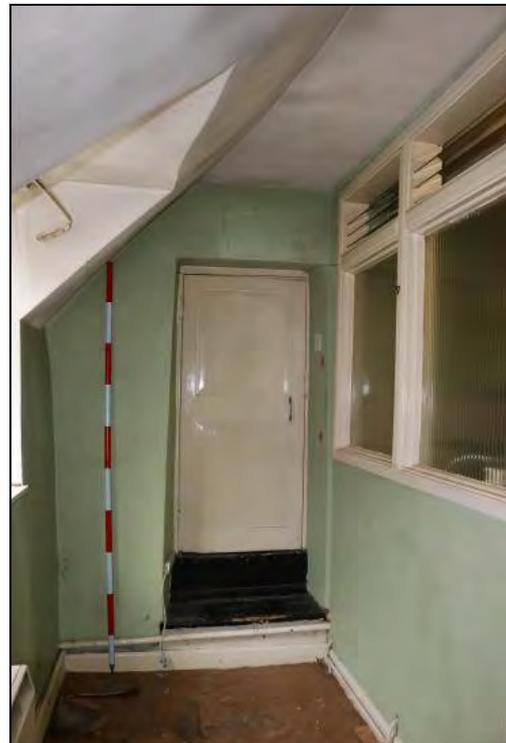
Plate 34 Hallway FF03 (Range 2) showing later 20th century partition with historic door to the rear (DP136)

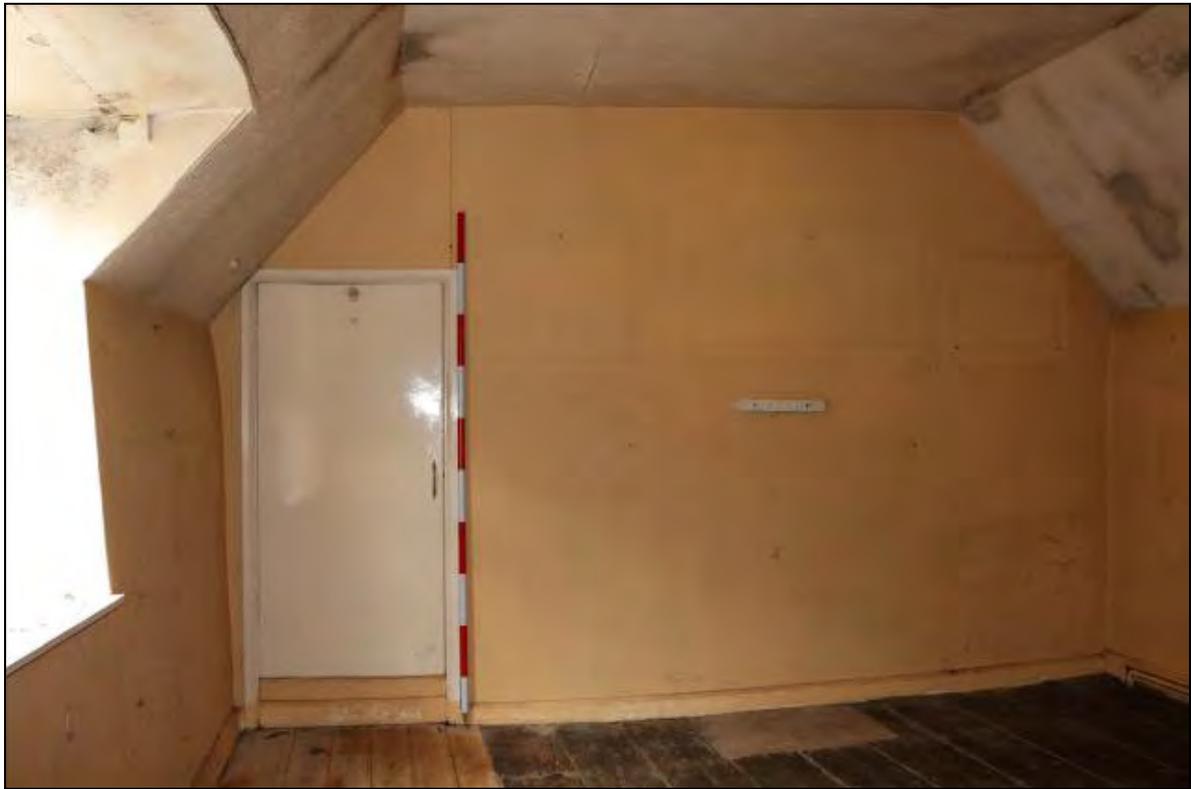
Plate 35 North side of Room FF05 (Range 3) showing position of former fireplace with cupboard to the left in the position of a former staircase (DP145)

5.34 As with the areas to the south, Room FF05 (Range 3) occupies part of the roof space but is all underdrawn so none of the roof structure is visible (**Plate 35**). The floor is covered in good elm boards that measure 10-10½” apart from a narrow section of boarding that extends adjacent to the south wall, and here these are even wider than those in Room FF04 with occasional examples being 15” (381mm) wide (**Plate 36**). The walls are all plain apart from a crude skirting board though a hearth is outlined on the north side indicating a blocked fireplace. The doorway from corridor FF03 contains the 18th century doorway, but the frame is also of interest in having a chamfer and stopped door head as well as a chamfered lintel above. Both the dormer window on the west and a cupboard door in the north-west corner are modern. The cupboard occupies the space over the flank of the chimney stack in the position of an earlier staircase; the small stone window aperture lies here and an area of modern boarding lies in the vicinity.

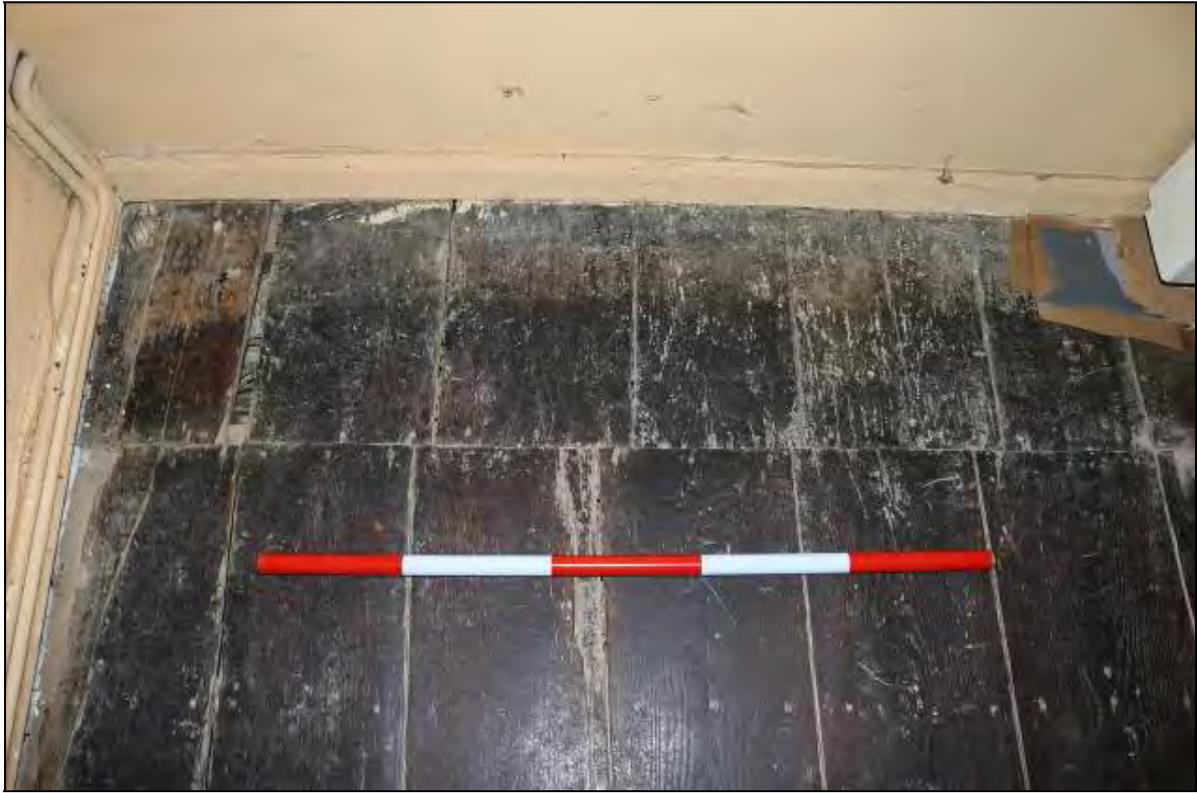
Plate 36 South side of the floor in Room FF05 (Range 3) showing straight joint between sections of wide historic floorboarding (DP154)
