37 WEST STREET, OUNDLE
NORTHAMPTONSHIRE

Historic building recording: Level 3

JULY 2020

TANSY COLLINS
Historic Buildings Survey

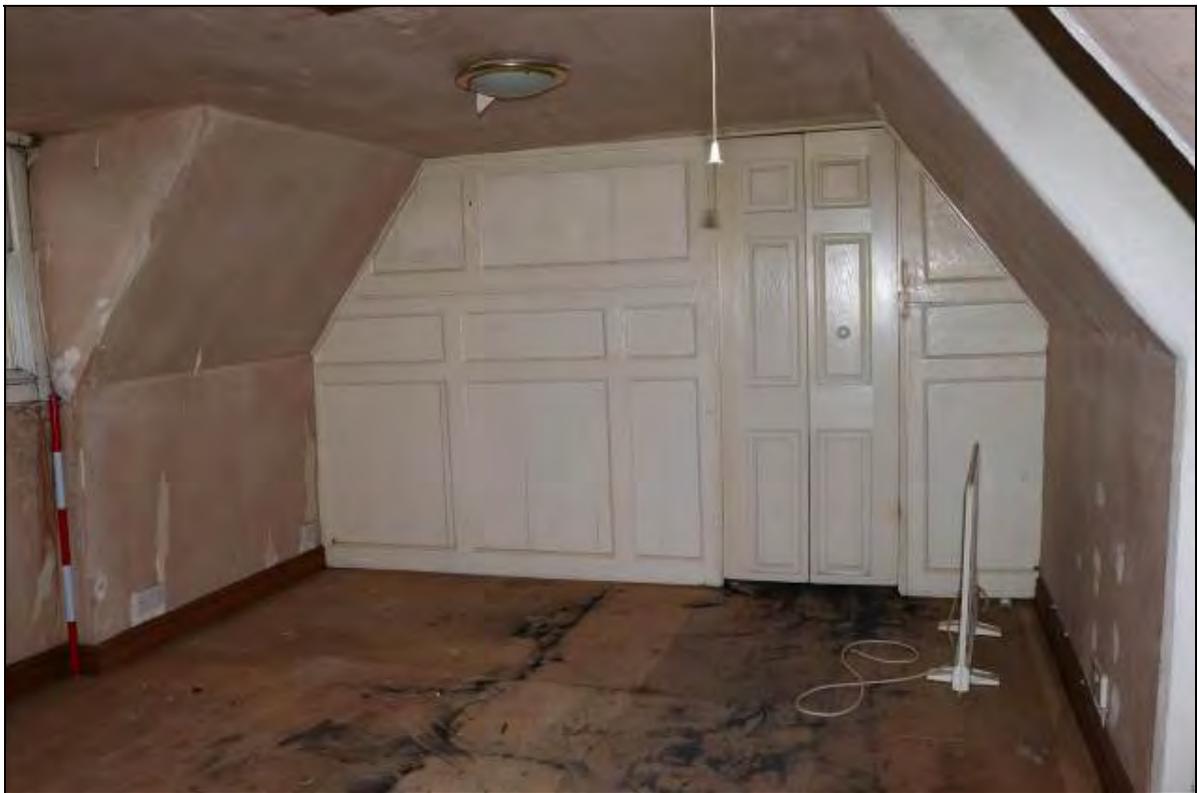
Plate 37 Room SF01 (Range 1) showing historic panelling relocated from elsewhere, taken from the east (DP168)

5.36 The attic space formerly comprised a single space but has been divided with a small room at the west end housing a WC. The space is relatively sterile, with modern dry-lining all round and a four-over-four sash window on the south, which replaced earlier reed lath and plaster and a similar window in 1992 following a planning application. The only feature of note is the partition which is made up of historic panelling introduced from elsewhere and cut down to fit (**Plate 37**). The doors are modern.

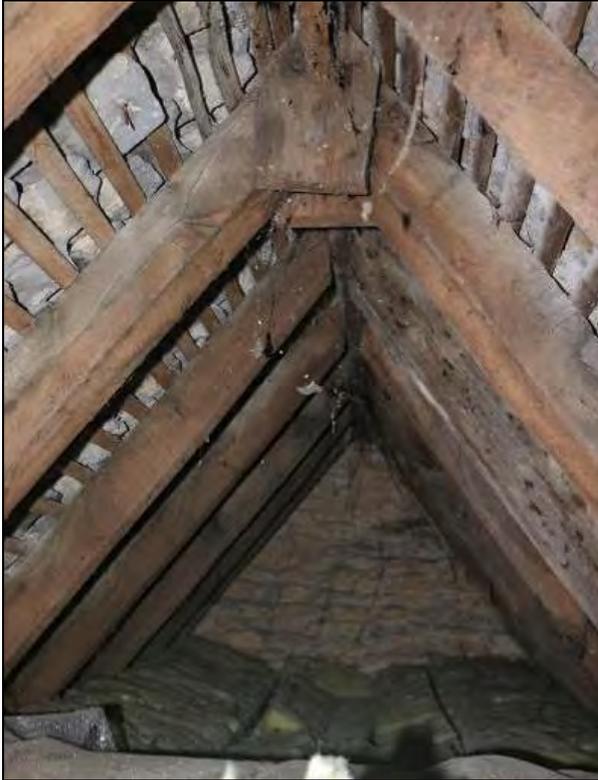
Plate 38 Roof structure over Range 1 showing rafter couples with occasional yoke piece, taken from the east (DP185)

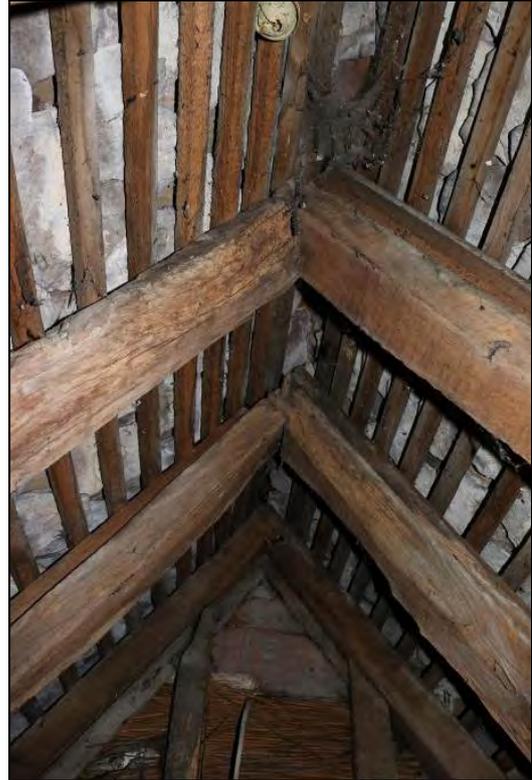
Plate 39 Apex of the roof structure over Room FF03 and FF04 (Range 2) showing bridled and pegged rafter couples (DP155)

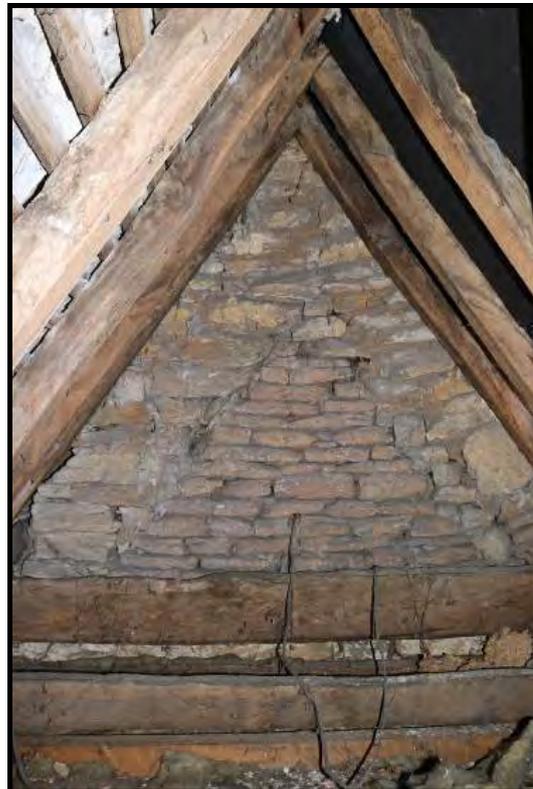
Plate 40 Roof structure (Range 3) showing north gable of Range 2 having been built up with Range 3, taken from the north (DP224)

5.42 The roof structure over Range 3 was assessed and recorded following the removal of the Collyweston slates in advance of the repair and re-cladding of the roof. From the exterior, some rafters of the west roof pitch are exposed as well as the upper surface of the north gable end onto which the end rafter couple rests. Below, the rear face of the lath and plaster lining the room below is visible where the laths are riven and fairly wide and the plaster is of lime. At the south end the stonework of the gable is significant in that it is built up over the gable end wall of Range 2 (Plate 40). The stonework of the lower gable is of fairly thin pieces laid in courses, while the upper masonry is of fairly large blocks interspersed with smaller pieces.

5.43 The roof spans a single bay and is of side-purlin form, the purlins housed in the stonework of the gable ends and a single thin-section collar clasping the purlins at the south end adjacent to the end gable. The rafters are of fairly square section and ride over the purlin, to which they are pegged, and are bridled and pegged at the apex. A number of rafter couples retain deeply chiselled assembly

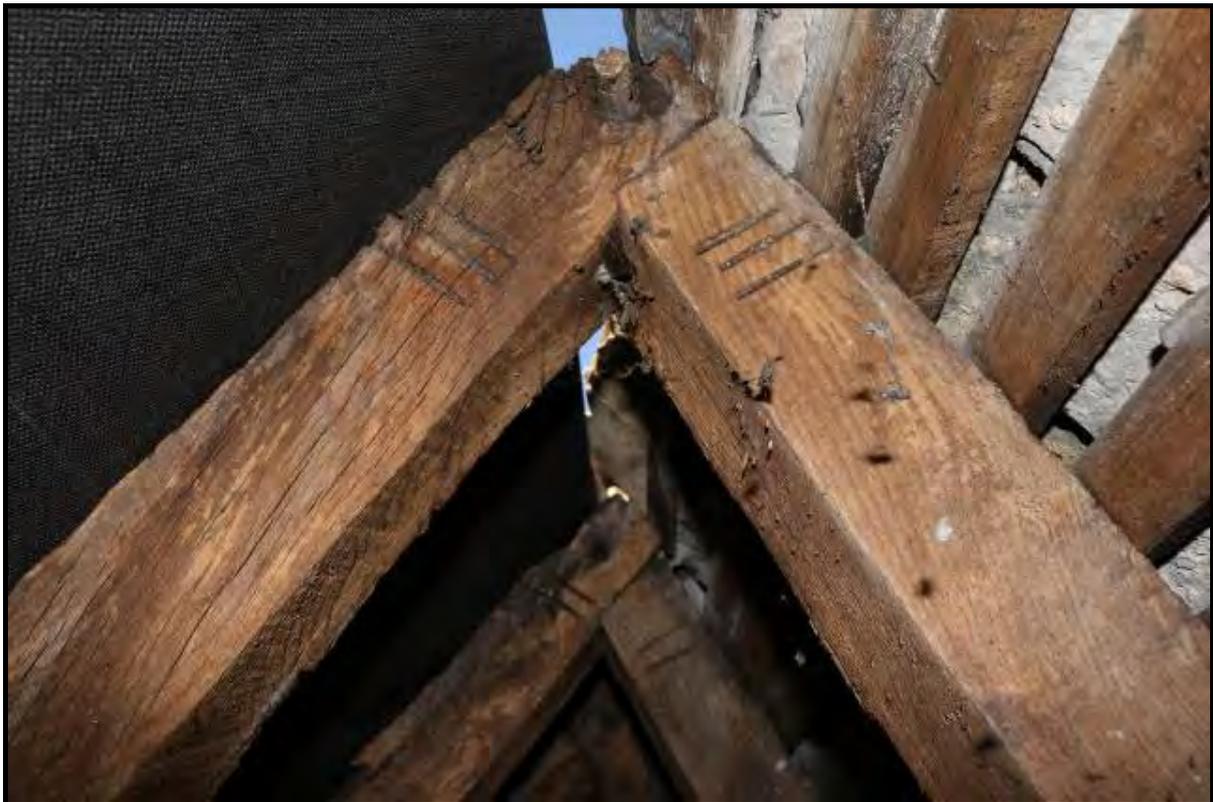
Plate 40 Roof structure (Range 3) showing rafter couples bridled at the apex with chiselled assembly marks (DP226)

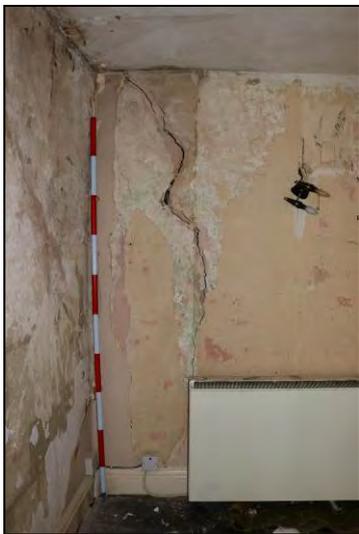
DP 135
Detail of the west wall of Room FF01 (Range 1) showing cracking in the original fabric, taken from the east

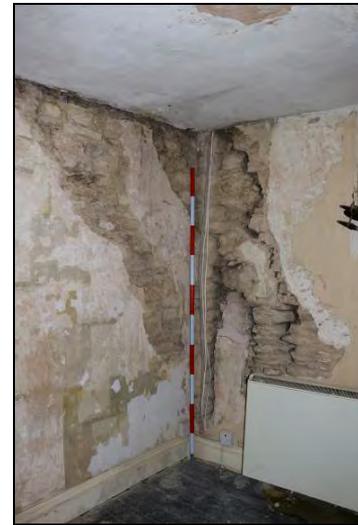
DP 214
South-west corner of Room FF01 (Range 1) showing structural cracking, taken from the north-east

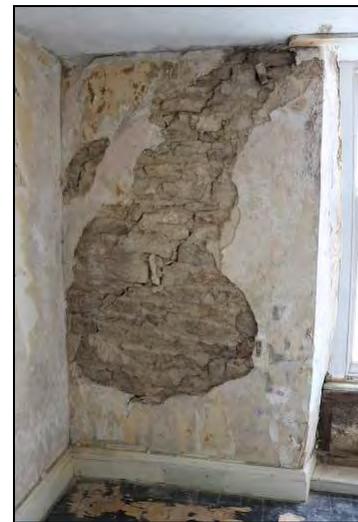
DP 216
Detail of the south wall of Room FF01 (Range 1) showing structural cracking, taken from the north
