Medieval formwork imprints in the Basilica of St Anthony in Padua

Louis Vandenabeele

Institute of Construction History and Preservation (IDB), ETH Zurich, Switzerland

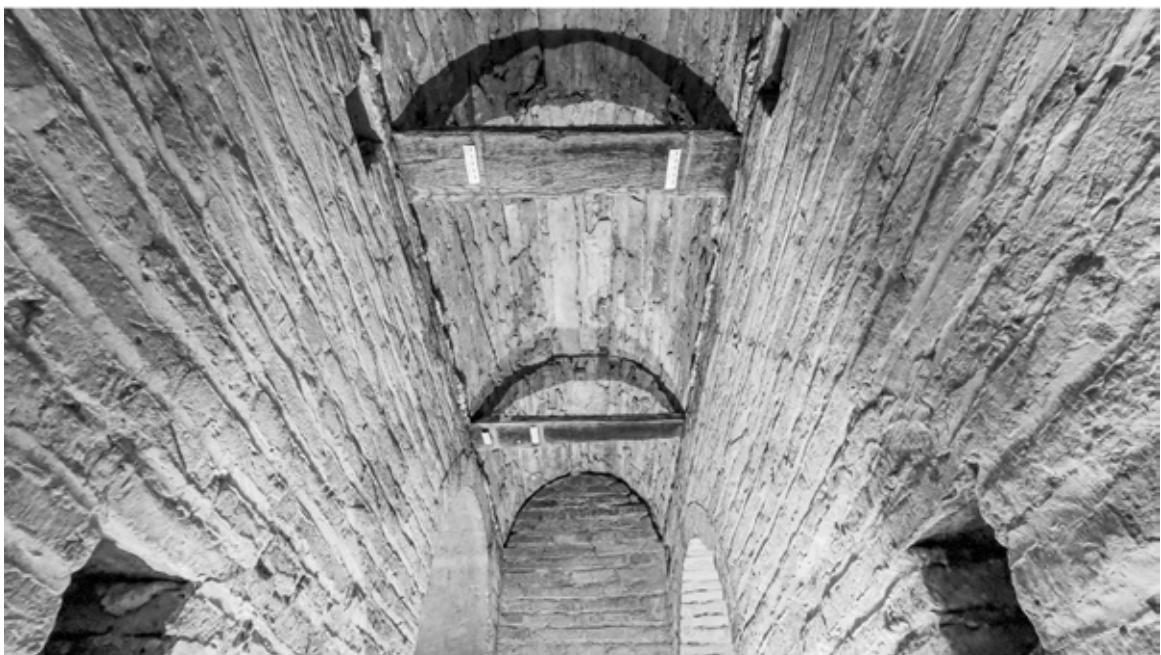
Figure 2: Boards used for vaulting the corridors of the front façade in the thirteenth century (picture: author)

The width of these corridors varies between 55 and 80 cm and their inclination can reach up to 50°. The highest corridors are to be found in the front facade (3.65 m), likely explaining why some components of the original formwork which do not hinder the passage were left in place (Fig. 2). These transversal elements consist of 3.5-cm thick boards inserted after completion of the vertical bricklaying and before the start of the barrel vault (Fig. 3). As revealed by imprints in the abundant mortar binding the bricks, each board was topped by a semi-circular element (likely made of two or three pieces) supporting about ten longitudinal boards, the positions of which are still perfectly discernible on the mortar or at the ends of the corridors where corresponding notches can be observed. Some of these longitudinal elements, albeit absent in the front façade, have been recovered intact in other corridors above the crossing and at the base of the northern bell tower.

Wood species analyses have indicated that the transversal boards consist of spruce, unlike the original roof structures for which fine-grained larch were felled in the last quarter of the thirteenth century [4]. Some boards are also drilled multiple times, indicating that they could have been part of a previous structure, likely a scaffolding fastened with ropes. Thus, as one might have expected, medieval builders did not use timbers of similar qualities for temporary formwork and permanent roof structures.

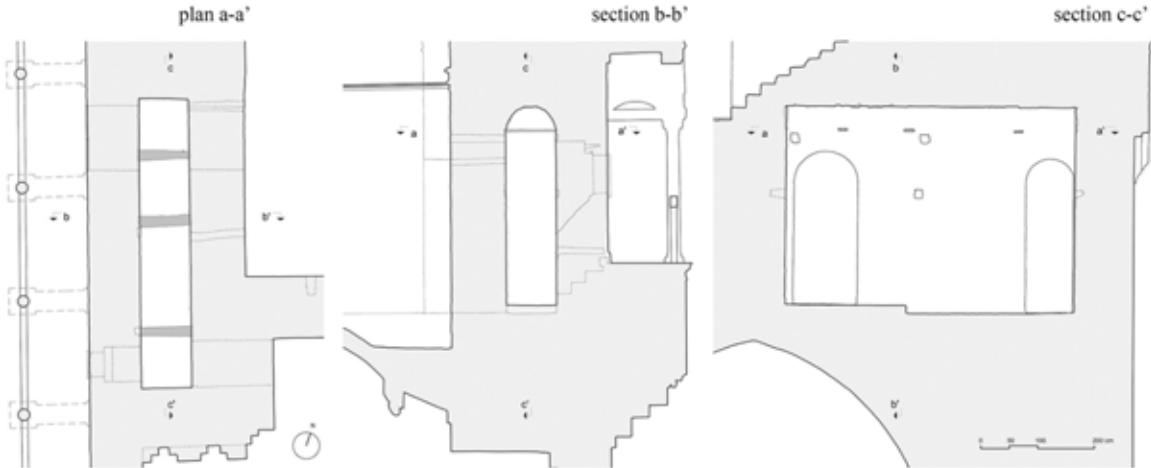
Figure 3: Three out of four original boards survived in this north-western corridor of the façade (drawing: author)

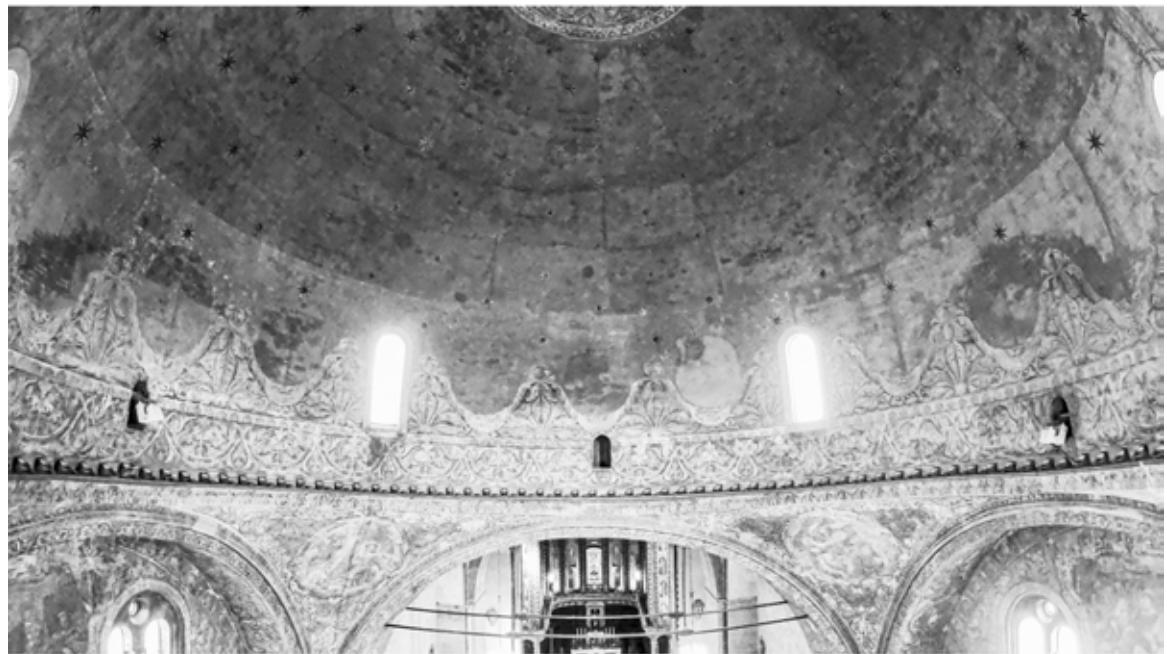
Figure 6: Wide-angle view of the intrados of the façade dome (picture: author)

A last example of traces left by temporary structures can be observed on the intradoses of the masonry domes of the Basilica, the diameter of which varies from 14.3 to 14.46 m and the thickness from 32 to 43 cm. Although direct formwork imprints are masked by plaster and paint (Fig. 6), geometrical deformations introduced by the centring clearly appear on the laser scan survey, as the horizontal deviations from ideal circles can reach up to 8 cm. (Fig. 7). The first traces start about 120 cm above the windows, indicating that the lower halves of the drums were likely raised without formwork. In the upper parts, the traces show the arrangement of 16 equally spaced centres converging at the highest point of the slightly ogival dome. How the centring was assembled and supported is currently under investigation. By systematically comparing the position of the centres to those of the putlog holes visible on the exterior of the drums (using drone photogrammetry) or under the plaster of the intrados (thermal imagery), one should be able to determine whether the hemispherical formwork was “flying” or supported by a 30-m high scaffolding (examples of both systems can be found in [7]).
