Building Investigation and Assessment of Significance

**The Old Zion Chapel
60, High Street
Birstall
West Yorkshire**

**Bev Kerr
April 2012**

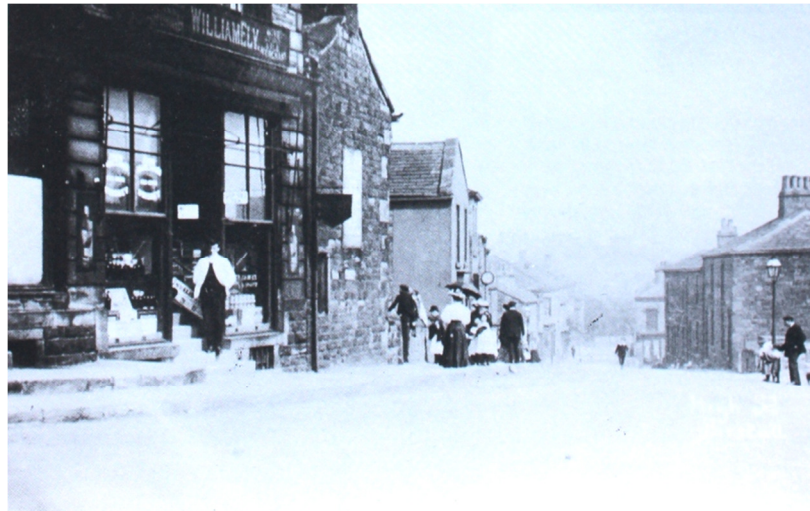
Figure 5: High Street in the late nineteenth century.

In contrast to the quiet backstreet it is today, High Street was once a focus for the community in Birstall (figure 5). Below The New Inn public house was the village market place. It relocated to its present position in 1887. Much of the older housing and shops were demolished in the 1960s²⁰. Now a mixture of modern and nineteenth century housing, it is characterised by traditional buildings constructed of the local honey-coloured sandstone and stone roof tiles, whilst much of the modern housing is of brick and concrete tile (figure 6). High Street sits above part of the village and commands views across the valley.

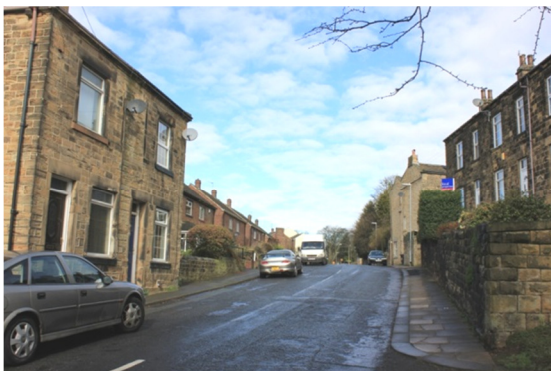
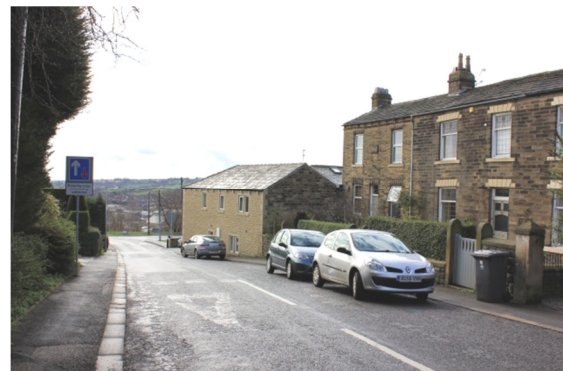
Figure 6: Left – view north-west above no. 60 along High Street. Right – view south east down High Street. Note the New Inn in the middle of the photo has recently been converted to housing whilst the old market lay below this.

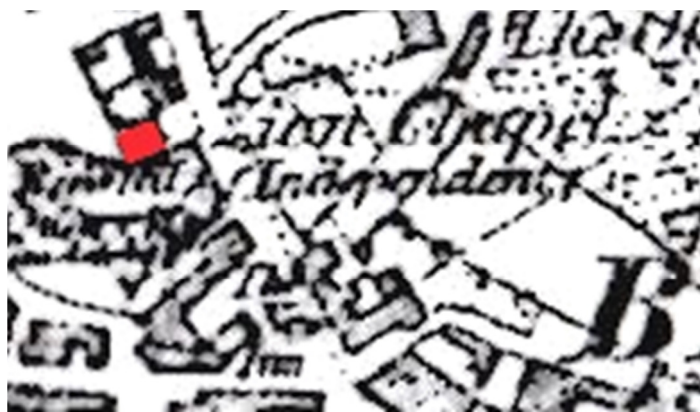
Figure 7: 1854 OS 61:10,560 map showing the 'Zion Chapel, Independent' marked in red.

But the New Connexion of Methodists do not appear to have worshipped there for long as deeds show that the chapel was sold by them in April 1847 to an Independent denomination (later known as the Congregational Church)²⁶. On the 1854 Ordnance Survey 1:10,560 series map, Zion Chapel is marked as 'Independent' (figure 7). What became of the Methodist New Connexion is unclear, but one suggestion is that some or all joined the Wesleyan Reform Church at Mount Tabor in North Terrace²⁷. For the new independent congregation this was only a temporary move, as new premises were built for them in Low Lane in 1853 (figure 7). This chapel was later called the Birstall Salem Congregational Church, and was also known as Birstall Independent Church²⁸. Built in the neo-gothic style, it is thought to have been originally built as the Sunday school with a church planned for the adjacent land. This did not materialise, and the Sunday school became the place of worship²⁹. Sunday schools had become an important part of non-conformist activity and they were either housed nearby or planned and incorporated into newly built chapels³⁰. The Zion Chapel at High Street simply couldn't accommodate this development.

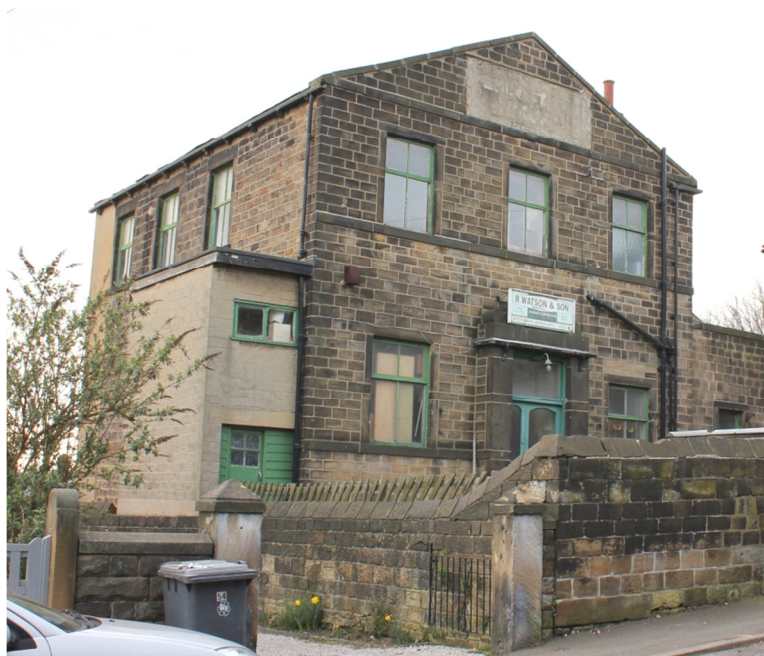
The former Zion Chapel, now 60, High Street, Birstall is rectangular and of three bays wide by three bays deep and gabled to the road. It is a two storied building of hammer dressed sandstone blocks with a stone slate roof, cement ribbon pointing, and part rendered to the sides and rear. It has two red brick chimneys attached to the north and west of the building. Some of the original timber guttering remains (figure 9)

Figure 9: Front façade of 60, High Street.

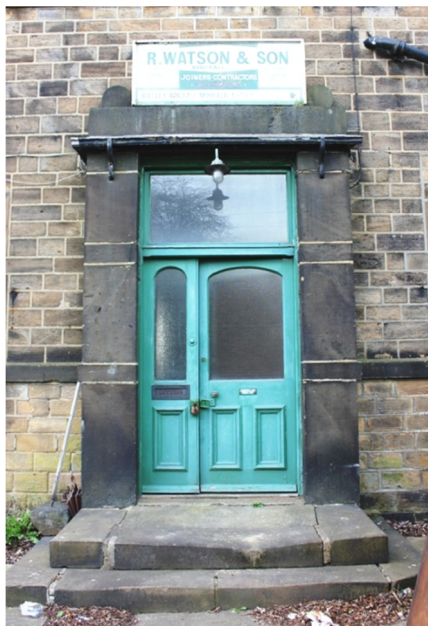
The building is symmetrical with a central projecting porch with a timber half glazed door, and rectangular light above. The door, with heavy moulded lower panels and arched glazed panes above and letter box appear to be of the later nineteenth century and probably date to when the Watson's lived here after 1879³⁶. The original door would probably have been a solid panelled door, rather than glazed³⁷. The steps up to the front porch are heavily worn and off-centre and suggest that even if they are not the original doors, they have been in-situ for many years, or respect an original door arrangement (figure 10).

Figure 10: front door and porch.

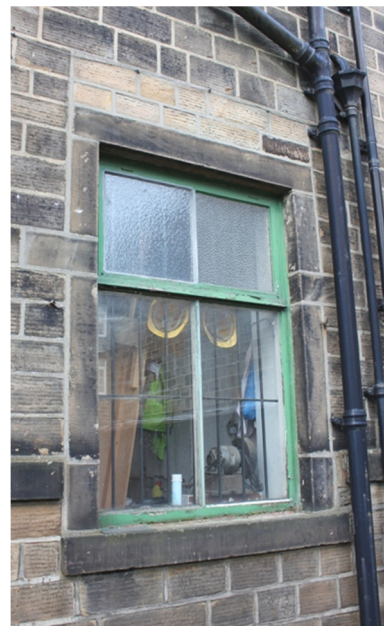
Figure 11: Re-set window to front gable.

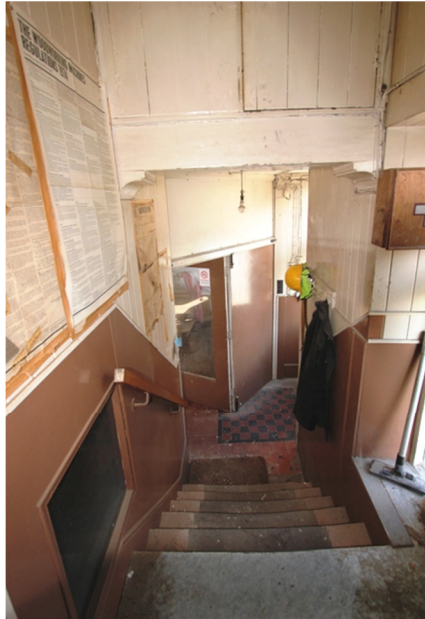
The entrance lobby floor is partly tiled in simple polychrome 'checker-board' pattern quarry tiles. These types of hard wearing tiles were very common in the Victorian household for entrance paths and halls³⁹ and mass production only began in the 1840s, after the chapel was constructed⁴⁰.

Figure 12: Looking down the first flight of stone stairs into the entrance lobby, facing north. Note the checker-board pattern to the quarry tiles cut by the modern doorway into the workshop beyond.

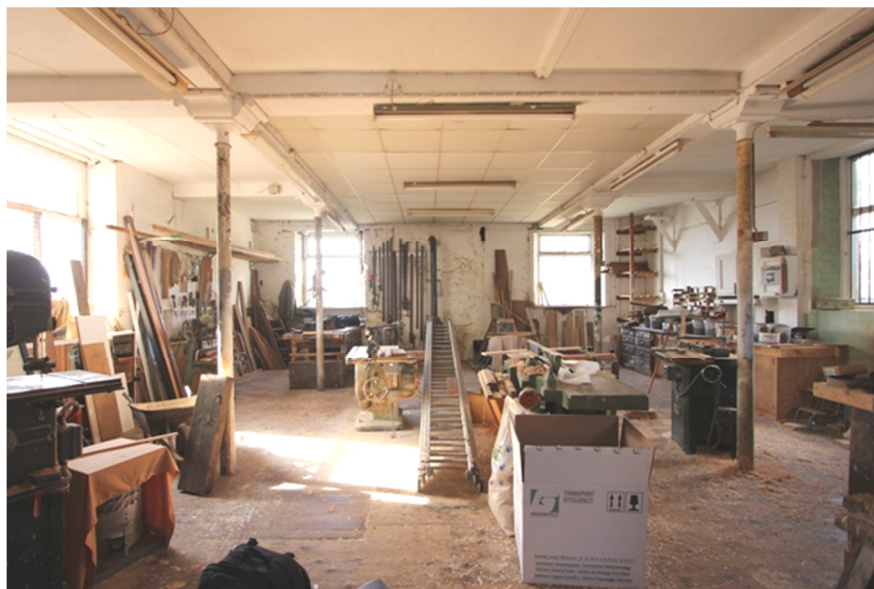
Figure 13: view facing west of the ground floor. Note the four slender iron columns and the modern suspended ceiling which would have once been open to the gallery above. The area to the right was once divided off as domestic accommodation – note the green tiles would once have lined the kitchen.

The ground floor is open plan, lit by five windows, with the entrance to an understair cupboard beneath the cantilevered stone stairs, whilst another door leads to the old vestry on the right. The main features observed were the four slender iron columns supporting beams to the ceiling, whilst the workshop contains a variety of machines,

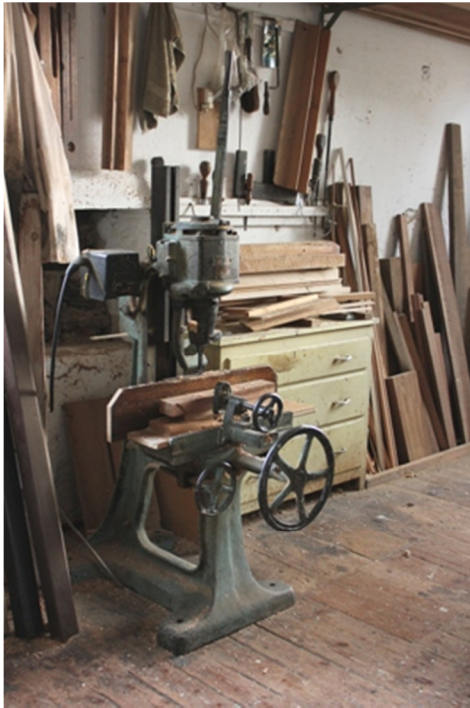
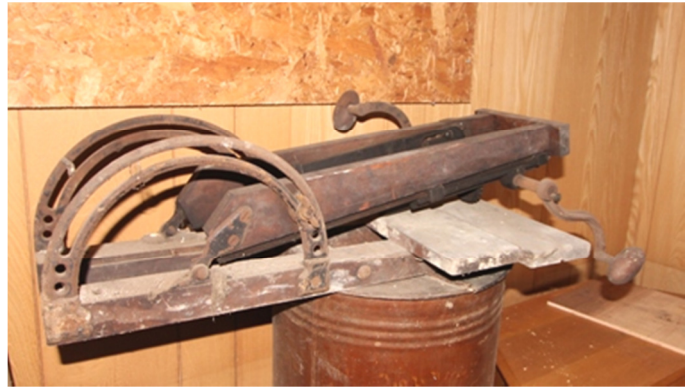
shelving, benches and equipment from its use as a joiners business for over 100 years. The majority of the equipment is powered by electricity and dates to the twentieth century, whilst a number of pieces of equipment may be much older; for example, a brace for drilling holes to form a king post truss whilst other pieces were hand powered or appear to have been adapted with the addition of electrical motors (figure 14).

Figure 13: Twentieth century workshop equipment (left), whilst (right) this brace for drilling holes for King Post trusses is probably nineteenth century in date.

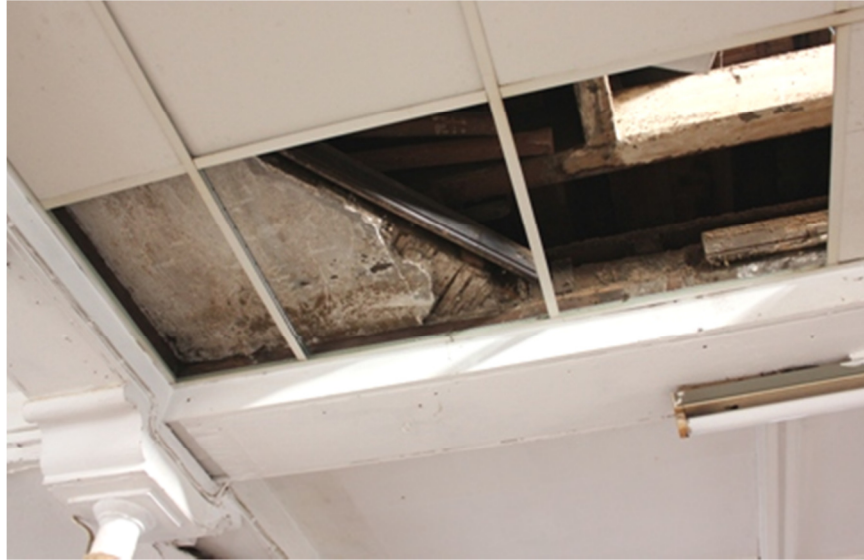
modern suspended ceiling indicates the central area which would have been open to gallery above, and shows that, despite the modest size of the chapel, it would have had a gallery running around three sides of the building. Removing some of the suspended ceiling tiles, it was possible to locate the edge of the lower gallery floor (figure 14).

Figure 14: Removal of tiles from the suspended ceiling reveal the underside of the gallery above. Note the decorative top to the iron column (camera facing east).

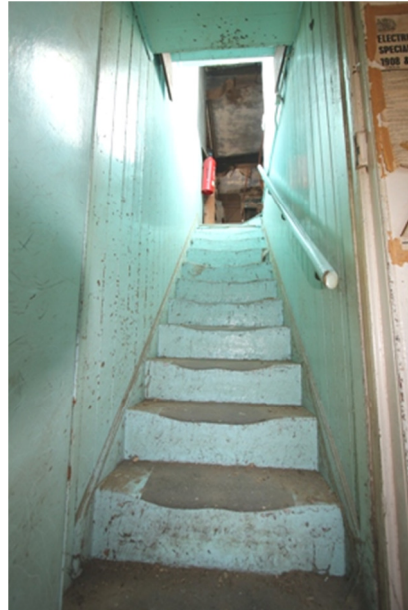
The stone staircase leads up to a modern door through to the 1970s extension, which did not form part of the survey. The stairs then turn right ninety degrees, through a modern door and up narrow and worn stone stairs to the first floor (figure 15). The stairwell walls are clad in tongue and groove panelling. The stone steps show many years of wear.

Figure 15: Narrow stairs to the second floor. Note tongue and groove panelling and worn steps.

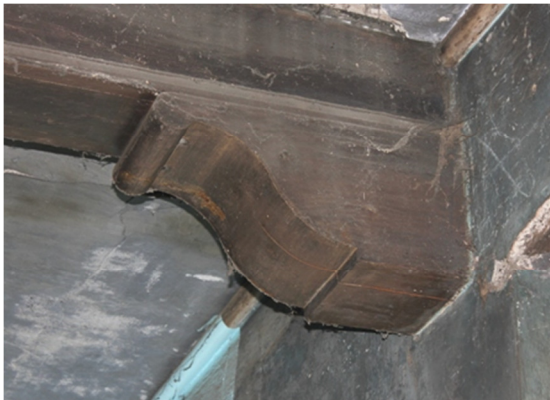
The first floor has a slightly barrel vaulted ceiling of lath and plaster, supported on three trusses terminating in large scroll brackets (figure 16). There are number of plaster ceiling roses indicating the position of light fittings (figure 17). Immediately noticeable are a number of changes in the floor level. It has also been divided into a workshop area whilst three rooms have been inserted into the whole space for domestic use.

Figure 16: Bracket to ceiling

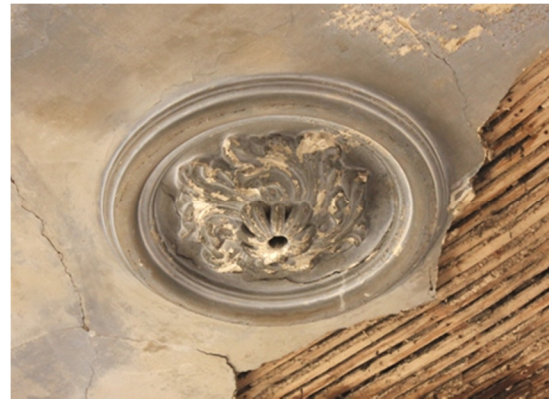
Figure 17: Ceiling rose

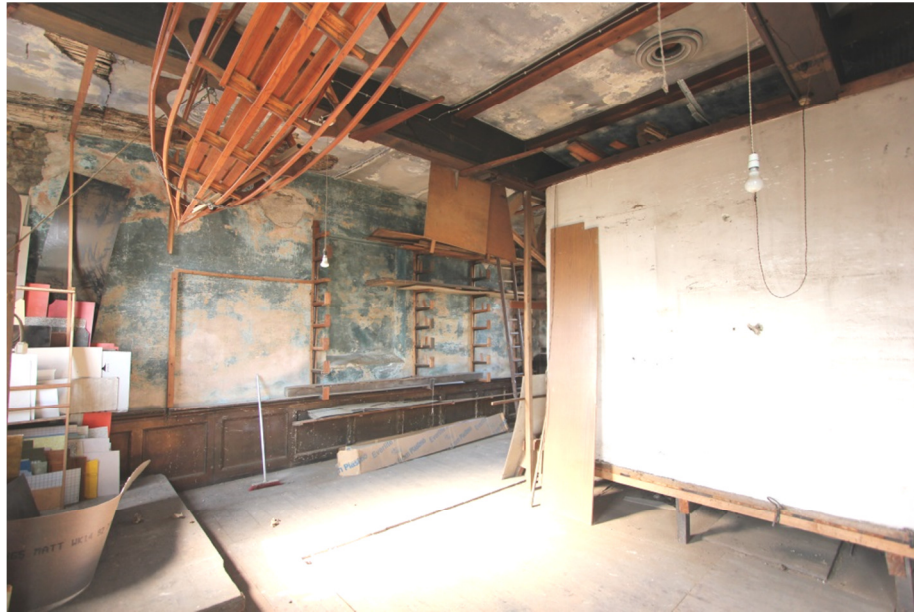
The three domestic rooms which partially occupy the first floor are constructed of timber and of concrete blocks. It became clear during the survey that these inserted rooms were built respecting the heights of the top two tiers of the chapel's galleries, with two rooms positioned on the highest gallery, along the east wall of the chapel, whilst a later room built of concrete blocks, is raised on a timber platform and respects the second gallery level (figure 18) The floor of this gallery can be seen running around the north, east and western walls. A step below this is a later timber floor to infill the area between the galleries. From lifting part of this floor it was seen to have been inserted on top of the lowest gallery floor level. This same gallery floor was also observed when ceiling tiles on the ground floor were removed (see above). It was therefore possible to reconstruct how the galleries once appeared (appendix 1).

Figure 18 First floor facing west. Note the inserted room on a platform to the right. Panelling to the west wall has been inserted or re-located to this position.

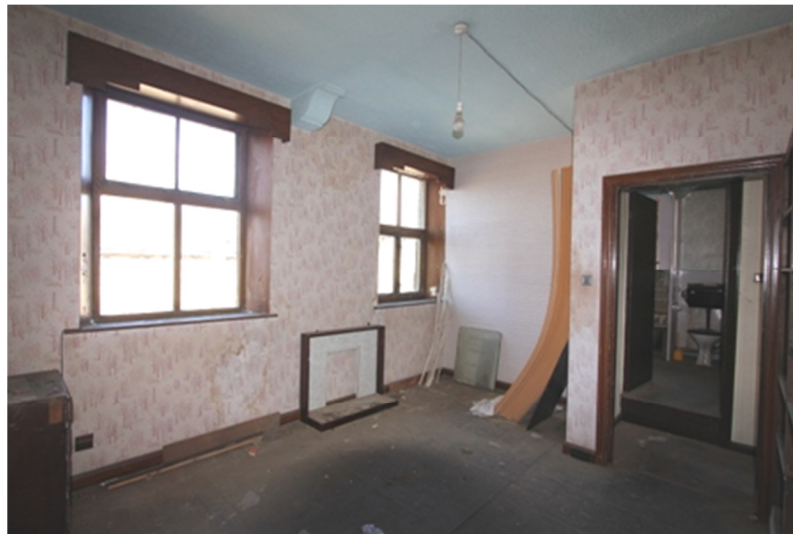
The domestic rooms are of little interest and contain a bathroom fitted out in the second half of the twentieth century, and two rooms used as bedrooms and later used for storage. All original features apart from the brackets indicating the end of the truss have been covered up or removed (figure 19).

Figure 19 – the same domestic room shown in figure 18 Facing north..

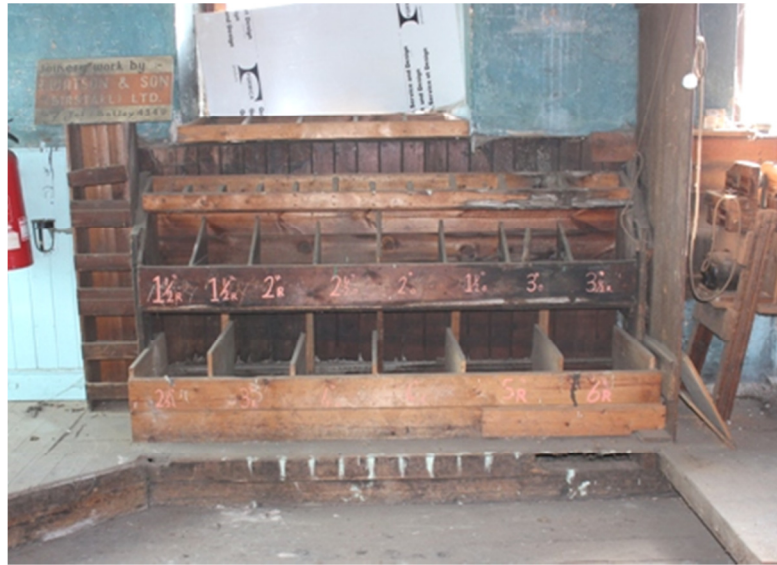
The timber tongue and groove wainscoting which is seen in the stairwell continues along two thirds of the south wall up to window sill height. This may date from the construction of the chapel and was originally stained dark brown. The wainscot continues behind storage containers. On closer inspection it was realised that the storage boxes were built into a pew. The extant pew was of simple construction with a seat and curved bench ends, the back rest was provided by the tongue and groove wainscot (figure 20). This was the only extant, and possibly insitu, piece of chapel furniture to be found during the survey.

Figure 20: Converted into a storage container, this is the last remaining pew to be found in the chapel. The middle containers rest upon the seat, whilst pew ends can be seen at each end. Note the change in floor level denoting the gallery edge. Facing south.

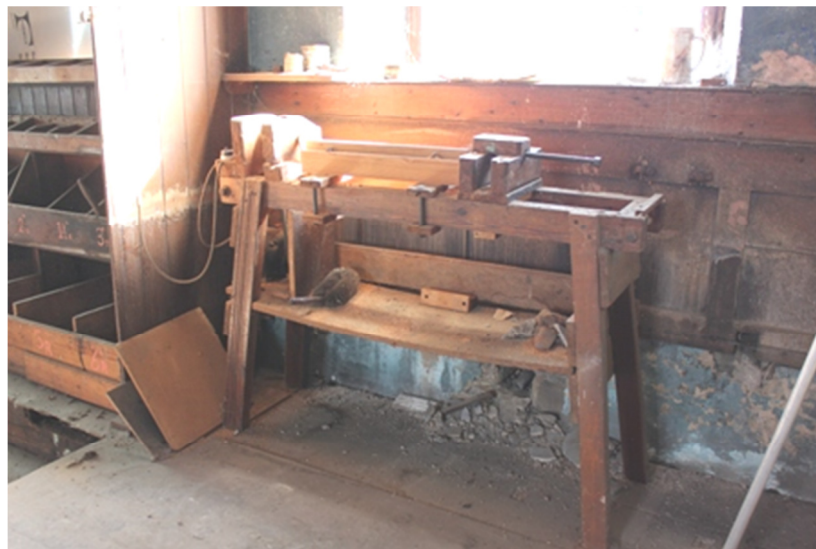
At the end of the pew, and towards the western end of the chapel, the tongue and groove changes to plain panelling. The panelling would have acted at the pew backs and does not extend to the floor (figure 21). This may indicate the seating area for the 'better off' chapel goers, who would pay more to sit closer to the galleried pulpit. The panelling terminates on the west wall. This same panelling can be found on the northern wall.

Figure 21: This plain panelling behind the lathe would once have been the backs of pews. Facing south.

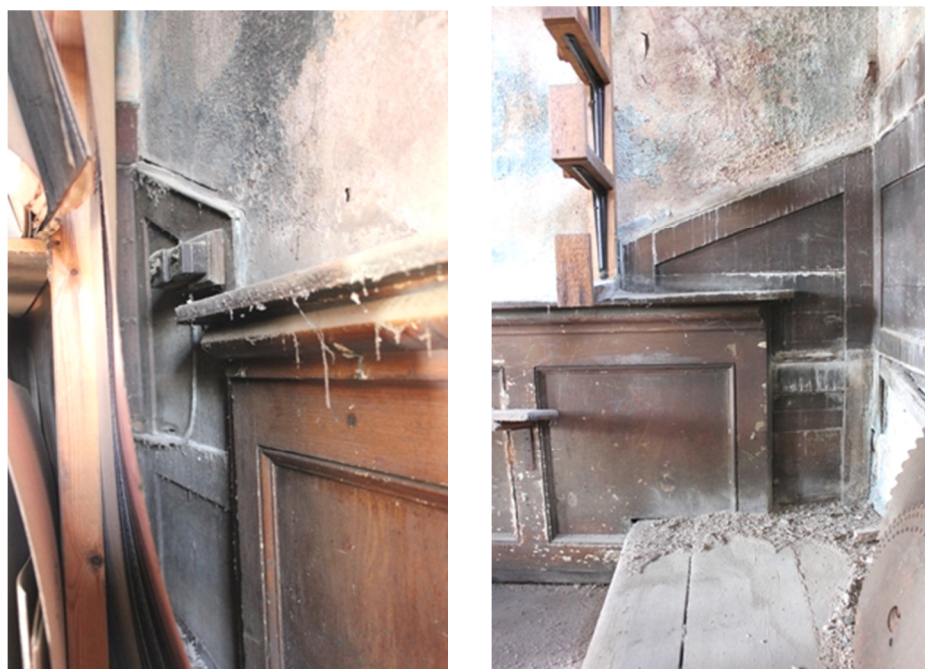
A wainscot extends across the length of the west wall, but differs from the panelling of the pew backs and is paint-grained with moulding. This panelling is topped by a narrow shelf at waist height. Evidence suggests this panelling has been moved from elsewhere and re-hung on the west wall as it sits on top of the inserted floor, does not 'fit' the west wall, fitting against the panelling of the pew ends on the left (south), but terminating awkwardly and cutting into the panelling on the right (north) (figure 22).

Figure 22: wainscot to the west wall. Left and right images are each end of the wainscot, showing both the awkward fit and the difference in quality. Note also the narrowness of this side gallery. Facing west.

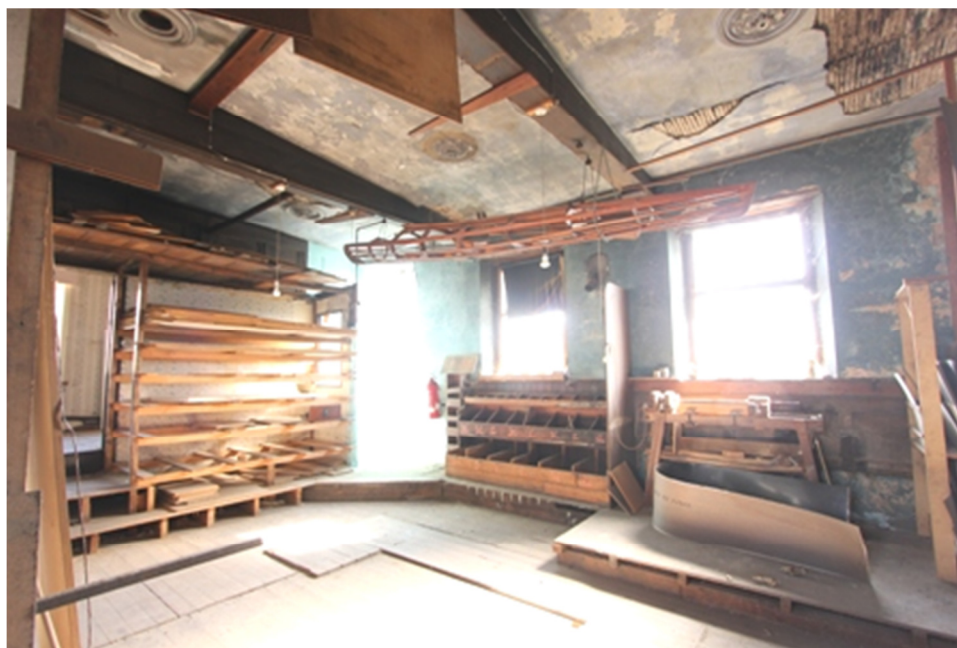
Figure 23: Facing south-east, this image shows both the over boarding to the floor for a possible snooker table, the various floor levels, and to the left a door through to a bedroom built upon the rear upper gallery.

Also supporting this idea is the curious over boarding on the floor which is thought to be where the snooker table once stood (pers. comm. M Brook). The dimensions of the boarding were found to be exactly the size of a snooker table and might have been a walkway around the perimeter. If a snooker table was ever installed here it would have predate the insertion of the third domestic room which overlies this boarding (figure 23).
