# Historical Static Analysis of the Coliseum

Simona Coccia, Mario Como, Maria L. Conforto and Ugo Ianniruberto

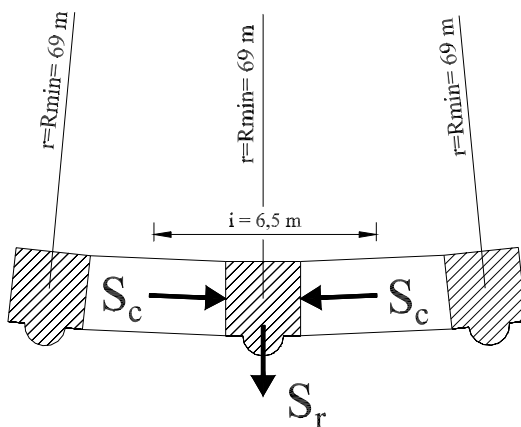
Figure 2. Radial actions  $S_r$

accepted that after dismantling, the concrete of the vaults did have sufficient strength in the radial direction, then the same lateral deformation of the outer wall and the inevitable little shocks caused by the many episodes of seismic activity during the time, may have caused the vaults to crack and thus lead to the loss of tensile strength. It is therefore reasonable that the calculation of the stress exerted on the ambulatory vaults must be carried out by assuming for the concrete the no tension model of material. Consequently states of minimum thrust will come into force the vaults. Indeed, the walls, and in particular the outer ring wall which receives the thrusts of the external ambulatory vault, undergoes small rotation and lateral deformation. The piers of the outer wall are therefore exposed not only to the vertical and horizontal radial actions of the ambulatory vault but also to the imperfectly aligned thrusts of the circumferential arches. The opposing thrusts of two adjacent circumferential arches do not completely cancel out one another and cause a *radial* action  $S_r$  which still tends to bend outwards the external wall. If the thrust of the arch is indicated by  $S_c$  and the curvature of the plan by  $r$  ( $r=l/R$ ), then (Fig. 2):

$$S_r = S_c \cdot r \cdot i$$

with  $i$  standing for the distance between the piers. The equivalent load, radially distributed on the external wall is given by the equation:

$$q_r = S_c \cdot r$$

In the original configuration of the amphitheatre there were no tie-beams or radial chains: the thrusts  $S_c$  or, equivalently the radial loads  $q_r$ , are exerted on the piers, in particular on those of the outer wall.

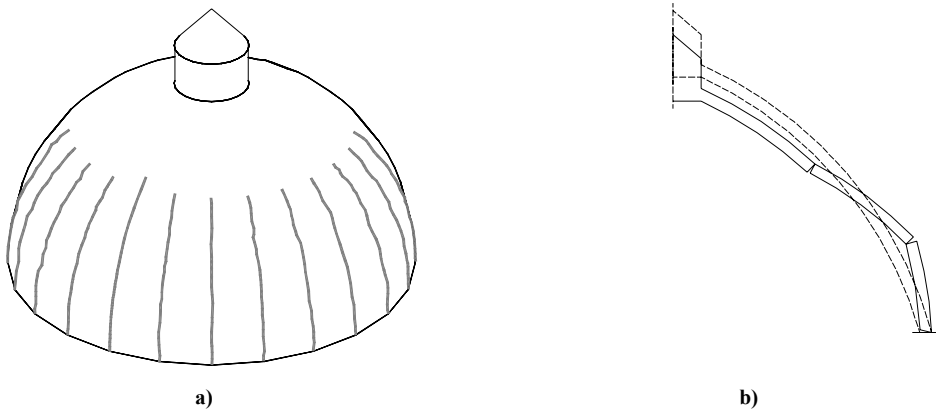
Figure 3. Masonry dome: a) Axial-symmetric view showing the meridian fractures  
b) Mechanism deformation of a segment of dome

The collapse mechanism, which involves the overturning of one or more circumferential walls, causes the expansion of the ambulatory vaults and of the ring walls. For the masonry domes the situation is similar. Figure 3a shows a spherical masonry dome subjected to its own weight and to the weight of the central lantern. The fact that the material is no tensile resistant causes meridian fracturing. (**Fig.3a**). These meridian fractures split the dome into segments which converge in the central supporting ring of the lantern. The collapse is axial-symmetric and occurs with meridian cracks accompanied by two ring cracks running along the parallels at the intrados and at the extrados of the dome (**Fig. 3b**).

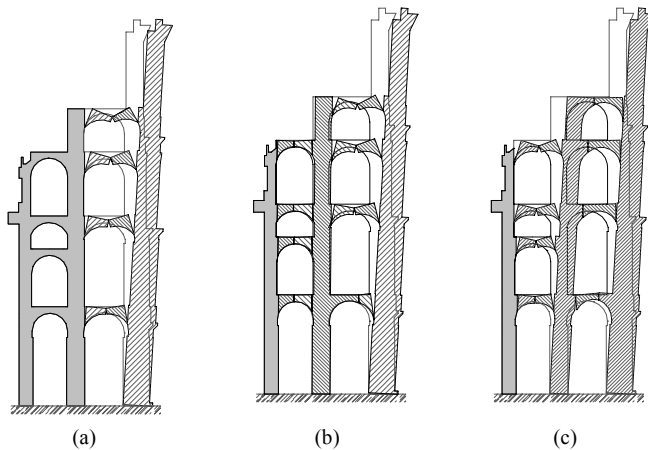
Figure 4. Radial section of the mechanism

- mechanism type a) involving the rotation of the whole external wall (**Fig.4a**).
- mechanism type b) and c) involving the rotation of both the whole external and central walls (**Fig.4b** and **4c**).

In the following sections the two possible mechanisms of the structure will be analyzed. The first mechanism considers only the external wall and the external ambulatory vault. The external wall rotates outwards while the inside and the central walls keep still. The ambulatory external ring vault, included between the central and the rotating external walls, cracks and three hinges will form transversally, two at the intrados of the abutments and one at the extrados. Figure 4a shows a possible mechanism of the structure and indicates an arbitrary distribution of hinges.

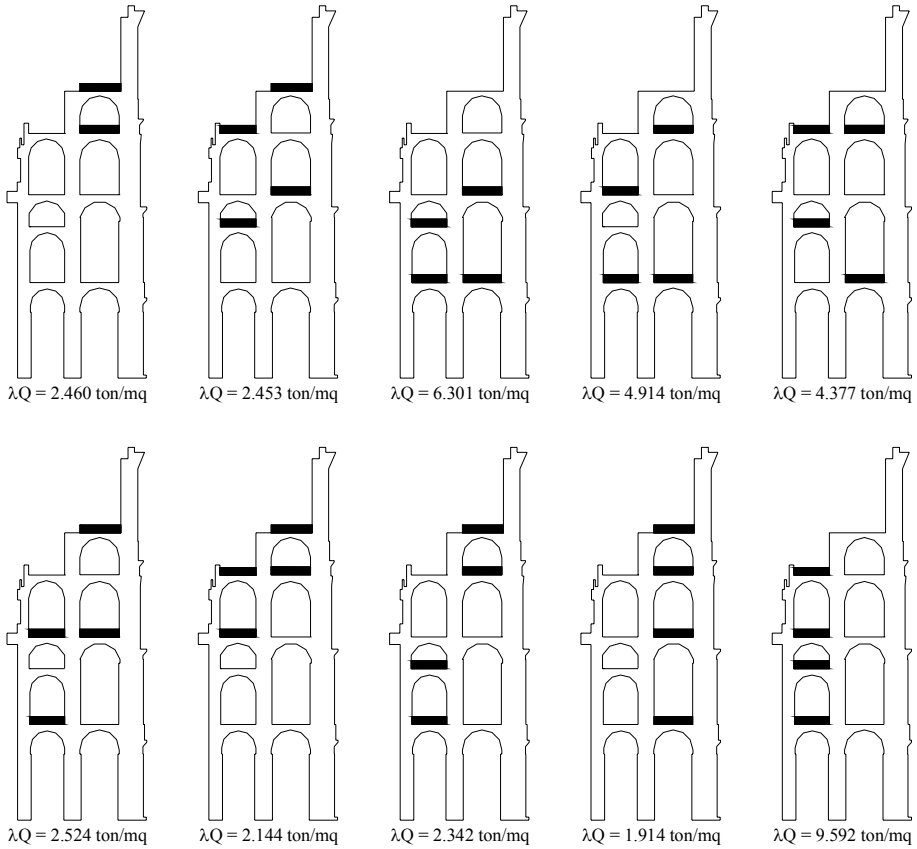
Figure 5. Various combinations of vertical loads applied on the ring vaults and the corresponding collapse loads

The minimum of the function  $\lambda q (d, d_i, x_i; i=1..N)$ , calculated with the constraint expressing the equilibrium of the wall in the vertical direction at a fixed level of the masonry compression strength, provides the collapse load  $\lambda_c q$  related to the set of the analyzed mechanisms. The minimum of the function  $\lambda q$  among all the various mechanisms sketch in (Figs 4a, b and c) gives the collapse load  $\lambda_c q = 11.47 \text{ kN/m}^2$ : it corresponds to the mechanism type a) (Coccia, 2001). The application of the vertical loads on a reduced number of ring vaults gives a higher collapse load (Fig. 5).

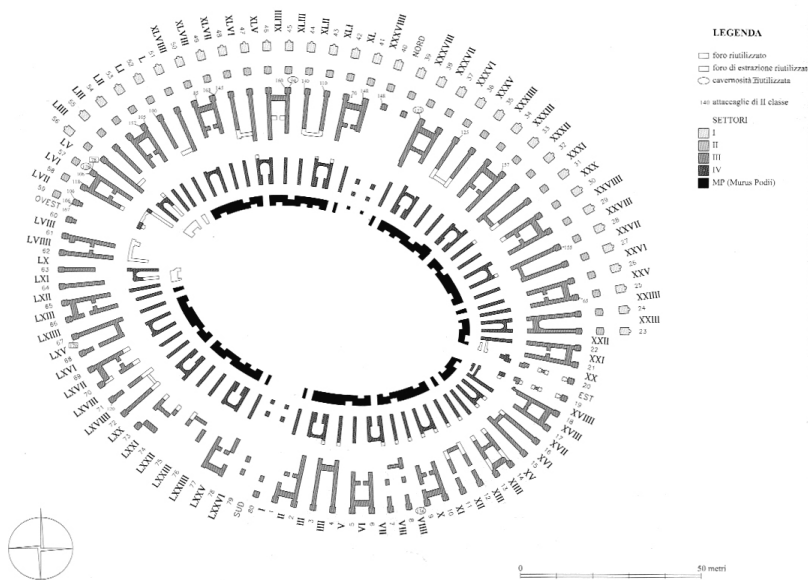
Figure 6. Plan of the first level of the monument in its current state, (reprinted from Rea, 2002)

Figure 6 shows the plan of the first level of the amphitheatre in its current state. The entire southern part of the monument, both the external and intermediate wall with all the corresponding piers, had been destroyed.. The outside of the arena is still well preserved around three quarters of its circumference: 50% of the outer wall is missing on the southern side, and part of the interior wall

has been rebuilt. It is unclear how the damage of the Coliseum evolved over time and how it reached the state shown in (Fig 6).

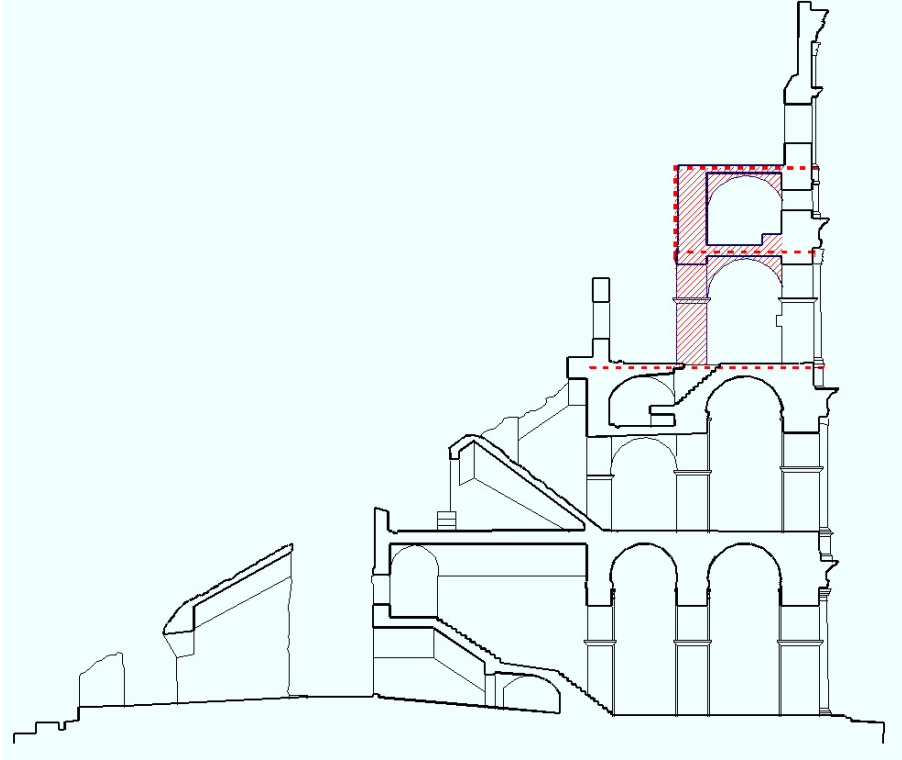
Figure 7. The chains placed by Canina at the various levels together with the new piers

There was fear for the stability of the external wall since only the 39 arches overlooking the Esquiline hill were still left standing and the balance of thrusts and counterthrusts in the circumferential direction had been interrupted. Stern, Palazzi and Camporesi constructed the buttress towards the east, which was completed in 1807, while Valadier built the buttress on the west side. Despite the works undertaken by Stern (1806 – 1820) and Valadier (1823 – 1826), the external wall continued to rotate outwards. Therefore later, in the 1850, Canina installed a triple order of chains corresponding to the thirteen central arcades (Fig. 7).

To anchor the radial chains in the uppermost part of the external wall, 13 piers of the third level were reconstructed and 13 pairs of chains were installed in the upper floor of the second level. Once the anchoring wall structure had been completed, the chains were positioned in pairs on the same level of the vaults. The chains placed on the floor of the third level, which were about 16 meters in length, and made of two pieces joined by hooks, were linked in pairs by horizontal iron bars passing through the eyes of the chains themselves.

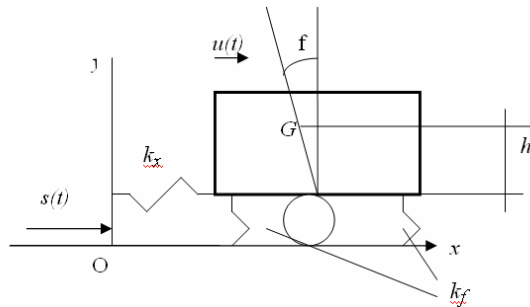
Figure 8 The simple model of the soil-structure interaction

A simple model of the structure, together with the assumed elastic connections to the underlying soil, is sketched in (Fig. 8). A rigid large block, representative of the monument, of mass  $m$  and moment of inertia  $I_o$  about the horizontal transversal axis passing through its gravity centre  $G$ , can displace horizontally and can rotate with respect to the rigid frame  $Oxy$ , integral with the soil. The system, with respect to the soil, has two degrees of freedom, the horizontal displacement and the rocking rotation. The monument cannot be considered rigidly attached to the soil but elastically connected by the translational and rotational elastic springs of suitable stiffnesses.

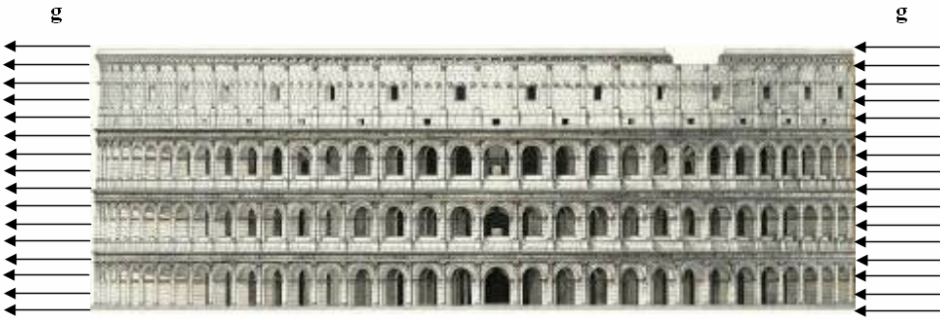
Figure 9 The plan of the Coliseum and the direction of the seismic action

By considering in plan the half of the whole ring vault pulled by the seismic loads, at a first insight we could come to the conclusion that the collapse of this vault can effectively occur with the in plane four hinges mechanism of (**Fig. 10**). This deformation of the vault, on the other hand, has to be consistent with the assumptions of no sliding and of no masonry penetration. Problems arise when the other parts of the building are considered. Beneath the ring vault there are the piers and the circumferential arches. Each pier must undergo movements in the two orthogonal directions in plan to rigidly follow the displacements of the ambulatory vaults. A plane translation of the head of a pier corresponds to its lifting.

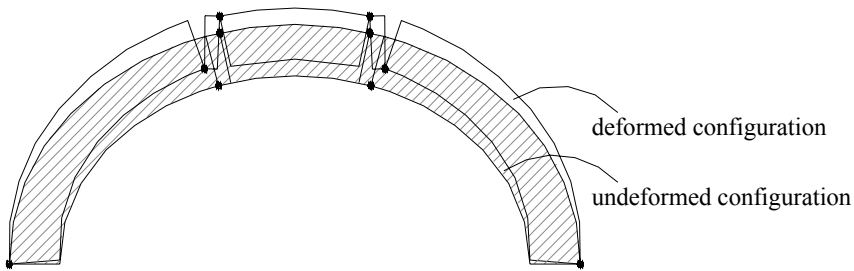
Figure 10. In plan kinematical deformation of half ambulatory ring vault and different displacements of the piers

Consequently, the pier rising cannot be always the same and the vaults must distort with the possible occurrence of masonry penetration. In the context of the simple model of the rigid in compression and no tension material, compatible displacement mechanisms of the ring walls could thus not exist and the collapse load cannot be obtained by means of the classical limit analysis applied to masonry structures.

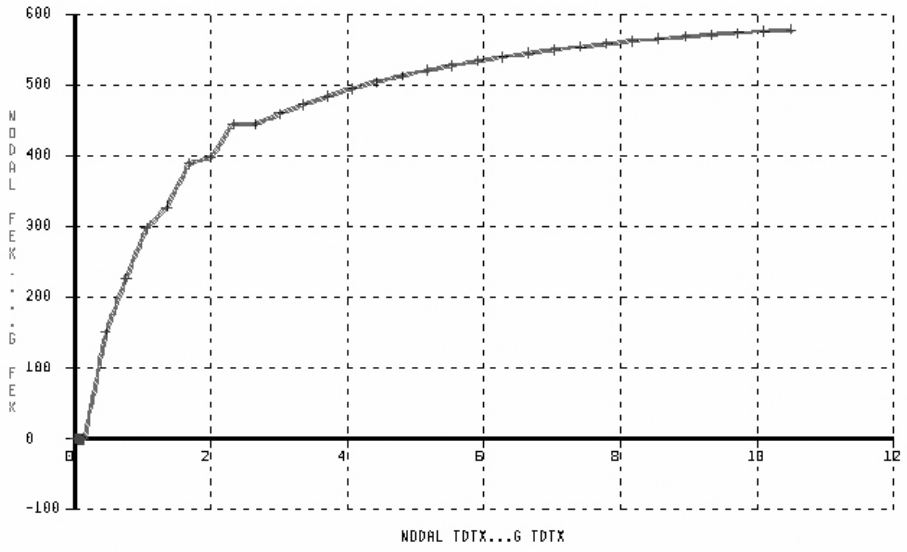
Figure 12. The force-displacement diagram

While the vertical dead load is kept constant, the push-over horizontal loads are gradually increased as far as the snapping failure is not reached. At each step of loading it has been evaluated the corresponding horizontal displacement occurring at the top of the monument and the force-displacement diagram of (**Fig. 12**) has been plotted. Inspection of this diagram allows estimating the collapse load: it occurs at the horizontal tangent point. The loading parameter  $l$ , the ratio between collapse horizontal force and the weight, reaches the value  $l_0=0.122$ , corresponding to the action of a maximum horizontal acceleration of about 0.1g, i.e. about ten times larger than the maximum ground acceleration that could have reached the monument during its whole history.

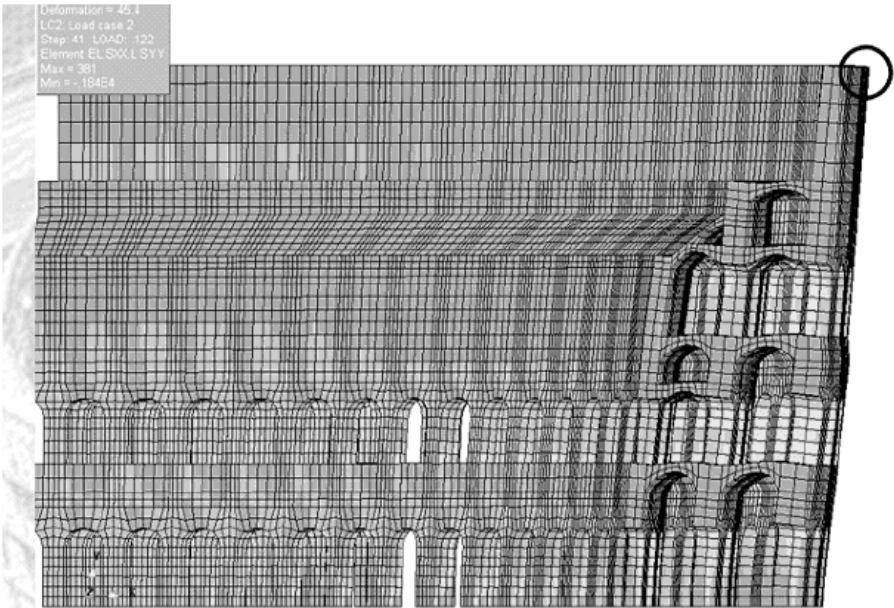
Figure 13. The horizontal deformation of the monument at the seismic collapse (Marasca, 2005)

Some of the results obtained (Marasca 2005) are reported in the following (**Fig. 13**) that shows a view of the horizontal deformations of the ring walls at the collapse.

The order of magnitude of the horizontal strength of the monument results to be much greater than the possible maximum level of the seismic forces that could have reached the monument during its whole history. The situation changes substantially if the monument is in an already damaged configuration. This consideration can explain the partial failures occurred during the past earthquakes.

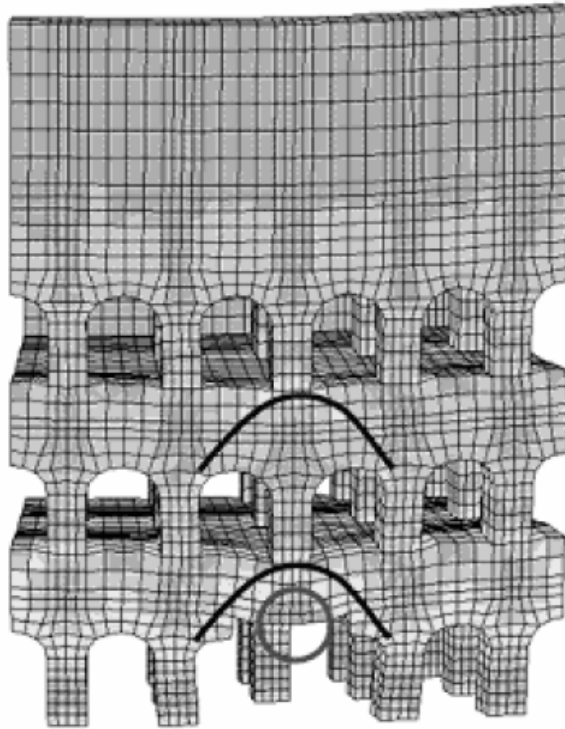
Figure 14. The arching effect in the external wall, in consequence of the demolition of a single external pier

The Figure 14 shows the effect of the demolition of a single external pier. The destruction of a single pier does not produce the collapse. The monument still stands up after the demolition of the pier because the arching effect occurring across the demolished pier (**Fig. 14**). The demolition of two piers, on the contrary, produces the collapse of all the part of the outer ring wall rising above the two demolished piers (**Fig. 15**). Figure 16 shows the step-by step weight-displacement diagram

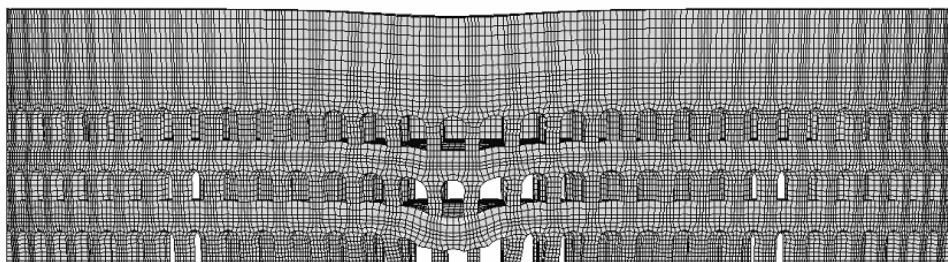
Figure 15. The partial failure of the outer wall as consequence of the demolition of two piers

Deconstruction by destroying piers therefore requires the simultaneous demolition of at least two adjacent external piers. This operation could have been carried out drilling holes in some close piers, by positioning colophony inside and igniting it by fire. Documents record various deconstruction works since the VIth century (Rea 2002).

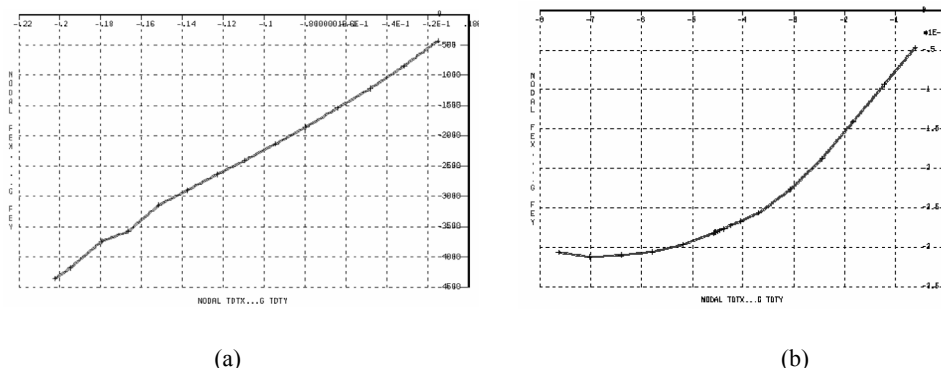
Figure 16. The step-by step weight-displacement diagram corresponding to a gradual increasing of the weight after the demolition of one (a) or two (b) external piers

corresponding to the gradual increasing of the weight in the two analysed cases. In the first diagram (Fig. 16a), corresponding to the cases of demolition of a single pier, the increase of vertical load with the displacement is practically linear just at the end of the loading, i.e. when the vertical load reaches the full weight of the monument. On the contrary, the load-displacement curve corresponding to the demolition of two adjacent external piers (Fig. 16b) reaches a maximum when the vertical load is only equal the 84% of the total weight.
