Translated Tradition in the Portland Bay Settlement. Traditional Timber Framing Techniques in a Cultural Development - Some Features Revealed in the Steam Packet Inn, Portland, Victoria, Australia

Christopher How

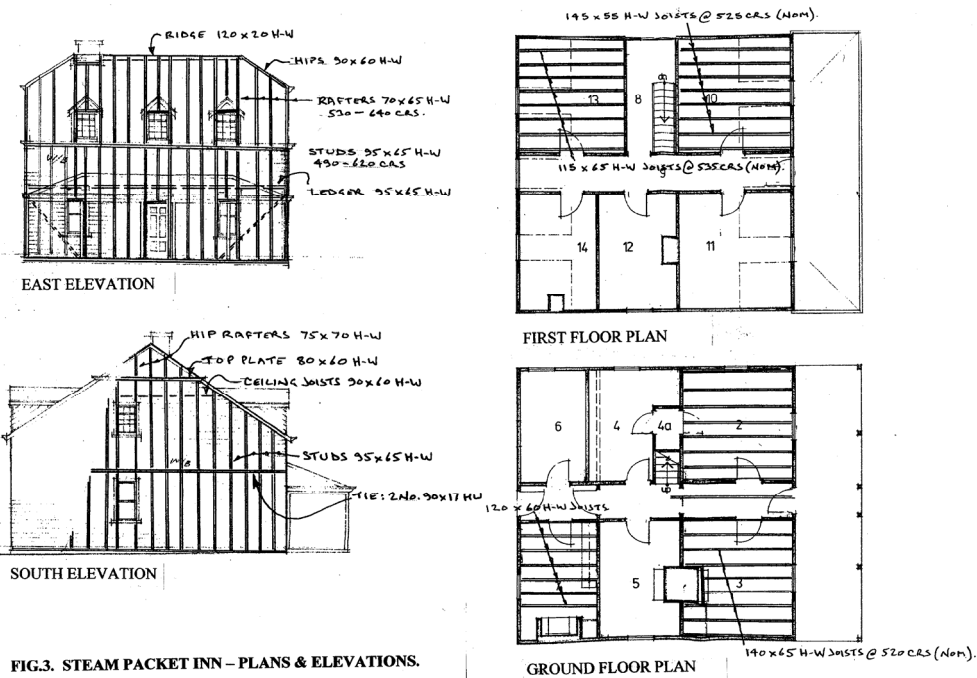
Figure 3. Steam Packet Inn - Plans and Elevations

The external walls of the Inn are framed using full height studs, which run from the bottom plate (at ground level), through to the top plate (at eaves level), in single lengths. This type of two-storey framing is one of the defining aspects of “balloon-framing” and examples occur from the 17th century in East Anglia, although this type of two-storey framing is far from universal. (Cummings, 1975 p74).

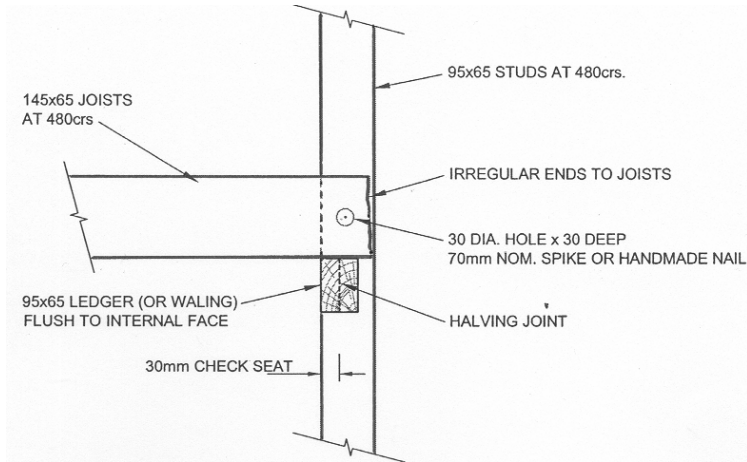
halving joint and **Fig. 4** shows the joint as revealed during the structural investigation. The ground floor joists sit directly onto the bottom plates and are the same dimensions as the upper floor joists. This is common in most pioneer buildings in the Western District of Victoria, and is the reverse of current Australian practice, in which walls are erected off a ground floor platform of joists and bearers.

Figure 4. Section through front wall at first floor level

The large drilled holes in the face of each upper floor joist seen in **Fig. 4** and in **Fig. 9**, were at first not understood and it was as if trenails (pegs) had been intended as fixings. It was possible to feel the head of a spike or nail inside the rebated well. By fortunate chance an unused fallen nail was later discovered within the wall cavity of unusual, sharp-point, rose-head design. The head matched those used to secure the floor joists in the rebated wells, and as it was only lightly corroded, it may have been lightly tinned or galvanised.

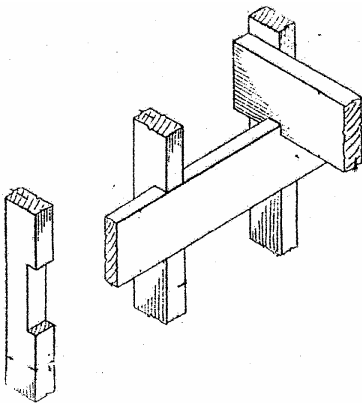
Figure 5 Modern ribbon plate

The structural system of balloon-framing still used throughout the English speaking world is often referred to as the American balloon frame as it is one of the break-through inventions which changed the whole development of the Mid-west USA. In this system, a lighter and thinner strip known as a 'ribbon', takes the place of the former wider ledger. The thinner ribbon requires only a notch to sit in, so there is no halving. The ribbon plate is one of the determining features of the American balloon frame as it later evolved. (**Fig.5**)

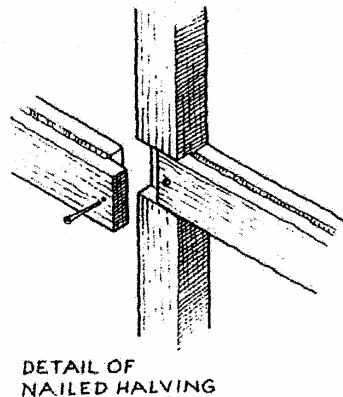
Figure 6. Ledger halving, circa 1750.(After Harris)

The halving joint used in rebating a continuous ledger is a legacy of an earlier period when buildings were pegged rather than nailed. (Brown, 1986 p61). Fig 6 shows how this practice continued to be used in the 1750's, after nails were widely adopted. It eventually gave way to a notched rebate of lesser depth, a thinner ribbon plate, and greater reliance on steel nails, as is still the current norm.

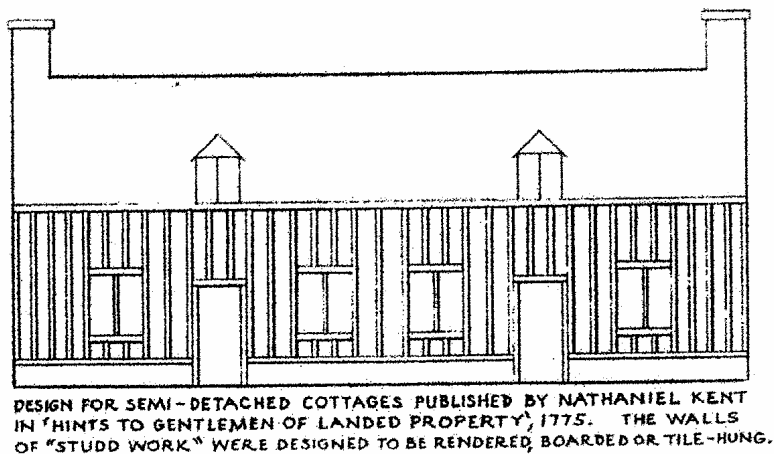
Immediately prior to Australian settlement, books of design, which included framing layouts, became generally available to artisans and property owners. An example of two-storey framing similar to the Steam Packet Inn was published in 1775 by Nathaniel Kent (**Fig.7**). It can be seen that this is a development towards balloon-framing.

Figure 7. English two-story frame in 1775

As noted in Fig 7, this type of frame would normally have a cladding of weatherboard or hung tiles to complete the walls. Weatherboards would have been radially cleft from hardwood using wedges and maul, or shorter lengths split using a heavy wedged blade called a ‘frow’. This process enhances durability, as the cleft timber is left with most of the cellular structure intact, whereas sawn timber has the cells laid open and is prone to decay etc. (Brown, 1986 p32).

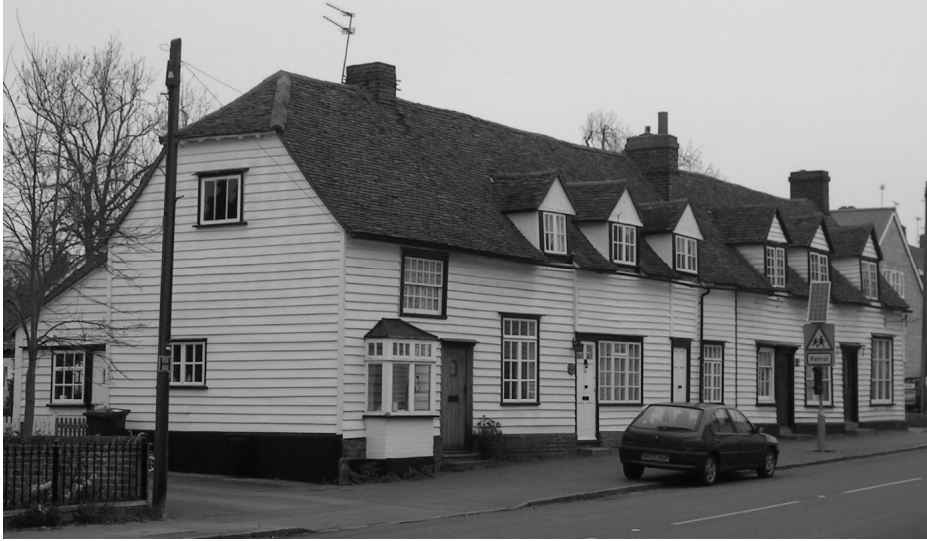
Figure 8. Balloon Framing at Hunsdon, Hertfordshire

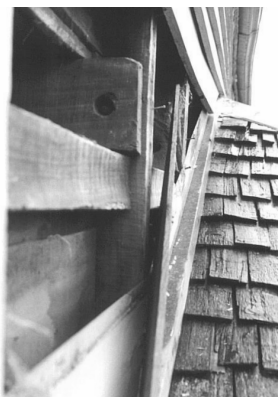
Figure 9. Rebated wells in floor joist ends.

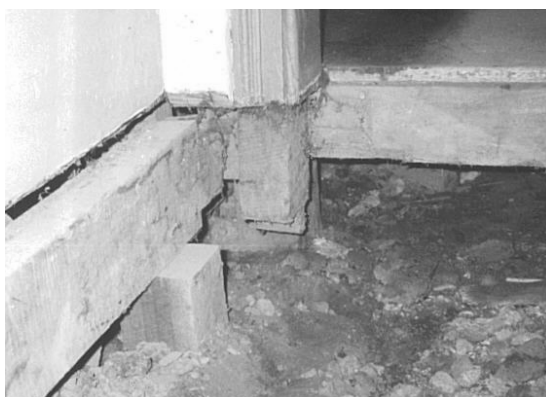
Figure 10. Tenoned end to centre wall stud

The original ground floor joists, most of which are still extant, are the same size as the upper floor joists. The front, back and central longitudinal walls were probably supported onto stone pad supports, which is a feature of earlier construction, pre-dating the normal Australian practice of support by red-gum stumps. This can no longer be verified, as several repairs based on conventional re-stumping have taken place, the latest being in 1986. Investigations of other later buildings within the pioneer area show occasional squared stone pads, or rough basalt pads, but in the Western District the norm is for full perimeter masonry plinthwork. Unlike a modern frame, the ground floor joists were placed after the walls had been raised as they sit onto the top surface of the bottom plates. The tenon of the corridor studs could be seen projecting below floor level in this same configuration, where the central bottom plate had rotted out. (**Fig.10**).

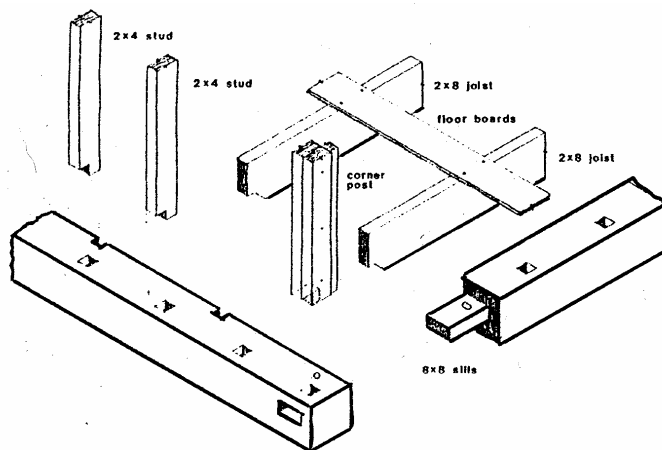
Fig. 7 Isometric drawing of the sills at the northeast corner of the two-story wing of the James C. Cowing House near Peotone, Illinois, built in 1855. *Allan Nelson, based on drawing by author*

Figure 11. Dr Sprague's drawing of the American balloon frame of 1855

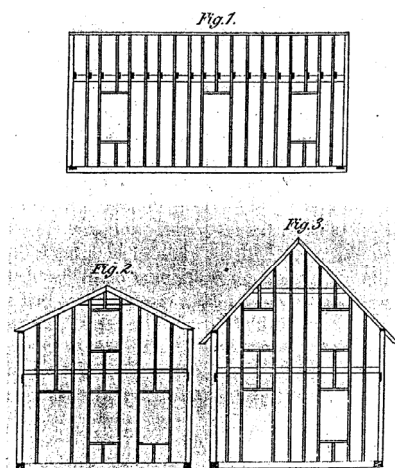
Fig. 10 These elevations of balloon frames are from William Bell, *Carpentry Made Easy* (1858). The original

Figure 12. American balloon frame of 1858

Fig 11 shows how far the Chicago balloon frame had reached by 1858, and one can identify the resistance to change away from the last vestiges of English Medieval thinking. Examination of this figure (from William Bell's "Carpentry Made Easy" of 1858), shows that a 200 by 200mm sill (bottom plate) was in use, with similar heavy timber corner posts, and horizontal tenons at the bottom plate corners. The ribbon plate is notched-in, unlike the ledger halving of the Inn.

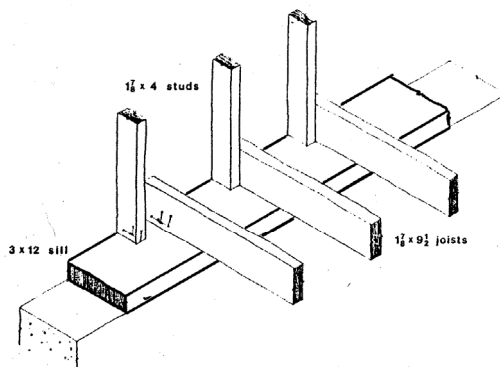
Fig. 15 Drawing showing sills of the Ella F. Beach House in the Beverly Hills neighborhood of Chicago, built in 1887. Allan Nelson, based on drawing by author

Figure 13. Nailed version of 1887

Later, by 1887, an all-nail form of balloon frame was developed, in which the studs and joists were skew nailed together, but still retained a 3 inch (75mm) by 12 inch (300mm) sill (**Fig. 3**). It was not until 1910 that the American balloon frame adopted the nominal 4 inch by 6 inch sills, roughly equivalent to the bottom plates of the Steam Packet Inn, which were 120mm wide by 90mm deep.
