Saga of the Half-timbered Skyscraper: What Does Half-Timbered Construction Have to Do with the Chicago Frame?

Randolph Langenbach

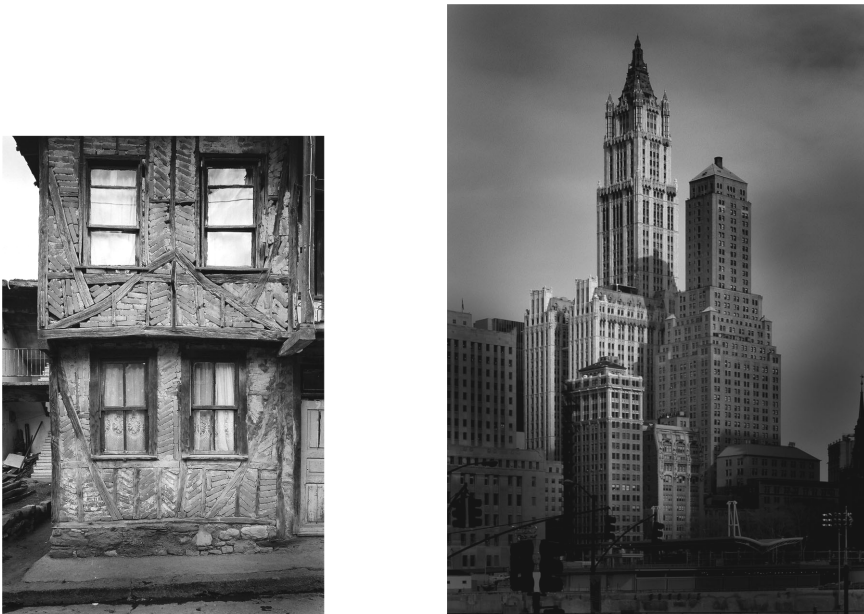
Figure 1. (L) Undamaged *hımış* construction in Gölcük, Turkey. (R) 1913 Woolworth Tower by Cass Gilbert, is now the tallest building in Lower Manhattan after the collapse of the World Trade Towers.

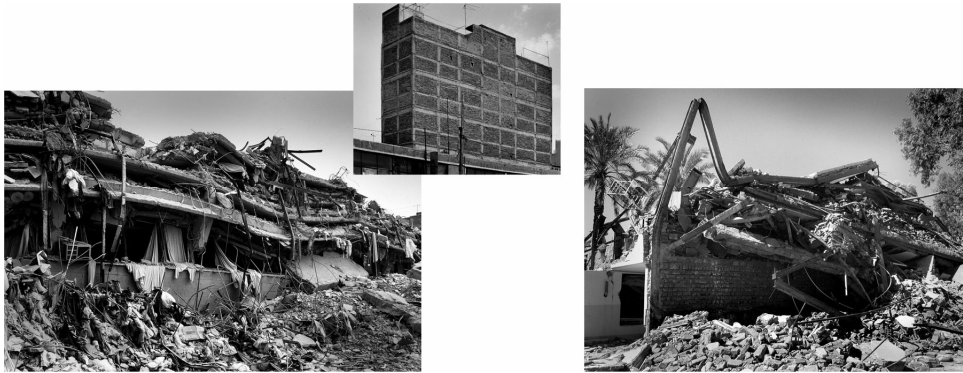
Figure 2. (L) Juarez Hospital after 1985 Mexico City earthquake with neighboring (C) undamaged infill-frame RC building. (R) Steel building after 2003 Bam, Iran earthquake.

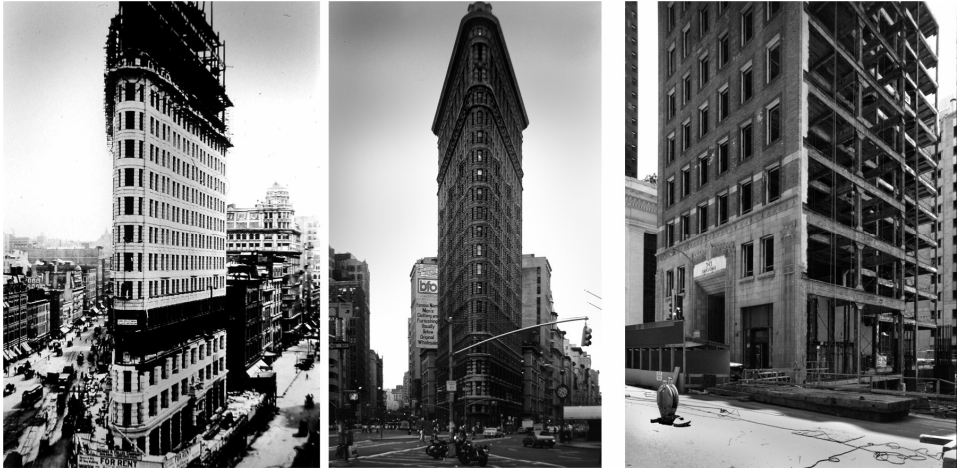
Figure 4. (L) Flatiron Bldg (1902), NYC. Masonry façade with construction beginning on upper floors at same time as at foundation (vazyvite.com). (C) Flatiron Bldg. (R) 343 Sansome, San Francisco.

The masonry infill commonly found today in the modern vulnerable buildings is much weaker and less densely packed into the frames than in the early Chicago Frame buildings. It can interfere with the idealized performance of the frames by throwing stresses onto portions of buildings that are not capable of resisting because of localized crushing and falling out of the frame (Figure 11). For skyscrapers this was not a common problem, because both the frame and the infill walls had to be robust and well constructed enough to support the much higher dead, live, and wind loads (Figures 4&5).

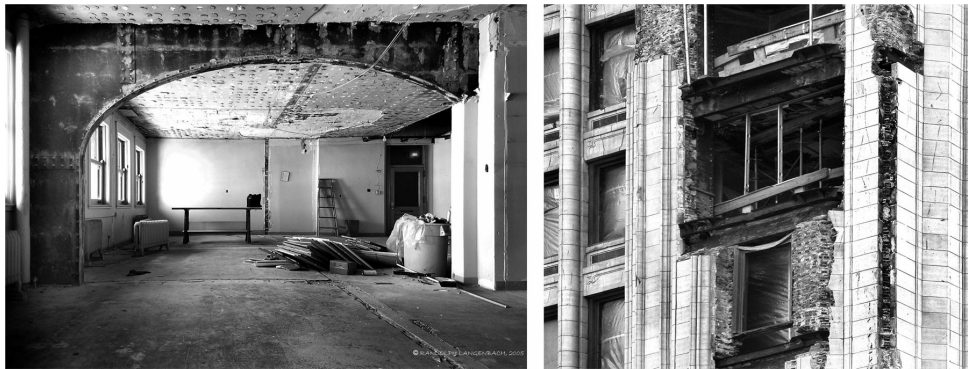
Figure 6. (L) Portal arch wind bracing in Monadnock Building, South Half (1891-3). (R) Cladding on 90 West Street (1907) damaged by World Trade Towers collapse showing steel shelf angles.

When one reads about the contest over which building was the first “true” skeleton steel frame” skyscraper, one gets the impression that the introduction of shelf angles (Figure 6) supporting the exterior cladding and the eventual elimination of masonry all together would lead not only to a new building type, but to a better way of building. For architects, it would mean the opening up of the interiors and the elimination of the thick membrane that had historically separated the interior from the world outside. This provided the basis for what would become a major philosophical shift in architecture, marking the emergence of what came to be termed “Modern Architecture,” or what Swiss architect Le Corbusier (1887-1965) called the “New Architecture.”

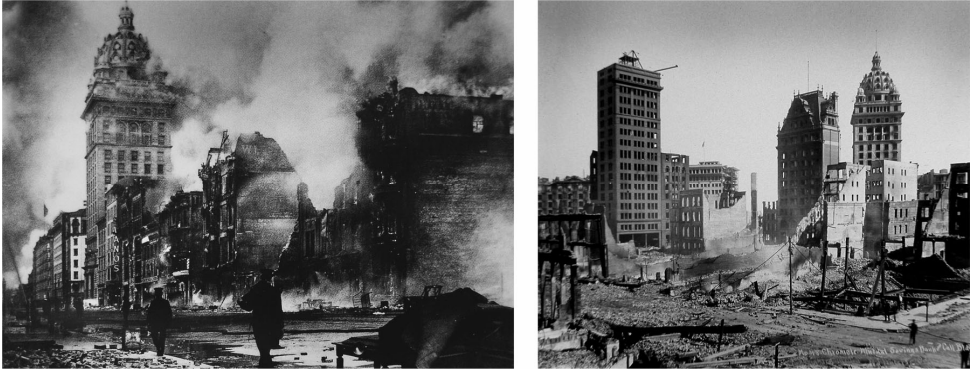
Figure 7. San Francisco in 1906 showing Chicago Frame buildings that burned out but remained standing. All of the taller buildings in these images are still extant in 2006. (Bancroft Library)

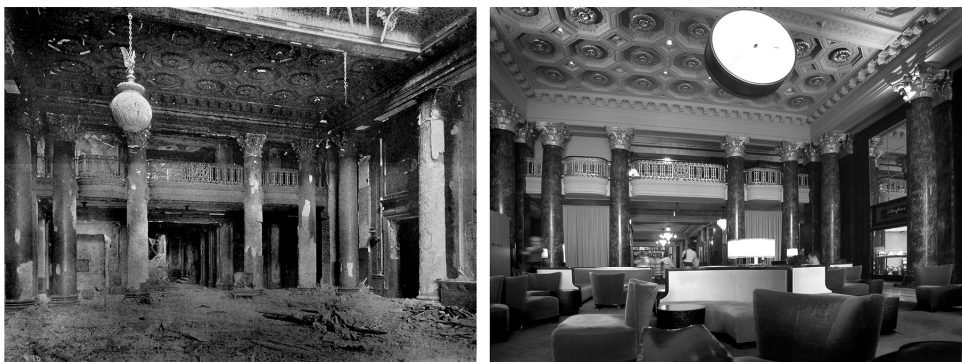
Figure 8. St Francis Hotel lobby after the 1906 earthquake and fire, and same space still extant 100 years later. (Roebling, 1906)

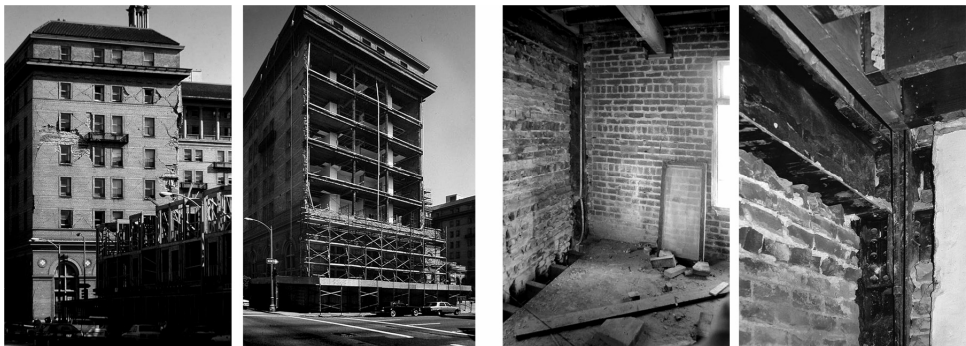
Figure 9. (L) The Oakland Hotel showing damage to façade, and later during repairs. (R) The Touraine Hotel, Oakland, California showing masonry exterior infill during upgrade work.

Interestingly, the 1906 damage can be compared to the fate of downtown Oakland in the 1989 Loma Prieta earthquake, where a number of early 20th century Chicago Frame construction buildings suffered the cracking of the infill masonry. In this later earthquake, the only skeleton frame building to suffer significant exterior wall collapse was the Oakland Hotel – ironically, the only large skeleton frame building that had been given a seismic upgrade. As part of this work, all of its original masonry interior partitions had been removed and replaced with light wallboard, making the building more flexible (Langenbach 1992), which resulted in greater damage than can be seen in the photographs of San Francisco's skeleton frame buildings in 1906, which helps to confirm Freitag's 1895 (p.137) observation about the interplay between braced frames and masonry infill.

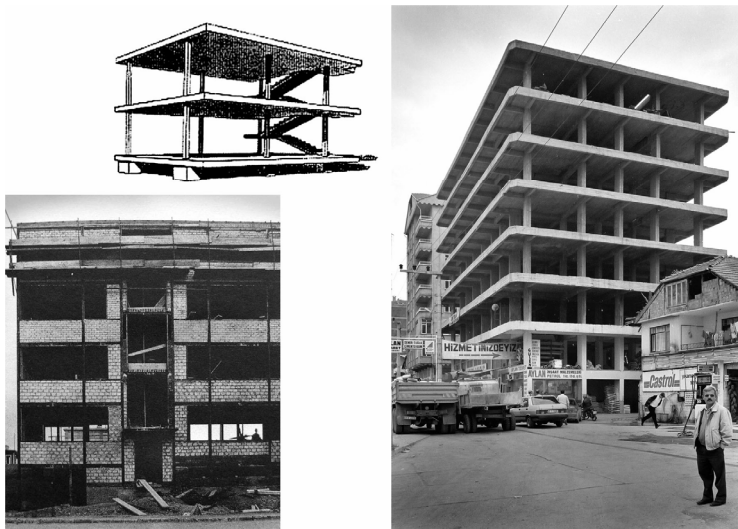
Figure 10. (L) Construction in 1927 of Stuttgart Werkbundsiedlung (Giedion, 1928). (C) Le Corbusier's Dom-ino House, 1915. (R) Gölcük, Turkey building under construction at time of 1999 earthquakes.

The photo shows the building supported by a steel frame of thin steel members that subdivide the thin exterior masonry wall into panels, with an absence of interior structural walls or shear walls – remarkably similar to many steel infill-frame buildings which collapsed in the Bam, Iran earthquake of 2004.

Later in his book, Giedion turns with an embracing excitement to the work in reinforced concrete of Le Corbusier, beginning with Le Corbusier’s 1915 iconographic drawing of the prototype structural form for multi-story residences known as the “Dom-Ino” house. Le Corbusier’s image of the bare concrete skeleton of the Dom-Ino House (Figure 10) stands as an icon of the “New Architecture” of

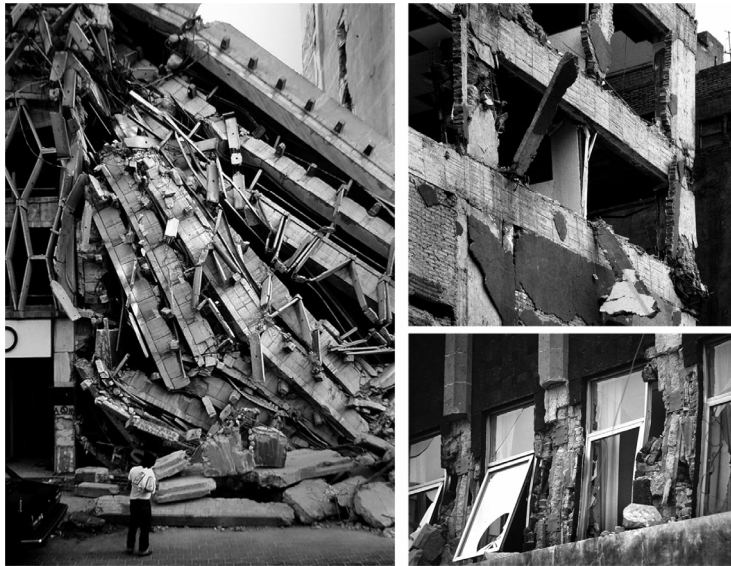
Figure 11. Mexico City 1985 earthquake: (L) Collapsed RC Parking garage. (C) RC frame showing column damage and loss of infill. (R) Bent steel frame in ca.1940 building with too little masonry to help.

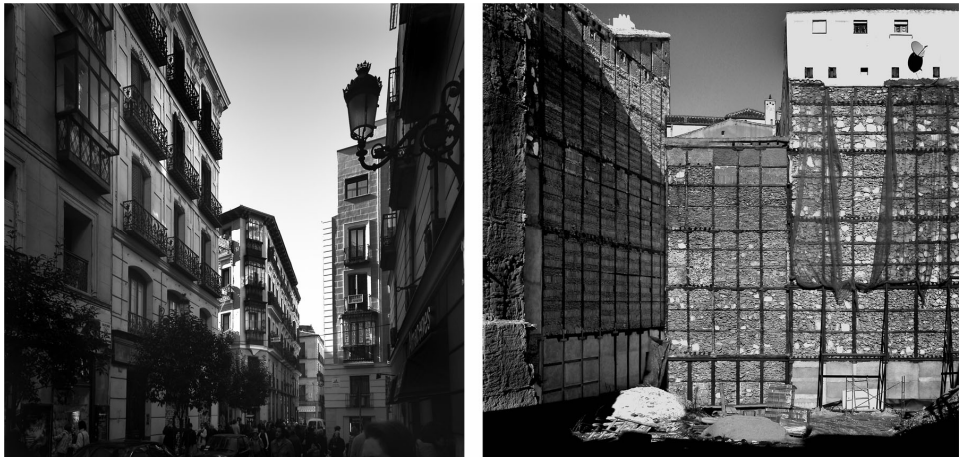
Figure 12. Historical center, Madrid showing front façades and infill masonry timber frame construction revealed on rear walls after demolition of adjacent structures in 2002.

Today, the historic center of Madrid is known for its solid masonry five to seven story façades, but this is an illusion. Almost all of these 18th and 19th Century buildings are in fact timber infill-frame structures hidden behind a single layer of masonry and stucco (Langenbach, 2003; Gonzales Redondo, 2003).

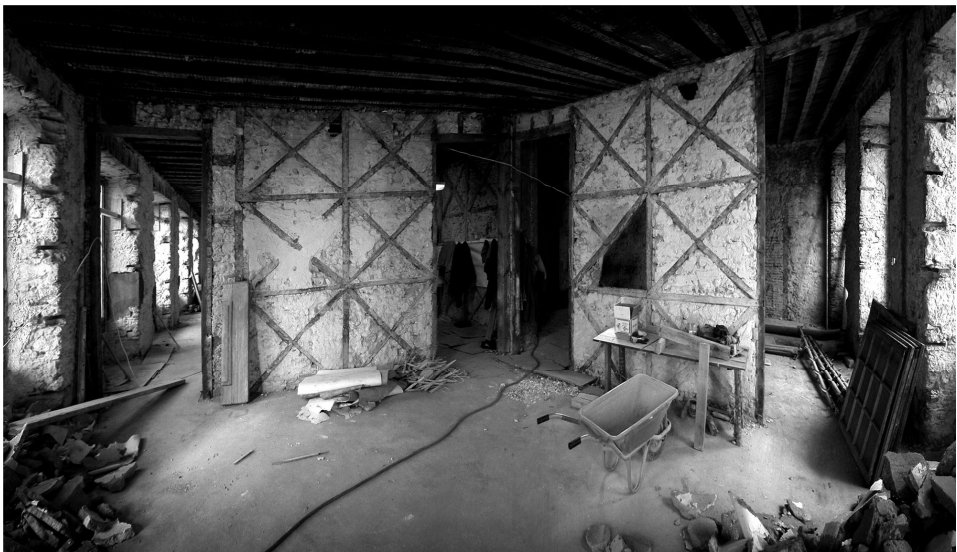
Figure 13. Interior of late 18th Century building with Pombalino walls revealed during renovation work in 2003. This example has does not have the *gaiola* frame extending into the exterior masonry.

The seismic capacity of the Pombalino walls was recently tested in the Portuguese Government’s structures lab, by subjecting actual wall sections removed from a building to cyclical tests. The wide hysteresis loops from these tests show that the walls were able to dissipate energy over many cycles without losing their structural integrity, and the loss of plaster shows that the forces were distributed across the wall section. The sample remained largely intact despite having been cyclically pushed beyond what would be expected from an earthquake (Cóias e Silva, 2002 & Santos 1997).
