Stratigraphic Study of Hernando de Zafra Arab Baths in Granada, Spain

Camilla Mileto, Fernando Vegas and Juan Antonio García

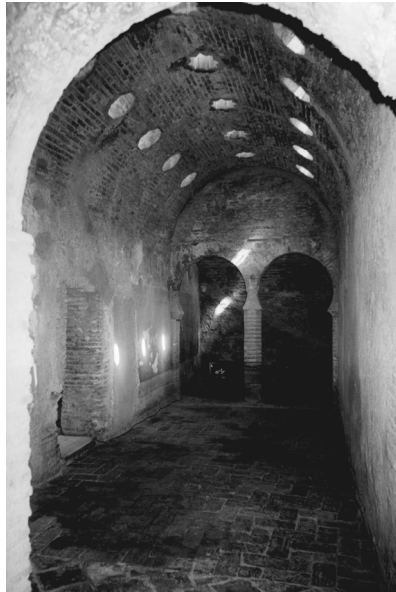
Figure 1. *Frigidarium* of the Bañuelo in Granada

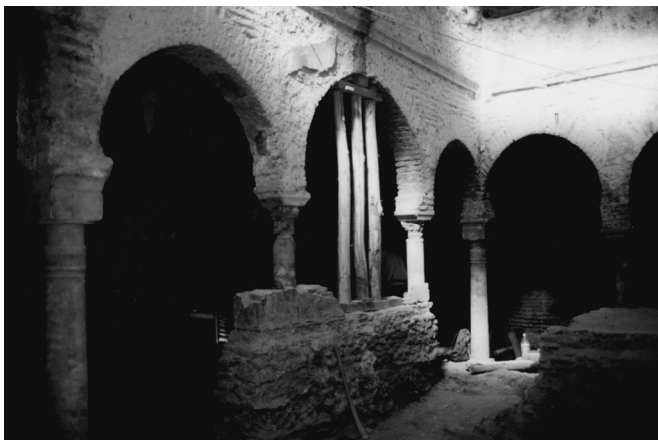
Figure 2. *Tepidarium* of the Baño de Hernando de Zafra

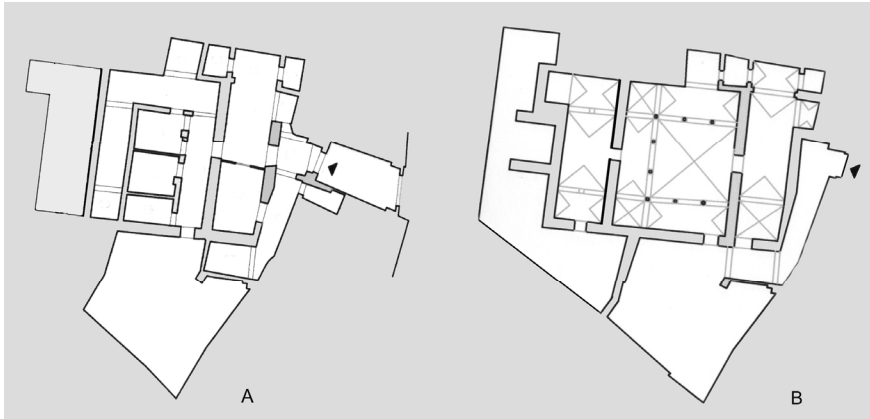
Figure 3. Lay-out of the baths before (A) and after (B) the demolition of domestic additions and expropriation of the *caldarium* area

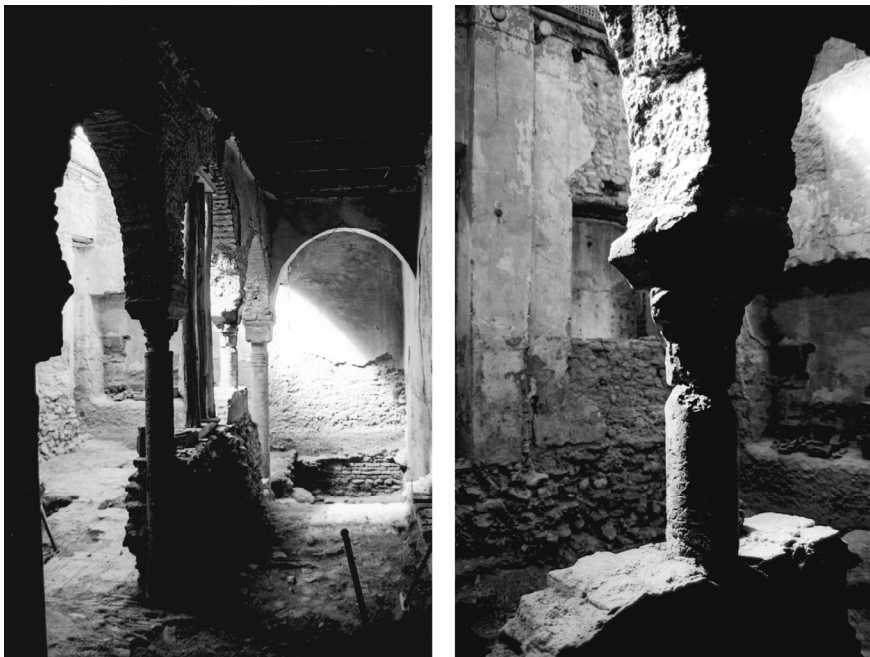
Figure 4. Images of the demolition to clear the Arab baths from domestic additions

It was not until the end of the 20th century that the regional administration showed an interest in it by proceeding to expropriate the houses and demolish them down to the vaults of the baths, as a preliminary step to drawing up a meticulous study and carrying out research, before continuing to retrieve the baths and restore them to turn them into a museum.

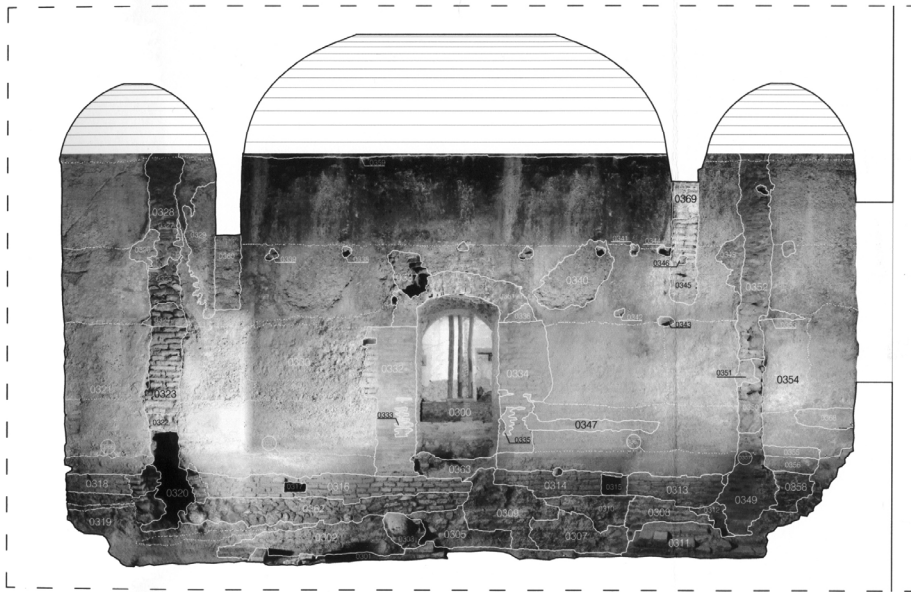
Figure 5. Stratigraphic study of the South wall of the *caldarium*

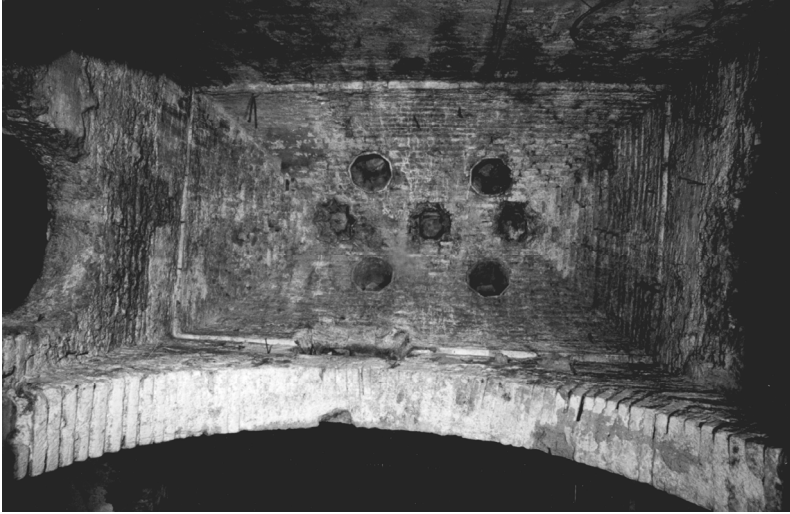
Figure 6. Sail vault with its skylights

In the sail vaults still conserved there are many little orifices or skylights (in Arabic *midwa*, singular, and *madwani*, plural), in geometrical star shapes, made out of special ceramic pieces. At the time of the study, they were mostly covered over, but integrally conserved. These skylights played a double role: in the first place, with their top part in multicoloured stained glass, they illuminated the different rooms in the baths and, in the second place, they made it possible to regulate the heat or steam in the rooms by opening them for ventilation.

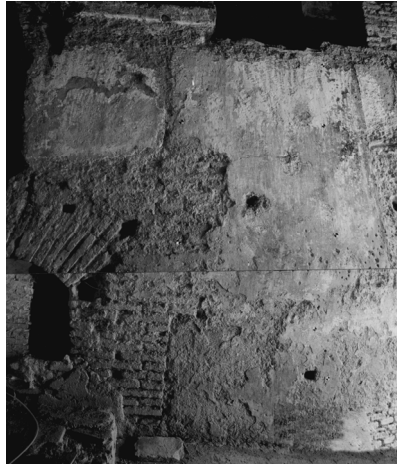
Figure 7. Pisé-de-terre with an arch made of bricks, both built simultaneously

This phenomenon responds to the building custom that we could call *material specialisation*, that is to say, the specific use of a material because of its qualities and building possibilities. This different use of materials can also be clearly seen in other parts of the baths, where *pisé-de-terre* was used for the main walls but the openings (for example, the bays between the cold room and the warm room, and between the latter and the hot room), the vaults, the alcove arches, the hypocaust, the chimneys and the back wall of the furnace were made of brick fabric. Material specialisation at a stratigraphic level may give rise to misunderstandings in the interpretation of the building stages. As a matter of fact, if this traditional building custom is not taken into account, the difference of materials could be interpreted as belonging to consecutive building stages (*pisé-de-terre* and brick fabric). This case affords a clear example of the need for the person performing the stratigraphic study of the site to be familiar with architectural building techniques.

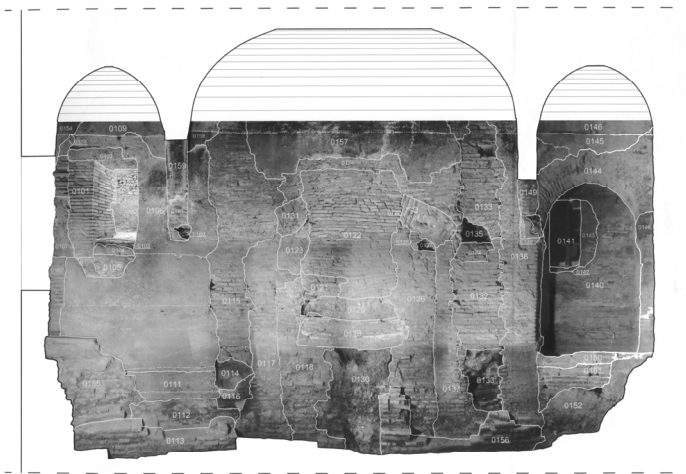
Figure 8. Stratigraphic study and hypothesis of constructive periods of the North wall of the *caldarium*

The first period goes from the actual building of the baths, possibly between the 12th and 13th centuries, during the Almohad period, until the late 15th century, at the decline of Nasrid domination, when, after the conquest of Granada by the Christians, the baths were banned from use and the building lost its original function. This period of the birth and original operation of the building is marked by the presence of different building techniques physically unrelated to each other. During this period we find the different building characteristics of the original construction of

The second period was probably when, having lost their original function, the first transformations were made on the baths in order to adapt them to their new use, which, in any case, did not bring about great changes to the original building. This period can be placed approximately between the 16th and 19th centuries, and has been divided into three phases with subtle differences between them and involving physical superposition. This period, for example, saw the insertion of the south wall of the baths, built with a fabric of brick piers and mortar and ceramic cases, later plastered with lime mortar. To build this biased wall, it was necessary to chip the walls to reduce the section of the adjacent wall and make it less thick to allow people to pass through.

The third constructive period goes from the works performed in the early 20th century to our day, and has been divided into three phases. This period includes the works carried out at the beginning of the 20th century, when the baths were converted into three-storey dwellings and their spaces were divided up to form small rooms. These divisions comprised above all a series of fairly thin partition walls made of brick, subdividing the large spaces and, for the same purpose, the horseshoe arches and the columns of the warm room were covered over. Also in order to turn the baths into residences, a number of bays were opened in the perimetral walls. During this phase, the large vaults of the warm room and the cold room were demolished to add another storey to the building.

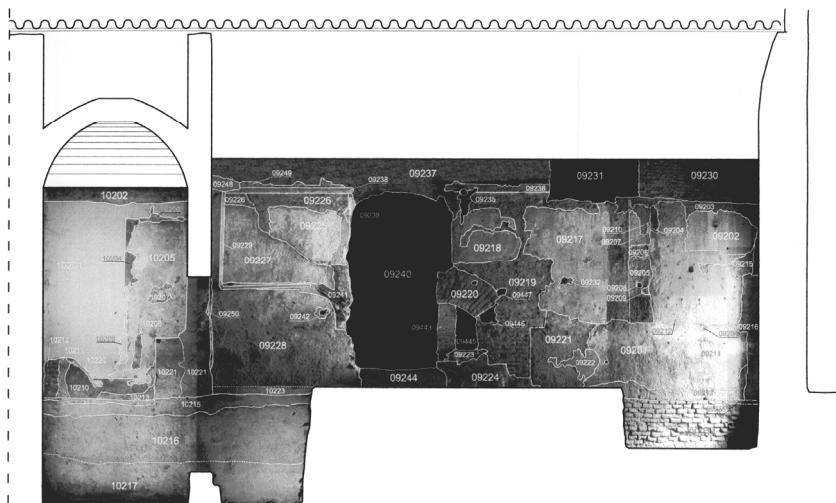
PERIODO I
(... - hasta S. XV)

PERIODO II
(S. XVI - ...)

PERIODO III
(... - S. XIX y XX)

Figure 9. Stratigraphic study and hypothesis of constructive periods of the South wall of the *frigidarium*
