# Materials Used in the Construction, Conservation, and Restoration of Ancient Stupas in Sri Lanka

Munidasa Ranaweera and Helarisi Abeyruwan

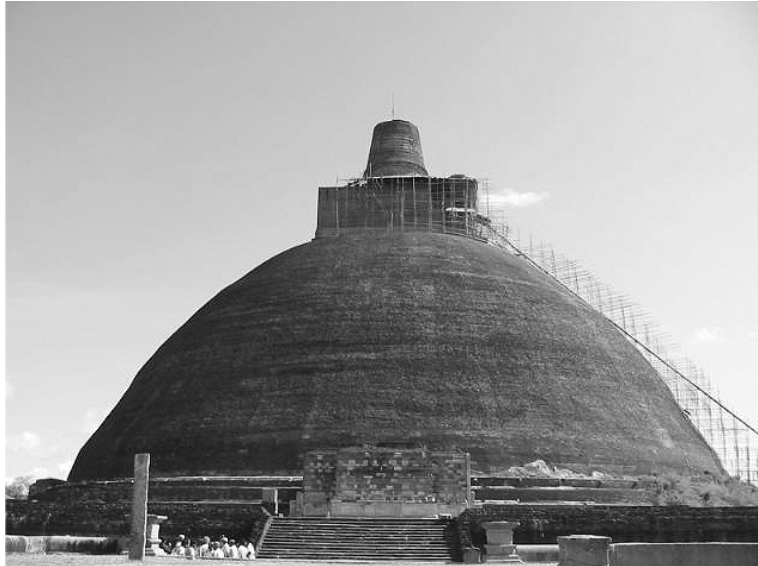
Figure 2. Jetavana stupa under conservation (height = 70.7 m, base diameter = 111.9 m)

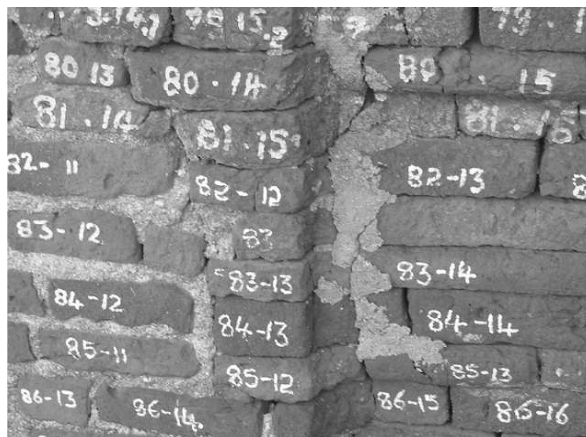
In ancient stupas brick bonding principle was strictly adhered to and no vertical joints generally meet (Silva R 1982). With the slurry like mortar the thickness of mortar layer is reduced to almost zero, making the load transfer from one brick to another virtually by direct contact. The ancient brickwork and the brickwork used by the British in the nineteenth century renovations of Jetavana are shown in Figure 6. It can be seen that five courses of ancient brickwork match four courses of the British era brickwork with thick mortar.

Figure 6. Comparison of ancient and British era brickwork in Jetavana

Following that line, a number of mixes comprising different proportions of slaked lime, rice-husk ash, termite mound clay, ground burnt clay tile fragments, and water were investigated for the soaked and dry strengths. Table 4 contains a description of a couple of mixes so investigated (Abeyruwan 2001). The investigation revealed that both rice husk ash and ground burnt clay roofing tiles had pozzolonic action, whereas the ground burnt clay bricks did not show such significant effect. The typical mix used for the conservation is Mix 5. Sand was omitted in the mixes, in order to ensure thin layer of bedding, replicating ancient bricklaying practice (fig. 6).

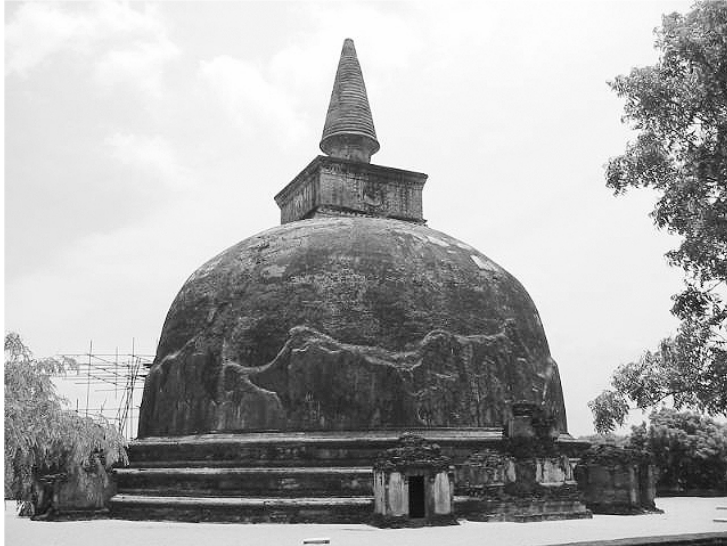
The outer surface of the stupa brickwork was water-proofed using a plaster layer. Some of the stupas have several layers of plaster, reaching overall thicknesses of 9 to 10 in. One of the best preserved examples is the Kirivehera at Polonnaruwa (fig. 7) built by King Parakramabahu in the twelfth century AD. These plasters are like lime-concrete rather than normal stucco (Silva R 1982).

Figure 7. Kirivehera (height = 24.4 m, base diameter = 25.6 m) showing thick original plaster

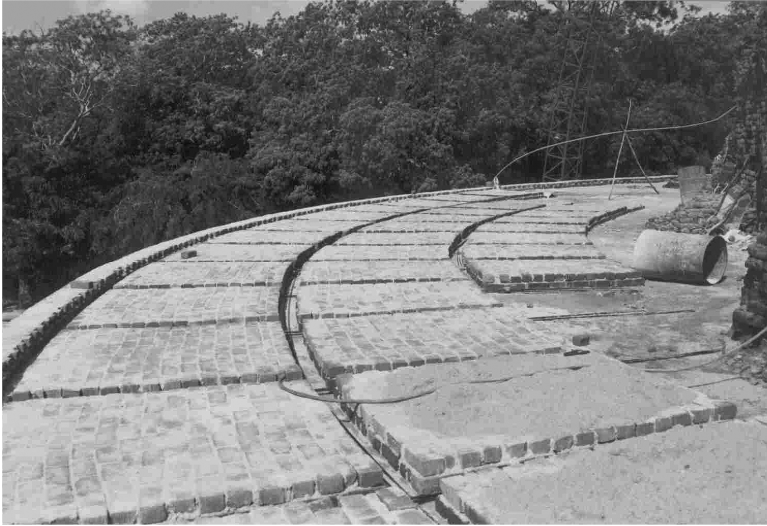
Hence in the third attempt to restore the stupa, a design concept where the new brickwork is acting as a thick shell without bearing on the remaining ancient brickwork was used, and the new brickwork was constructed with radial and circumferential ring beams of reinforced concrete (**fig. 9**) to take up tensile stresses. The construction work started in 1990 and completed in 1992 with the unveiling of the pinnacle (**fig. 10**).

Figure 9. Mireseveti stupa restoration – new brickwork and groves for RC beams

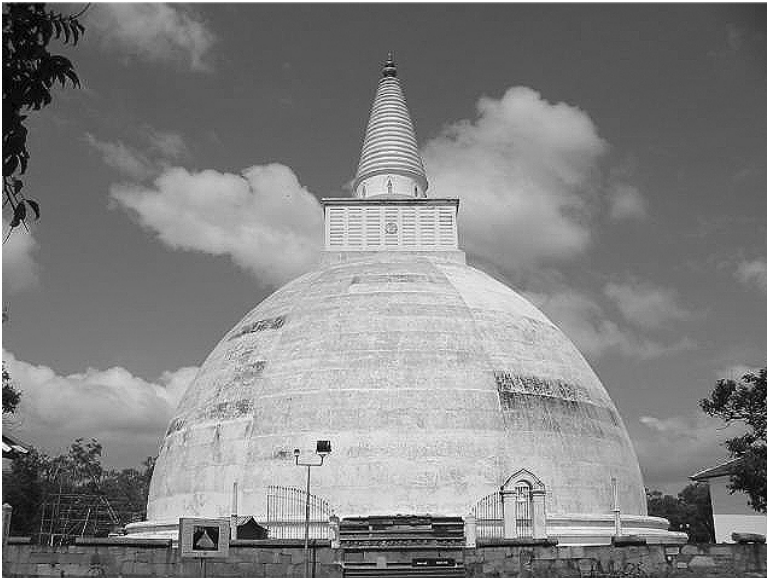
Figure 10. Mireseveti stupa after full restoration (height = 43 m, base diameter = 54 m)
