Traditional Becomes Modern: the Rise of Collegiate Gothic Architecture at American Universities

Deborah Robinson and Edmund P. Meade

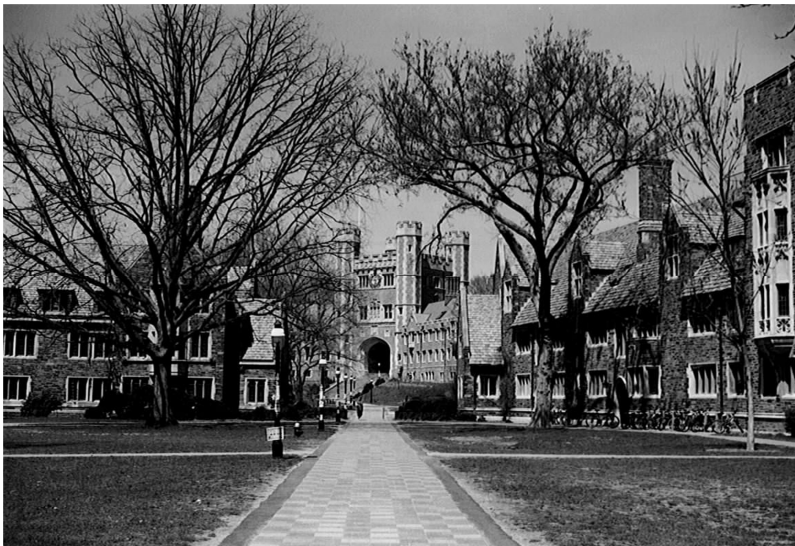
Figure 1. Princeton University: Blair (center, 1897), Foulke (left, 1923) and 1901/Laughlin (right, 1924)

In the late 19th and early 20th centuries American universities zealously embraced the architecture of Oxford and Cambridge as models for university life. This included both the enthusiastic building of housing for growing student populations, and the design of architectural features that mimicked stylistic components of the Gothic structures. Technological and sociological changes resulted in engineering and architectural changes in the planning and construction of new Gothic buildings in the United States. This paper will highlight both these changes and the challenges of dealing with the restoration of several examples of this building type. (**fig. 1**)

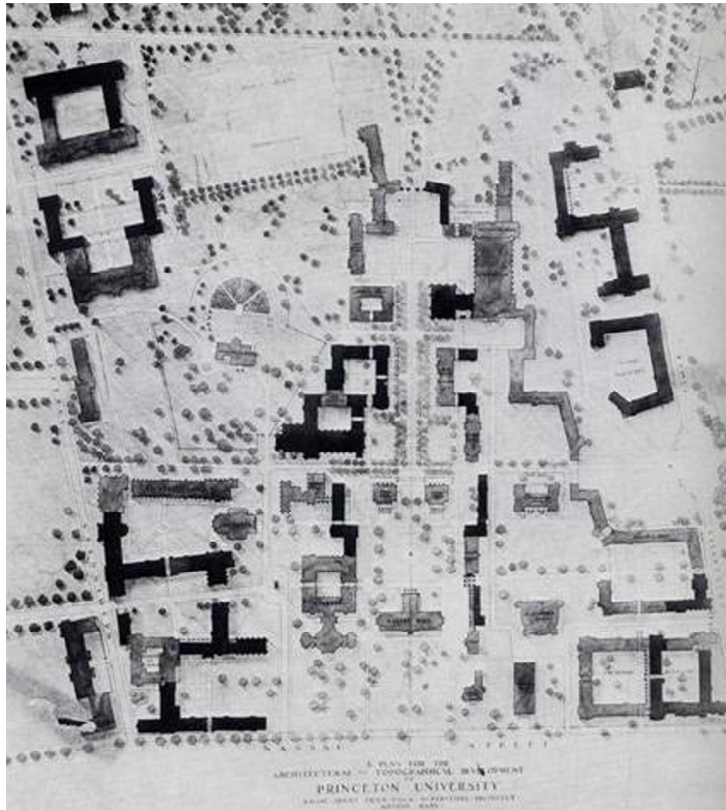
Figure 2. Cram's plan for Princeton, updated 1911

The development of the Princeton campus was strongly influenced by Cram and his master plan of 1908. This plan attempted to restore some formal order by adding new buildings in relationship to the existing in a manner that created linked cloisters. The design of individual spaces, rather than following the rules of symmetry and axiality, followed more picturesque principles of narrowed and intensified vistas, unanticipated paths and quadrangles, and the revelation of the unexpected (Turner, p.233). Much of this plan was not executed, but the Collegiate Gothic flourished, particularly in residential buildings, into the 1930's. Overall, the buildings at Princeton, however,

did not programmatically coalesce into residential colleges until much later. For this reason, the linear, meandering style of building rather than the enclosed quadrangle, remains the dominant Princeton type. (fig. 2)

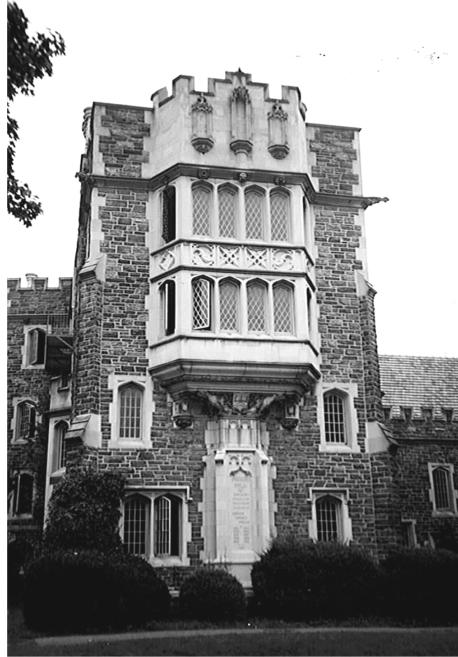
Figure 3. Patton Hall's exterior is made of rock-faced schist with ornamental limestone trim

Patton Hall, designed by Benjamin Wistar Morris and constructed in 1906, was somewhat unique amongst the Collegiate Gothic buildings at Princeton. As one of the earlier Gothic buildings and as something that created the southern edge of campus at the time it was constructed, Patton's architecture included a richness of ornament and materiality that became less pronounced and more institutional on some of the later projects. (fig. 3)

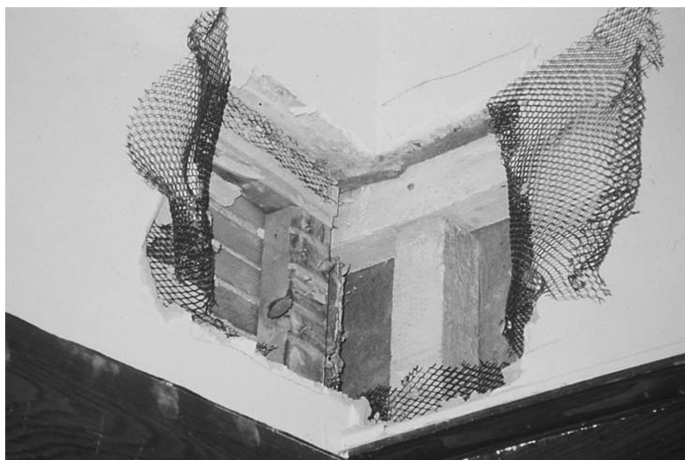
Figure 5. Destructive investigation uncovered original gypsum and wood studs

Non-loadbearing wall construction typically included wood studs with wood furring and plaster. At stairwell walls and separations between suites, however, partitions were constructed with studs made of gypsum with a wood core. This product appears to have been something of a novelty. An early construction handbook identifies these as “Gypsinite Partitions” (Kidder, p.878). Under the sub-heading of Fireproofing of Building, these studs were described as follows:

The studs are carefully made and are plumb and true. Metal lath or plaster boards are secured to the studs and plastered, completing the partition, which is about 4 1/2” thick. This partition is slightly heavier than the ordinary partition of wooden construction. It is quite as stiff and as strong as a good tile or other partition, and the nailing strip feature of the studding facilitates the application of a wooden trim. It is said to be particularly sound-proof, and the spaces between the studs afford an opportunity to conceal pipes, wires, etc. Gypsinite studs are 3 by 3 by 12 in, and weigh 3 lb to the foot. They can be made any size required. In the partitions the studs are usually placed 16 in on centers and bridged as may be required. They are fastened to the floor or ceiling by the use of sills and plates of the same material, or by light channel irons, which are spiked to the fireproofing. The manufacturers believe that in large quantities these studs can be furnished as cheaply as wooden studs and that the partitions can be erected as cheaply as ordinary lath-and-plaster partitions. Gypsinite studs are manufactured by the United States Gypsum Company, Chicago, Ill.

At Patton these studs were covered with 1/2” gypsum sheets and 1/2” plaster. At some locations, where repairs had been made due to water infiltration problems (generally related to interior rain leaders) wire lath had been added prior to plaster repairs. (fig. 5)

Structurally, there was some concern as to whether or not the partitions below concrete beams might be contributing structurally. Where partitions were removed for architectural reasons, or where concrete beams were damaged prior to or during construction, reinforcing steel channels

were added to the existing concrete beams. There had also been some concern with the gypsum studs. For one thing, there was a need to identify the fact that the fire-resistance rating for this material is at least the equivalent of a 1-hour assembly, since the renovated building would need to comply with current building code requirements. Additionally, there was concern that these studs might not be structurally sound enough to withstand architectural modifications such as the need to secure handrails to them. In the end the studs were acceptable on both counts, and they remain as part of the building construction.

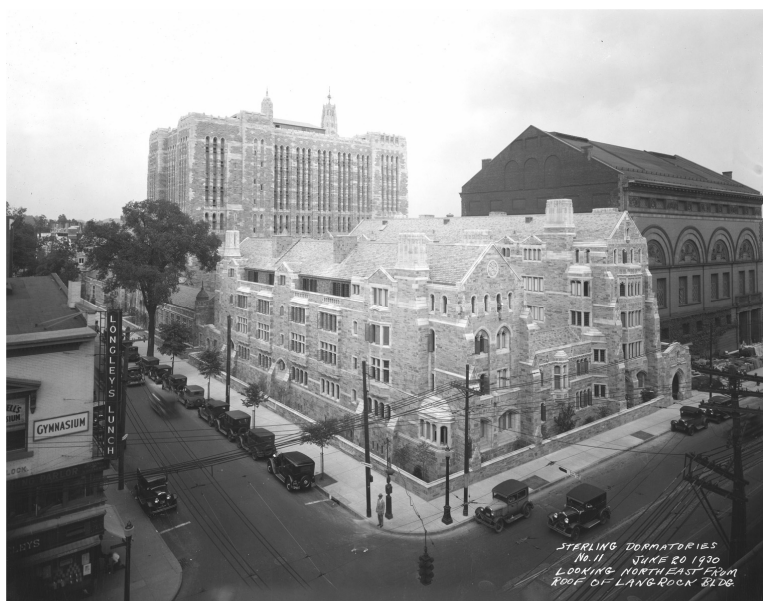
Figure 7. Construction photo from June 20, 1930. Sterling Dormitories and the old gymnasium

Trumbull College is currently one of 12 residential colleges at Yale. It consists of five ‘wings’, three of which were constructed in 1929 as the Sterling Dormitories. The remaining wings were completed in 1933 and included the dining hall wing and master’s house wing. The complex currently is approximately 118,000 square feet in size. It houses approximately one half of the 400 students who are called “Trumbullians”, and also provides social and recreational spaces, a dining hall, library, seminar rooms and faculty offices, as well as residences for Faculty Fellows, the Trumbull College Dean and the Trumbull College Master. An early plan shows that at the time of the construction of the dormitory wings it was anticipated that the complex would be completed as a residential college in the future. The phasing of the project was at least in part required by the need to wait for the completion of Yale’s new gymnasium prior to demolition of the old gym. (fig. 7)

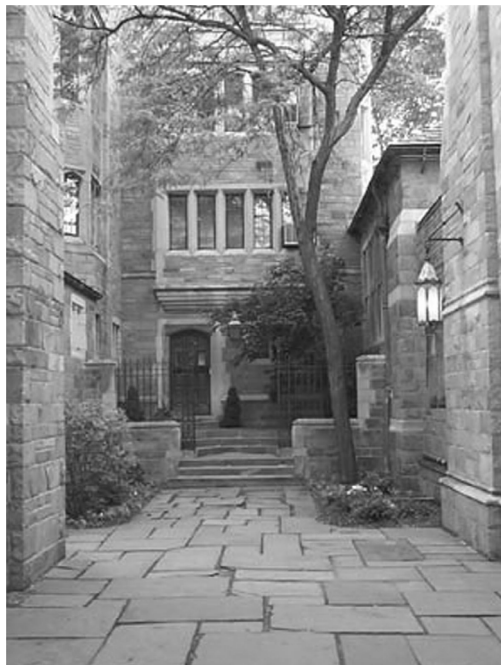
Figure 8. Courtyard entry to Trumbull master's house

There's a small fourth courtyard at the entrance to the master's house, so photogenic it tends to show up on postcards. James Gamble Rogers, who designed nine of the twelve residential colleges, on its completion in 1930 considered Trumbull--modeled after King's College, Cambridge--his masterpiece. (**fig. 8**)

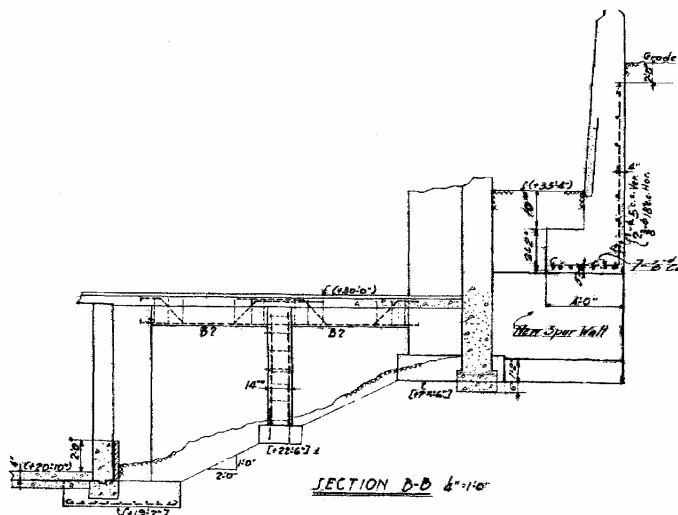
Figure 12. Section at Wing C addition adjacent to Wing B

Nearly all of the load bearing foundation walls that extend just one story below grade are made of plain concrete footings and unreinforced masonry (usually stone). If a foundation wall extends more than approximately 12 feet below grade and/ or has significant additional structural loads imposed by adjacent construction (for example, with adjacent footings at higher elevations load from one building is transferred to the lower elevation foundations), the wall is made up of either large mass concrete or reinforced concrete.

Along Elm Street, where lateral loads can be transferred through the entire frame of Building C there are plain concrete buttresses hold back reinforced concrete retaining walls. Along the west side of Wing C (where it is separated from Wing B by less than 15 feet of space), the below grade basement walls of Wing C extend to a lower elevation than those of Wing B. Because of this the foundation walls of Wing C were designed to take the superimposed load from Wing B. This condition is, in fact, noted on the original drawings for Wing C. It is also evident from the structural design shown on the drawings. (**fig. 12**)

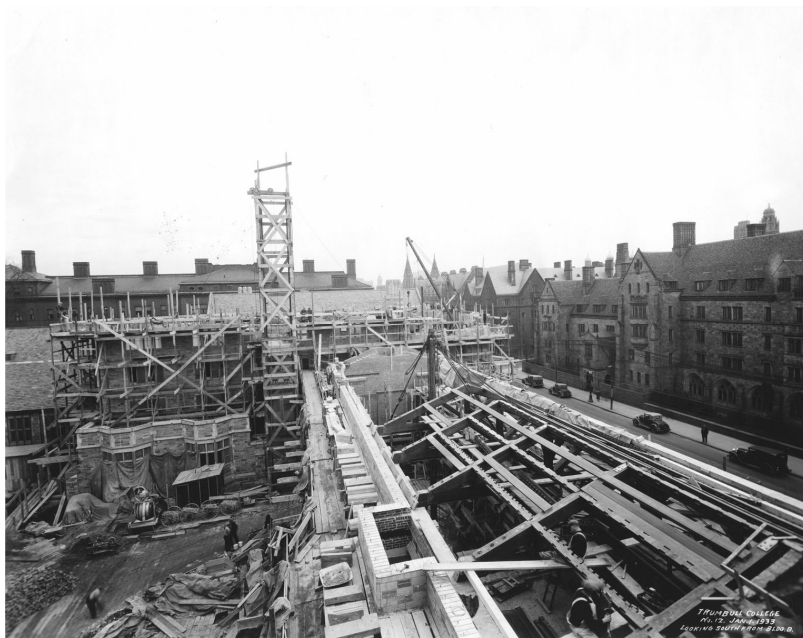
Figure 14. Construction of framing for dining hall roof, January, 1933

In general, structural wood members were not used in the construction of the Trumbull College complex. The main exception is the wood trusses in the roof framing of Wing C for the main dining hall and library spaces. (fig. 14)

The trusses in Wing C are composed of heavy timber members and because of this they have significant intrinsic fire resistance. These trusses do contain an iron rod in the vertical wood member (which is labeled as “false” on the drawings), additional steel plates, and additional bolts (especially to transfer shear loads from one member to another). (Fig. 15)
