Life on the Edge: the Rock-Cut Dwellings of Kinver Edge

Edmund Simons

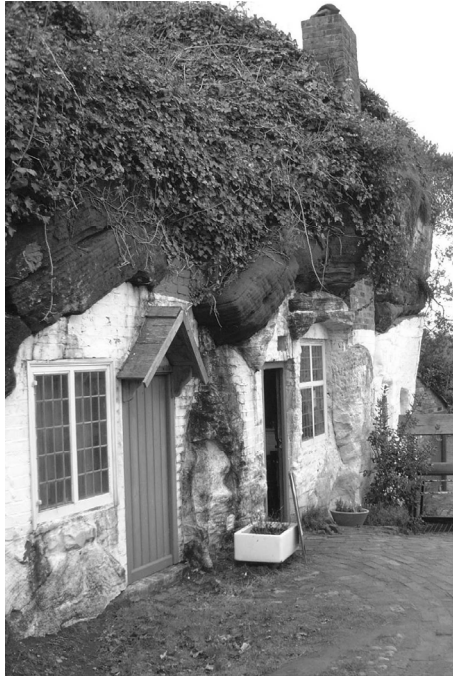
Figure 2. The National Trust's restored rock-houses at Holy Austin Rock, Kinver

In the 1980s many caves were used for parties and vandalism, particularly fires and the sawing through of rock walls with cables, caused several roof falls. Partly to stem this loss the National Trust restored the caves at Holy Austin Rock and rebuilt a lost sandstone dwelling from old photographs. This allowed a permanent custodian to live on site and the reconstruction of a furnished set of dwellings. This restoration also initiated the only detailed archaeological assessment yet carried out on one of the rock houses (Shoesmith 1993). The other sites remain in a state of decay.

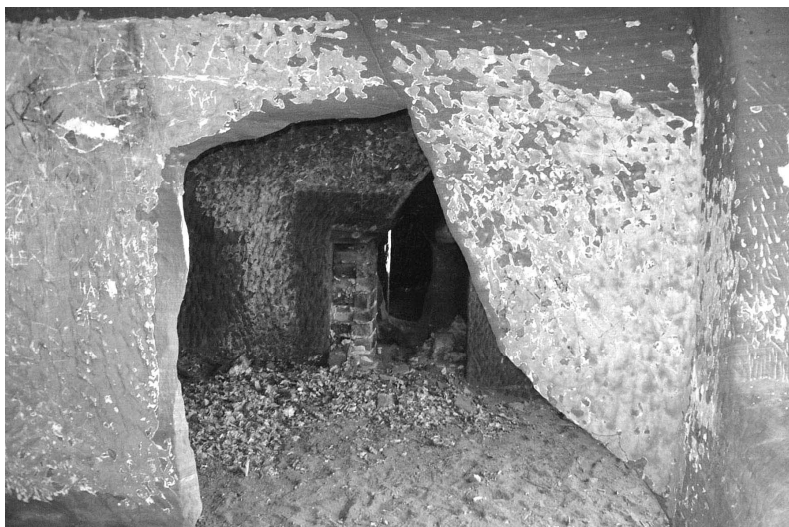
Figure 3. Thin internal walls dividing rooms at Drakelow, east group, the holes in the walls are due to vandalism.

In construction many of the eastern Drakelow rock houses are almost identical to each other and unlike earlier examples, the rock hewn walls between individual rooms may be very thin (**fig.3**). A number of other complexes in the study area have similar units, the upper level at Vales Rock (**fig.10**), the Sladd Lane Rock houses, lower level Holy Austin Rock, and these are likely to be similar in date to the Drakelow examples.

More serious vandalism has included the destruction of almost all the thin rock-cut walls on the assessable sites. These walls are often only c100mm thick and can be easily kicked out. Similarly brick and stone fireplaces and brick lined flues have been demolished. In several sites quarry tile floors have been uprooted and either thrown out of the entrance or stolen (**figs. 3, 9 & 10**).

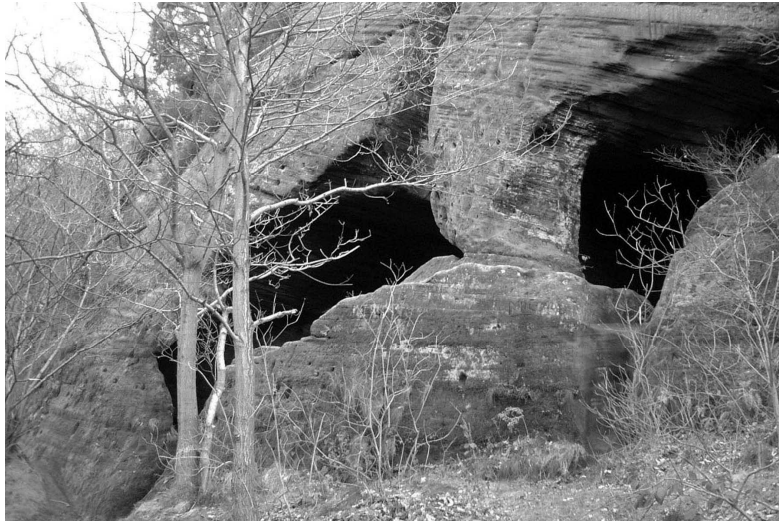
Figure 4. Nanny's Rock, an enhanced natural cave.

Nanny's Rock (**figs.4 & 8**) is another enhanced natural cave site which is somewhat easier to interpret but like Gloucester Coppice is both unusual and enigmatic. This is a very large cave

The rock house is made up of an enlarged natural cave which still survives at the south end of the monument. It sits high on a sloping cliff face and may only be accessed by a steep water channel at the north end of the main cave (a smaller artificial cave lies to the immediate north). This entrance gives access to a suite of separate chambers bored into the hillside. These are lit by large windows on the west side and were heated by two fireplaces with impressive chimneys cut into the stone above (scars indicate that these had timber framed fronts). What is clear at Nanny's rock is that the irregularity of the cave entrance meant that part of the front was made up of a timber frame. This survives as slots, scars and beam holes which are difficult to interpret but seem to represent a large timber framed façade

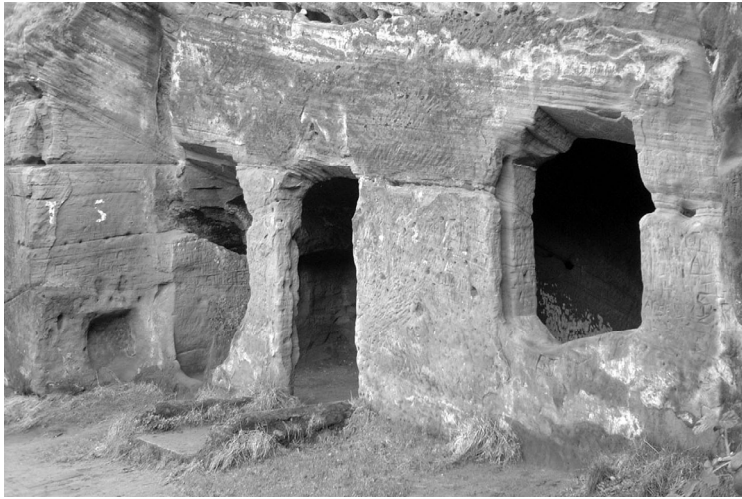
Figure 5. An exterior view at Holy Austin Rock, Kinver, note the slot for a window frame and painted internal walls.

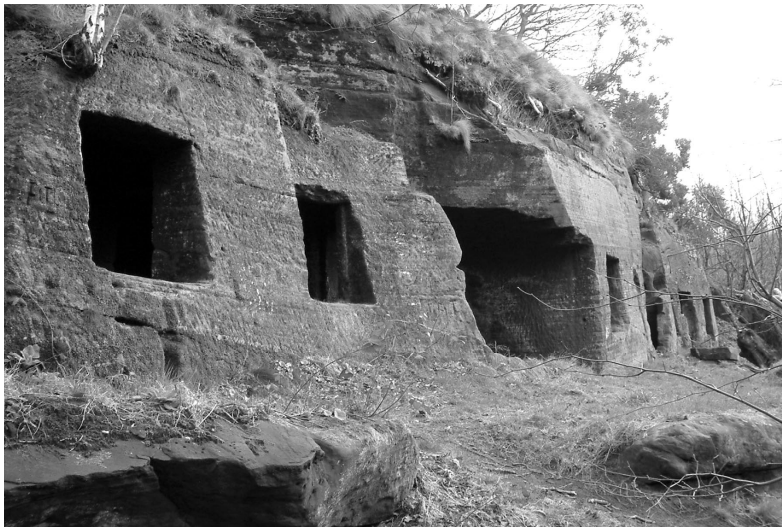
Figure 6. 1850s caves at Drakelow, east group, built by retired ironworkers. The collapse in the centre was caused in 2000 by tree roots penetrating the rock.

The isolation and lack of monitoring and maintenance of many of the sites is both a threat and a protection. The uncontrolled growth of tree roots through the rock caused major collapses at Drakelow in 2000 (**fig.6**). Elsewhere in this complex, however, tree, ivy and scrub growth has protected many caves by disguising their entrances and hiding nearby ruined buildings. In Vales Rock, which is in Kingsford Forest Park and owned by Worcestershire County Council, the cave sites have been cleared of trees and scrub and an attempt made to fence the site and put warning signs up. Unfortunately this has made many previously hidden features more visible and since the clearance they have been almost destroyed by vandalism.

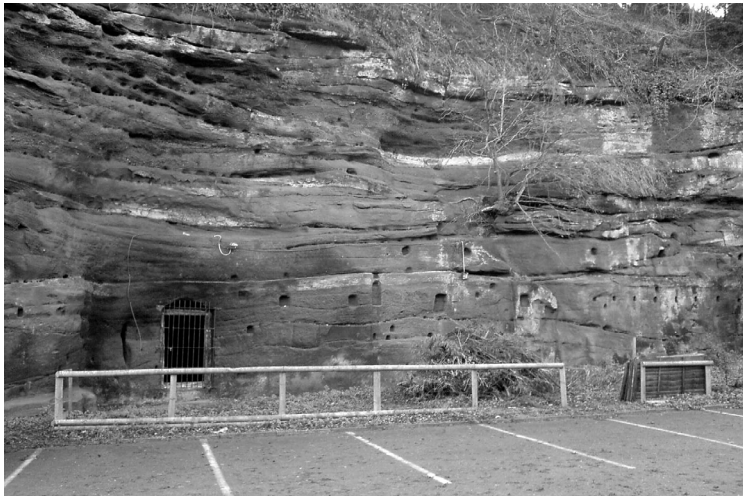
Figure 7. Rock cut features at the Queen's Head, Wolverley. Some relate to vanished timber buildings, others remain mysterious.

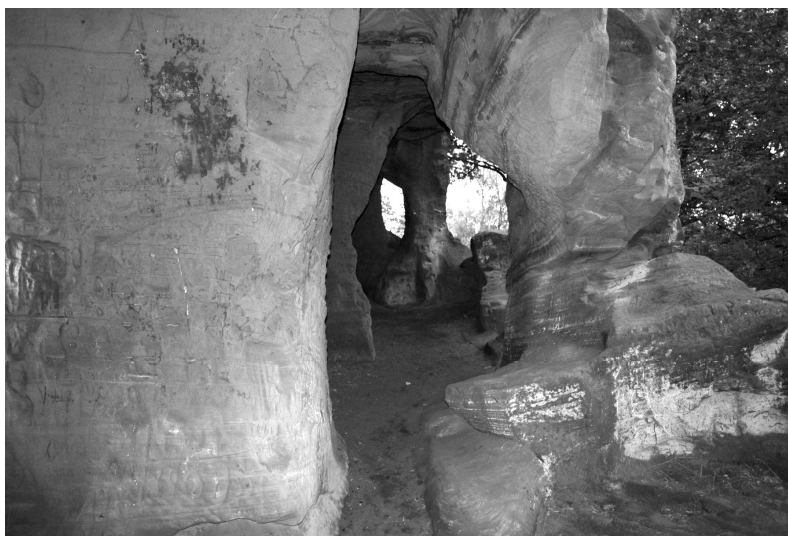
Figure 8. The interior of Nanny’s Rock is unlike any other rock-house and contains a wealth of archaeological information.

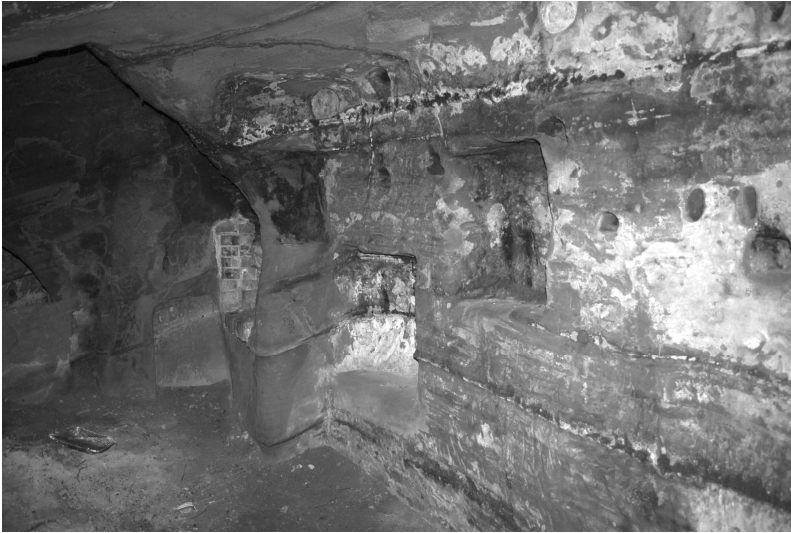
Figure 9. The lower level at Vales Rock (Wolverley) retained its quarry floors, fireplaces, fittings and even some furniture until the 1970s, the site is now in very poor condition.

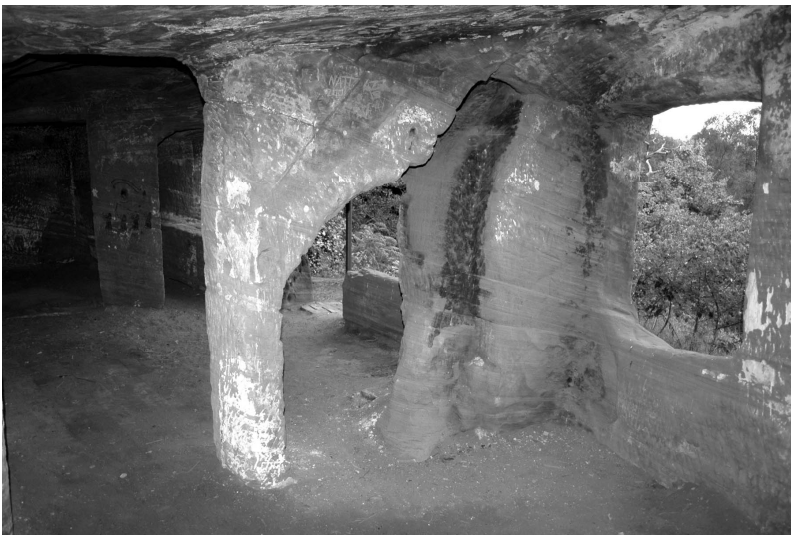
Figure 10. A fireplace and flue at the upper level of Vales Rock (Wolverley) has suffered from repeated and sustained vandalism and has benefited from neither protection or recording.

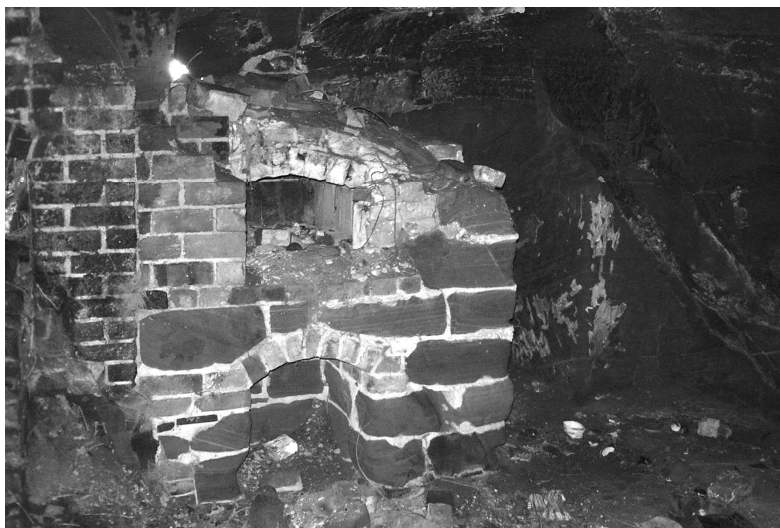
Figure 11. A Sandstone oven at Drakelow (west group) has only survived because of the isolated and overgrown location.
