Brickwork-Related Innovations in the Seventeenth and Eighteenth Century

Dirk Jan de Vries

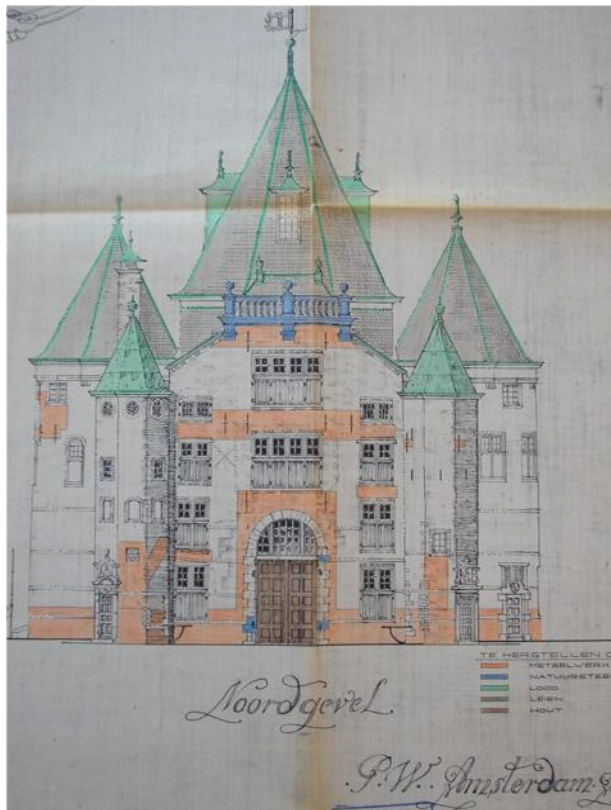
Figure 1. North side of the Amsterdam Waag (weighhouse) with entrance turrets to the guildrooms (Gemeente Werken Amsterdam 1942)

Since 1617 the guild of the Amsterdam masons and bricklayers had held its meetings on the first floor of the refurbished St. Anthonispoort, which then acquired the function of the new weighhouse 'De Waag' (fig.1).

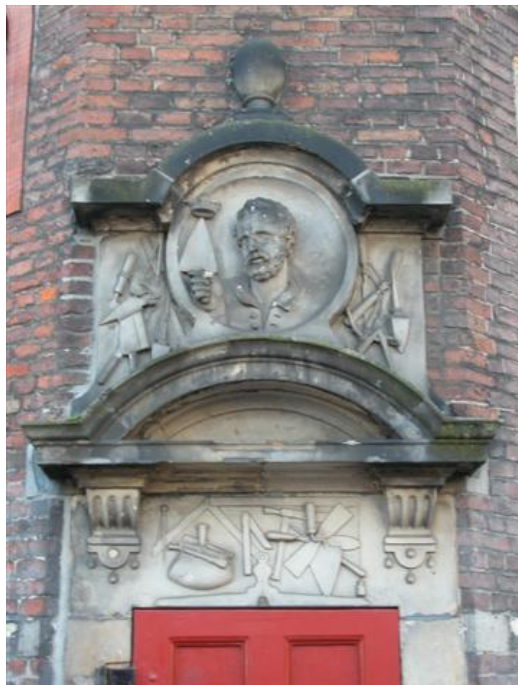
Figure 2. Entrance of the guildhall for the bricklayers, stonemasons, slaters and pumpmakers in the northeast tower, sandstone 1617

The northeast staircase tower gave entrance to it. The door is framed with Bentheim sandstone with in relief the tools of the four guilds united here, notably the bricklayers, masons, slaters and pumpmakers (fig.2).

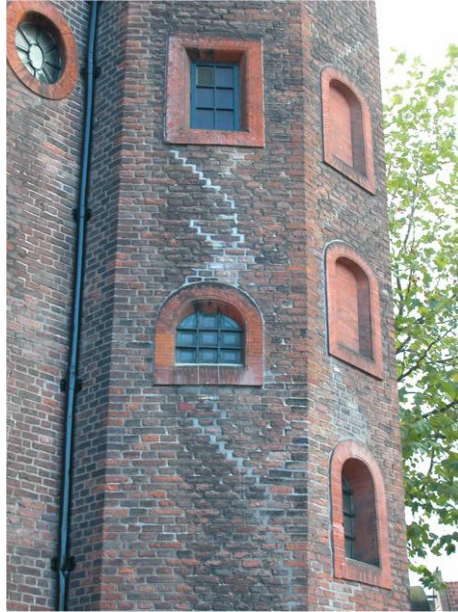
Figure 3. Masterpieces in the northeast tower of the Amsterdam weighhouse

Once we are inside the weighhouse, a winding stair leads to the small room of the guild servants on the first floor (Scheltema 1874, p. 306). Above the stair handrail we see a row of niches and windows of gauged brickwork, several of which are also visible on the outside (**fig.3**).

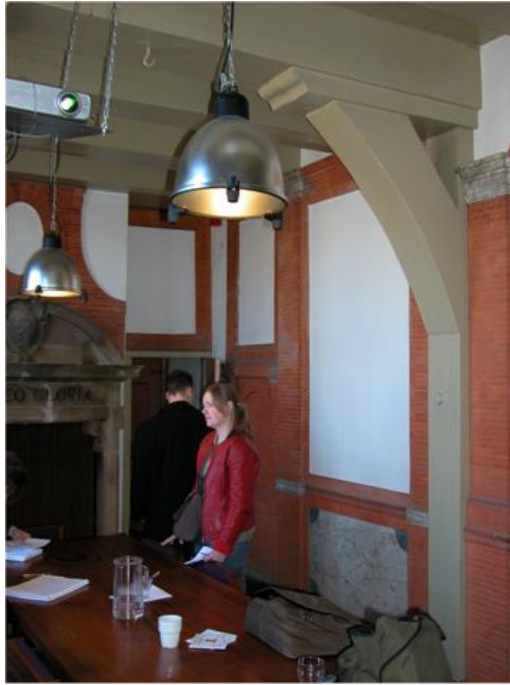
Figure 4. Meeting room of the guild on the first floor of the Amsterdam weigh-house

The room of the guild servants also contains masterpieces of fair-face brickwork and is covered by a stucco ceiling, signed *H. Husly 1753*. This is the anteroom of the actual guild room (Scheltema 1874, p. 307), where windows give a view of the former canal (*Gelderse kade*); the other side wall is covered with masons' masterpieces (**fig.4**).

The passageways in the end walls are surrounded by gauged brickwork, and next to the entrance to the large northwest tower there is a natural-stone mantelpiece. There is a description of the layout and furnishing which in 1874 was still more or less intact (Scheltema 1874).

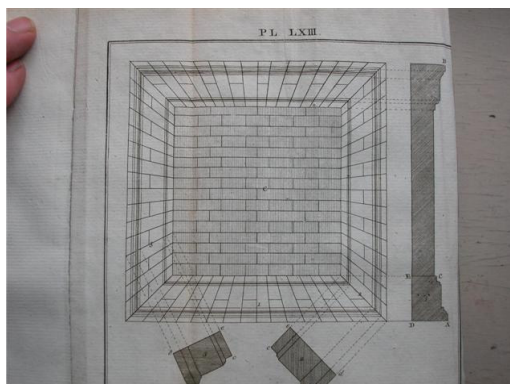
Figure 5. Masterpiece in brick (Erzey 1777, plate 63)

Nine examples are illustrated and discussed, several of which “being communal masterpieces” are present in “the upper room of the weighhouse” (**fig.5**).

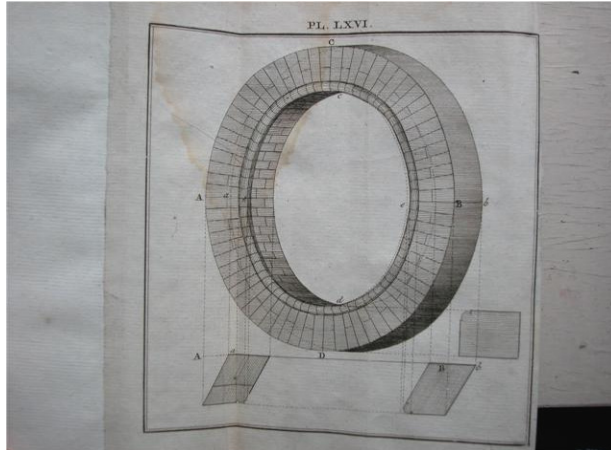
Figure 6. Oval masterpiece in brick (Erzey 1777, plate 66)

Some can also be executed in larger blocks of natural stone “however, these can also be made of brick, and are then again masons’ masterpieces” (Erzey 1777, p. 109). A window in the form of an oval or an elongated circle has an inside and outside, “which is one of the ordinary masons’ masterpieces, several of which can be seen on the outside of the aforesaid weighhouse and are usually beautifully worked on the inside and outside, and the insides are decorated with a quarter-round profile (or other profile), and therefore it is often assigned to two persons as a masterpiece” (fig.6) (Erzey 1777, p. 110).

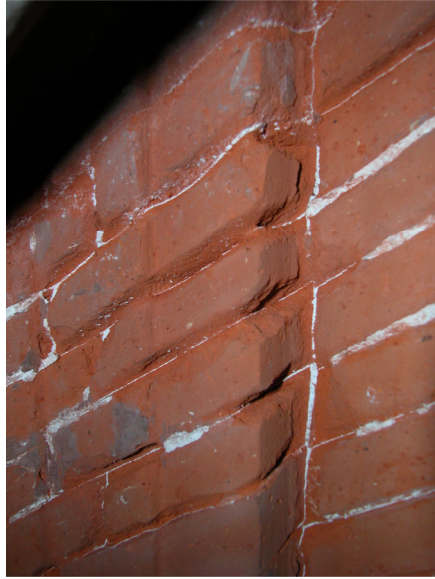
Figure 7. Dilapidation along the narrow pointing of a masterpiece

As a number of masterpieces, mostly on the inside of the staircase tower, are in an alarming state of dilapidation, architecture students of Delft University of Technology and Rob van Hees of TNO (Netherlands Organisation for Applied Scientific Research) have taken a good look at the brickwork again. The dilapidation has been going on for quite a while and manifests itself in dropped-out bricks, cracking and pulverisation of the soft bricks (Scheltema 1874, p. 310 and Van den Klooster 1995, pp. 12-13). It is visible that the extremely narrow lime pointing – it is just a matter of a few millimetres – remain equally narrow at the back (fig.7).

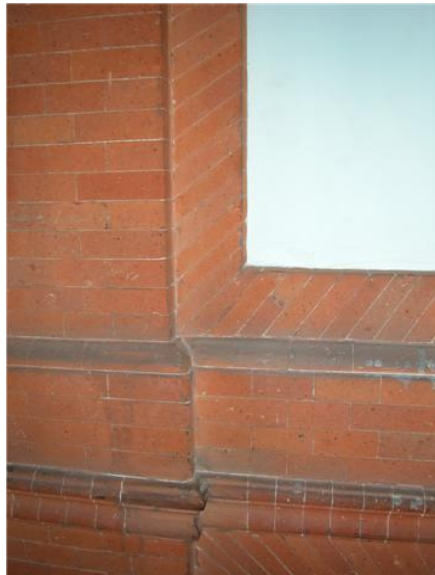
Figure 8. Gauged surfaces of a masterpiece in the guild's meeting room

In other words, the bricks have parallel joint faces. Where these visibly connect with an interior angle, it is noticeable from the side surfaces that the bricks have been rubbed away 3 to 5 millimetres (**fig.8**).

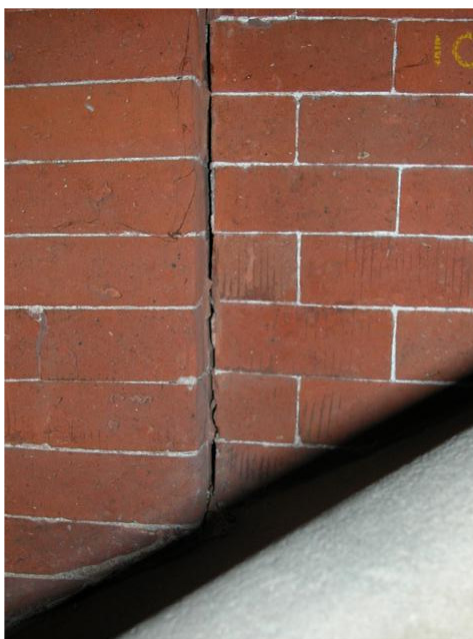
Figure 9. Vertical grooves on bricks in a corner above the banisters

Here remnants of grooves can be seen on the bricks, a kind of rough char finishing, in the terminology of natural-stone treatment. These grooves do not run vertically across more courses, from which we can conclude that they have not been applied to an already built brick wall surface, but have been fired into the individual bricks in advance.

This must also have happened to the front surfaces, which is confirmed by the places that could evidently not be reached very well, for less material has been removed there (**fig.9**).

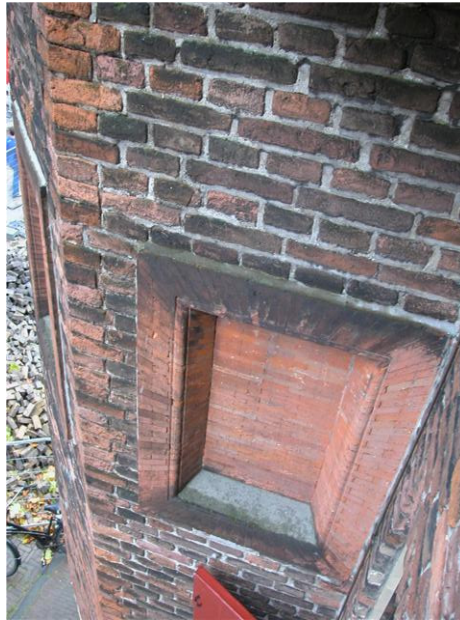
Figure 10. Rubbed corner stones in the northeast tower (1488) with a few gauged masterpieces (17-eighteenth century)

Just as with natural stone there are various types of finishing for the surface of bricks. Hand-moulded bricks are usually sanded at the sides, recognizable by a rough surface with grains of sand. Hatches or grooves may also have been applied. A first, rough distinction may be possible. The question thereby is whether these hatches developed after firing the bricks, or if they were applied to the green-clay brick in advance. Moreover, the phenomena appear to be much older than the seventeenth or eighteenth century we are discussing here. E.H. ter Kuile concluded in connection with the late fourteenth-century sections of the Pieterskerk in Leiden that “The brickwork of the ambulatory and sacristy has been cut flat” (Ter Kuile 1944, p. 65). It is not quite clear whether this had already been done during construction or, for instance, during the restoration in the early twentieth century. For it is conceivable that the wall section was given the desired roughness before plastering it, but also that it concerned a correction of a surface which emerged more or less damaged underneath the plasterwork. Fired bricks could certainly be cut into. This appears to be the case, for instance, in the profiled gutter board above the choir of the Broerenkerk in Zwolle (1466-82) which – just as natural stone – is provided with a mason’s mark (De Vries 1989, pp. 23-25). In the nave (1492-1500) of the same church, both on the reveals of the windows and on the outer corners of the buttresses, specially moulded (unsanded/cut) bricks are noticeable, which are slightly lighter in colour than the other brickwork. The same phenomenon can be observed on the outer corners of the northern staircase towers of the Amsterdam weighhouse – St. Anthonispoort (1488) (fig.10).

Nevertheless these bricks appear to be just as well-fired as ordinary bricks. We also know such bricks from one of the outer corners on the auditorium/refectory of the *Broeders des Gemeenen Levens* (Brothers of Communal Life) behind Praubstraat in Zwolle, where the date 1497 had been inscribed on the green-clay brick. Optically this method is reminiscent of corner bonds for which natural stone was used in combination with bricks, as for instance in the Brabant Gothic style. Older is the combination of corner blocks and rubble-work in between. The method may have to do with the aesthetic need for evenly finished demarcations, but also with the technical necessity to make a corner or side sturdier, which may have played a part in the construction of solid or hollow Romanesque walls.

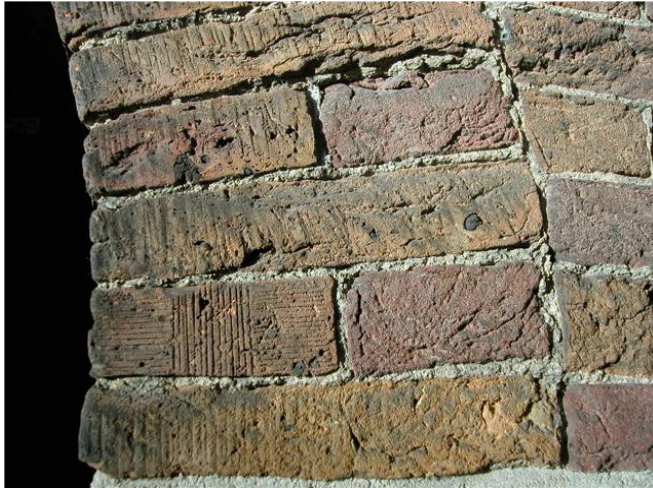
Figure 11. Zijlpoort Leiden (1667-'69) prepared bricks with grooves and hatches at the inside of the gate

The hatches may have been applied to the green-clay brick with a piece of wood, a comb with teeth or a wire saw, or cut into the bricks later, as referred to before. The article invariably starts from the idea of a deliberate aesthetic effect and not from any technical reason. Consequently, this seems to be inconsistent with the application of the (much more recent) grooves that we came upon as (unintentional) remnants of the rubbing process. Another reason, which is rather of a practical, technical nature, seems to be adjustment of ‘ordinary’, rectangular bricks in order to realise oblique angles. In that case the hatches only occur on one side, while the other side is sanded. In the Middle Ages this was customary for the springing of funnel-shaped or profiled openings. Returning to the period under discussion, a good example is to be found in Leiden. For a slanting town plan requires adjustment of all the individual bricks forming the corners of the building. Such corners are abundantly present in the Zeilpoort in Leiden (1667- ’69); as twisted passages in the brickwork were opted for– for military-strategic reasons – these special cornerstones were necessary. Invariably only one side of such bricks was adjusted. It is not clear yet whether it concerns bricks shaped like that in advance or cut to the required shape later. In the same gate there are arches in which some springing stones have grooves, arranged in patterns and unmistakably applied before firing (**fig.11**). Considering their dark, fired colour they were not intended to be rubbed.

century instances are known in Leiden, where all the bricks in the wall surface show such grooves and one in Haarlem dating from 1756, where only the stretchers and three-quarters against the window openings have them (Regentenkamer Leprozenhuis). The question is whether it here concerns bricks with imitation char finishing or brickwork that still had to be rubbed. For the time being we opt for the former, which may be confirmed or rejected by carrying out hardness measurements.

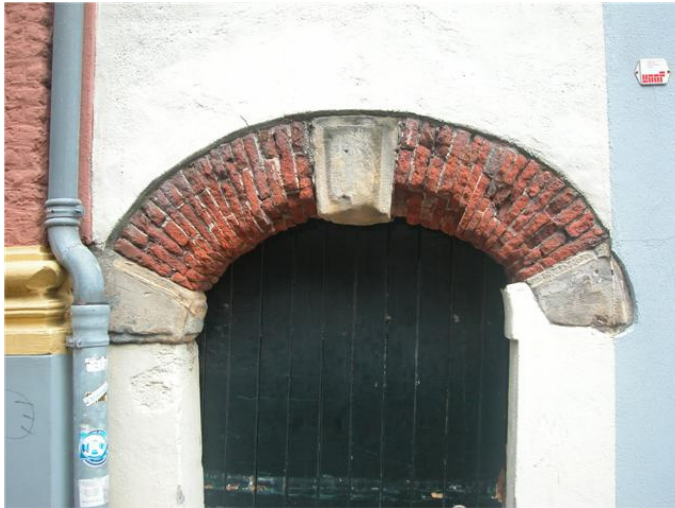
Figure 12. Arch next to 4 Springweg Utrecht, dilapidated gauged brickwork

A brick that was deliberately fired less hard was indeed meant to be rubbed after the bricklaying. Compared to 'normal' bricks these can be recognized by their lighter, orange-red colour. Yet another possibility presents itself: the above-mentioned meter to measure the hardness of the pointing, which we have not used yet in connection with this question, however. There may be a third (optical) characteristic for recognizing softly fired bricks meant to be rubbed and that is the dilapidation as a result of frost and salt damage with the passage of time. Many of the Amsterdam masterpieces appear to have suffered from it, but also several gates of gauged brickwork found elsewhere (arch next to 4 Springweg, Utrecht, for example) (**fig.12**).

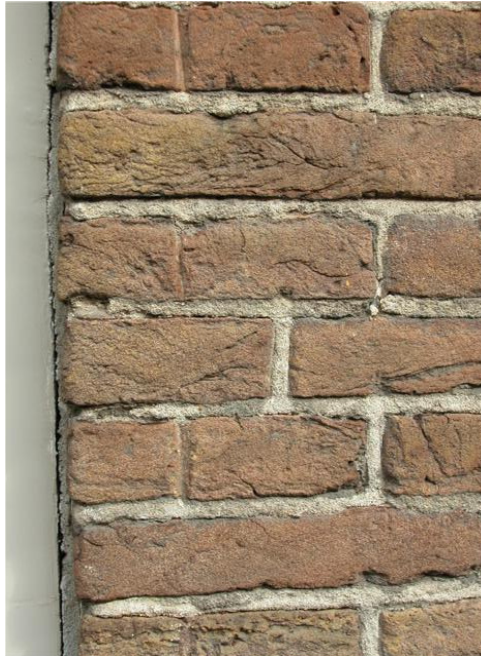
Figure 13. False vertical pointing on three-quarter bricks near an edge in the façade of 15 Koningsstraat Amersfoort (ca. 1685)

Besides being used as a masterpiece, from the seventeenth century onwards gauged brickwork also occurs elsewhere in façades, exterior walls, gates, stretchers above windows and the like, although not on a large scale because it probably concerned a very laborious and expensive method. The largest-scale application is the previously mentioned concave (Baroque) façade of the Van der Perrehuis in Middelburg (1765). Gauged brickwork probably reflected the highest ideal of perfectly and precisely executed masonry, such as that of the masterpiece. The ideal is a smooth and even wall surface, mathematically precise, built in Tudor bond or English bond with the pointing as narrow as possible. With used, selected bricks in combination with fine, pure lime mortar that had probably been sifted in advance or had been rotting for a long time, so that the bricklaying was more like glueing. The pointing is not “struck”, nor has it been applied separately and consists of flush mortar, at most brushed away diagonally. In technique and appearance the best built façades approach this intended perfection of gauged, mathematically precise brickwork. Particularly in the West Netherlands several examples are still to be found of unrubbed yet perfectly built brick façades, but these are threatened by sandblasting, cutting out and re-pointing, which are nearly always done in the wrong way. The intentions of the old bricklayers are easier to understand when we look at gauged brickwork more closely and respect old pointing as much as possible. Apart from the surface treatments referred to above, varying hardness, colours, pointing and bonds, there are a few other phenomena which should be mentioned briefly here. They have to do with the same striving for perfection and mathematical purity. Sometimes bricks have false joints, intended to suggest the end of a brick, but actually just a groove filled with mortar. In the left part of 7a Vijfde Binnenvestgracht in Leiden (approx. 1590) there are brick-sized basket arches with sandstone keystones. Apart from the fact that here and there vertical grooves seem to have been made in the surface, every other stretcher a groove was applied in order to suggest alternating stretchers and headers. However, the two arches only consist of stretchers on their sides, which is the more striking because in most false joints there is no sign of mortar anymore. This also occurs in some of the masterpieces in the Amsterdam weighhouse, also because these are not ‘deeper’ than half a brick. The bricklayer of 15 Koningsstraat in Amersfoort (approx. 1685) still placed closers in the header courses against the outer corners of the façade, but looking more closely we notice three-quarters against the reveals of the openings. Apparently – as more often in the second half of the seventeenth century – (queen) closers seem to stand directly against the jambs. However, this effect is caused by vertical false joints in three-quarters, which ‘betray themselves’ because the pointing mortar has fallen out (**fig.13**).

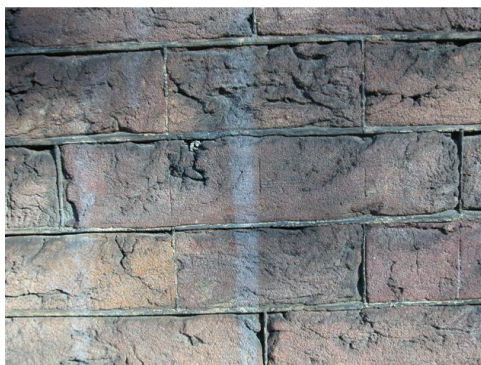
Figure 14. Leiden, façade of 12 Nieuwe Rijn, stretch with marking scratches

recognized them on the exterior walls of Mauritshuis in The Hague (Janse 1980, p. 36), but good examples can also be found in Leiden. The façade of 12 Nieuwe Rijn, for example, dates from 1790 and contains both short ‘marking’ scratches (**fig.14**) on several stretchers and continuing vertical scratch lines, half a brick next to the window openings. Apparently one of them was slanting and was corrected by means of a cross.

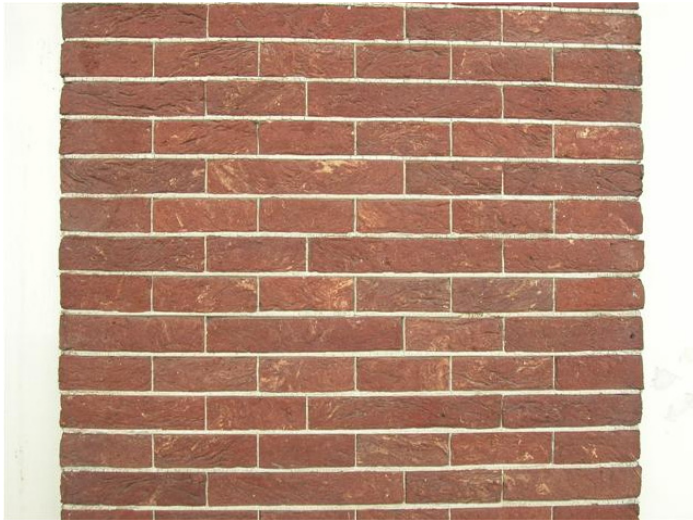
Figure 15. Utrecht, 17-19 Plompstorengracht. Rubbed façade with marbling bricks

Finally, a special effect could be given to the surface of a brick by mixing little balls of yellow and red clay to a certain extent, since the aim was not to obtain a homogeneous mixture but rather a kind of flaming pattern. On the sanded side of a brick such an effect cannot be seen, and therefore these bricks were ‘opened up’, cut to shape before firing, in order to make it visible. This technique is already found in early bricks in North Germany (Zahn 2005, pp. 33-34). In the Netherlands we also know it from seventeenth/eighteenth- century earthenware floor tiles, probably used to try and imitate marble. What is special is that there are also façades – only the lower fronts – with similar bricks, for instance, those of 5 Oude Rijn in Leiden and 17-19 Plompstorengracht in Utrecht (fig.15).
