The Failure of the Bouzey Dam in 1895

NORMAN A.F. SMITH

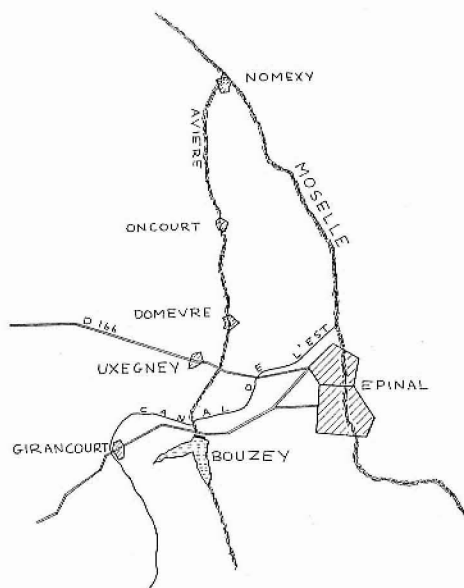
Fig 2: The Bouzey Dam and its environs

France continued to undertake major canal building long after the railways had won the argument in Great Britain. The Canal de l'Est was a particularly important project which was begun in 1872 following France's loss of north-south navigation along the Moselle-Rhine system as a consequence of the Franco-Prussian War. The Canal de l'Est consisted of two distinct parts: a northern section, essentially a canalised River Meuse, from Givet to Troussey; and a southern section from Toul to Corre on the River Sône. The two were connected west of Toul by utilising 20km of the already built Canal de la Marne au Rhin. The summit-level of the southern section of the Canal de l'Est is situated just to the west of Epinal; it runs for 10km between the D166 road bridge and the village of Girancourt (Fig. 2). It was to supply this summit that the Bouzey reservoir was created by damming the River Avère.¹⁵

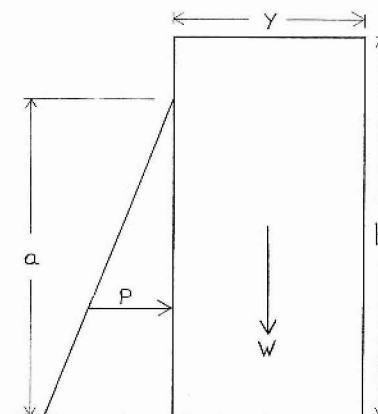
Fig 3: Belidor's problem

Even in the eighteenth century there was an emerging interest in calculating the ability of a masonry wall to resist overturning when loaded by some horizontal force. Charles Coulomb had applied himself to the particular problem of retaining walls bearing earth pressure, while B.F.de Belidor addressed the essence of the dam problem in his consideration of the behaviour of the walls of navigation locks.⁴ Belidor examines the stability of a rectangular wall of height b and width y , to be determined, when resisting a depth of water a , less than b (Fig. 3). It is assumed that masonry is $5/3$ times as heavy as water. By equating the overturning moment due to the water pressure, P , and the restoring moment developed by the weight of the wall, W , Belidor shows that y^2 must be at least $a^3/5b$ and in addition, to achieve a safety factor of 1.5, he shows that y^2 has to be $3a^3/10b$.

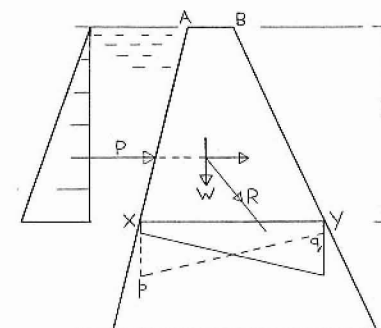
Fig 4: De Sazilly's profile of equal resistance¹; the vertical component of water pressure is ignored

work in the strength of materials by, for example, C.L.M.H. Navier and J.B. Bélanger. De Sazilly's ideas can be followed, in their essentials, by referring to Fig. 4.

De Sazilly stated in full the two requirements mentioned above: that it should be impossible for the section of dam above XY to slide relative to the part below and that the line of thrust representing W and P should be contained within XY so that the piece $ABYX$ could not overturn. A huge

set a condition. He specified that throughout the dam on every section, at the point X reservoir empty, and at the point Y reservoir full, the maximum compressive stress that the material could withstand should be realised. Hence the term "profile of equal resistance" used in his title. It means, of course, that the two compressive stress diagrams, reservoir full and reservoir empty, are mirror images of each other. It also means that in Fig. 4 every horizontal section is subjected only to compression, never to tension; the shape of the profile and de Sazilly's conditions see to that.

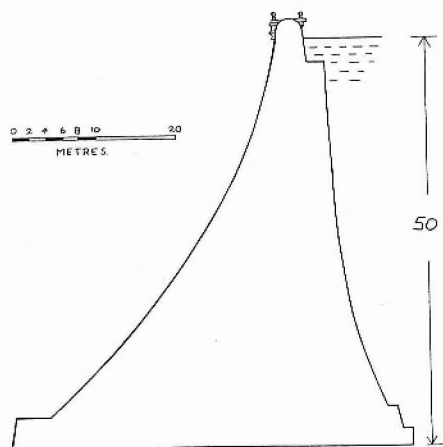
Fig 5: The Furens Dam, 1866

De Sazilly's propositions were applied immediately. The Furens dam near St. Etienne, generally reckoned to be the first "modern" dam, was designed and built between 1858 and 1866 (Fig. 5). Its designer, F.X.P. Emile Delocre, in his discussion⁸ of dam design follows de Sazilly exactly and their concepts were adopted immediately as the basis of European and American practice for half a century.

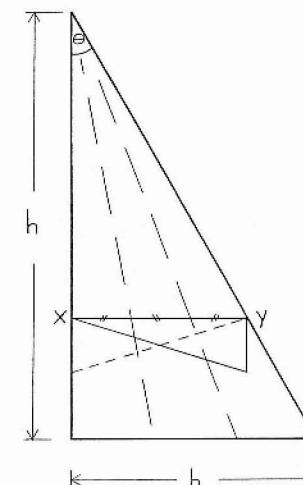
Fig 6: The basic triangular profile

As background to the Bouzey dam's design, which began in 1876, to its demise 20 years later, we can simplify the essential design concepts prevailing by considering the most basic of all dam profiles, the triangular one shown in Fig. 6. It is defined by the relationship $h^2 = b^2 w$, where w is the specific gravity of the masonry.

It is elementary to establish a number of properties of this particular form of profile. For example, it can be shown that on the typical section XY, reservoir empty, the compressive stress diagram is itself triangular. If the same maximum compressive vertical stress is developed at Y, when the reservoir is full, then the same triangular stress distribution, reversed, will obtain, as shown. This will be true at every level, and in a sense what we have here is a profile of equal resistance. However, and this is crucial, it is not, and cannot be, the profile of equal resistance because the *maximum* working stress of the masonry cannot be realised at every level. Approaching the crest of a dam, up to and above maximum water level, stresses decrease progressively so that de Sazilly's theoretical profile is, to that extent, unattainable. On the other hand, the triangular profile automatically meets Rankine's middle-third condition because the lines of pressure, full and empty, pass through the two mid-third points, respectively, at every level. Thus we have here the most straightforward

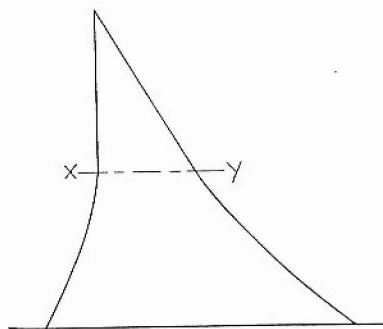
Fig 8: Below XY the profile must widen to restrict stress levels

The maximum stresses allowed have a marked effect on a dam's profile and the height to which it can retain the simplified triangular shape we have been visualising. It reaches its limits according to the range of numbers given in the Table in Fig. 7. To have a higher dam not stressed, front of back, beyond the prescribed limits requires a base of increasing width, and thus the more familiar shape of a high dam begins to emerge, as in Fig. 8.

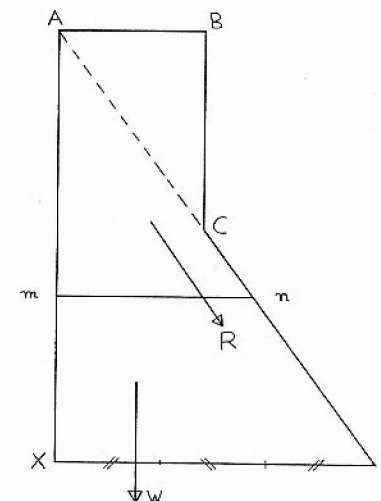
Fig 9: Dam with widened crest

As soon as the crest of gravity dam has some useful width, lines of thrust move and middle-third requirements are affected. Consider a width of road added to the top of a triangular profile as in Fig. 9. It is evident that when the reservoir is empty the mass of the piece ABCYX, will, below a certain level, XY say, shift the line of thrust *forward* and violate the middle-third rule *on the air-face*. This is very unlikely to be a problem but it is a fact. On the other hand, a very real issue arises when the reservoir is full. The fact that the top of the dam now has width means that above a section such as mn, the centroid of the profile is in any case much nearer the air-face. Therefore the possibility of generating tension at the water-face, at a point such as m, is greatly increased when the reservoir is full. In other words, on the section mn, the line of thrust, R, is forced to the right by the addition of ABC.

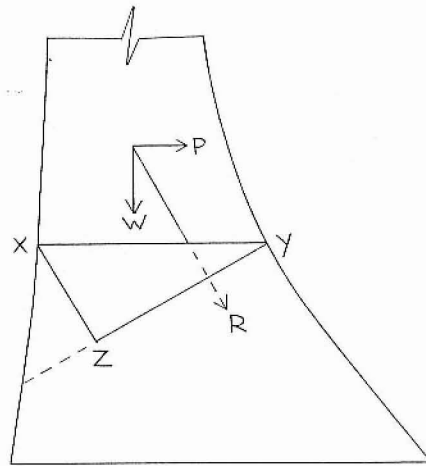
Fig 20: Bouvier's method

There is one other feature of Bouzey's ill-judged design to consider. The dam was proportioned, apparently, by the method of M. Bouvier. His procedure was much in vogue at the end of the nineteenth century and in a French ministerial circular of 1897 was even specified as mandatory. But in reality Bouvier's method was never more than a device and its use at Bouzey may explain a good deal. Consider Fig 20. Bouvier, in an effort to allow that maximum stresses are not vertical ones, considers the resultant of *P* and *W*, the force *R*,

as acting on the plane ZY rather than XY . The stress distribution on ZY , at right angles to R , is assumed linear, as usual, but the calculated stresses are higher than those obtained by considering W acting on XY . It is a device which is plausible but without rationale. But what is crucial is that whereas Bouvier's method gives an augmented compressive stress value for the air-face point Y , as intended, it gives no stress value for the water-face at all, the point Z being in effect nowhere. As Langlois complained of Bouvier's method, "it does not determine anything about what happens on the air-face."³⁴ In short a designer relying on Bouvier's method will almost certainly design an adequate air-face at the same time as he ignores the water-face completely. The method is intrinsically a technique for determining a peak stress at a point, not a stress distribution between two points.
