Traditional Construction Techniques of the Newars at the Itum Baha Monastery in Kathmandu

Matthias Beckh

This paper discusses traditional construction methods of *Newar* architecture in the Kathmandu Valley. The first part considers traditional construction and design details as well as typical structural problems associated with this kind of construction. The second part deals with construction principles and techniques as associated with the restoration of the Itum Baha monastery in Kathmandu.

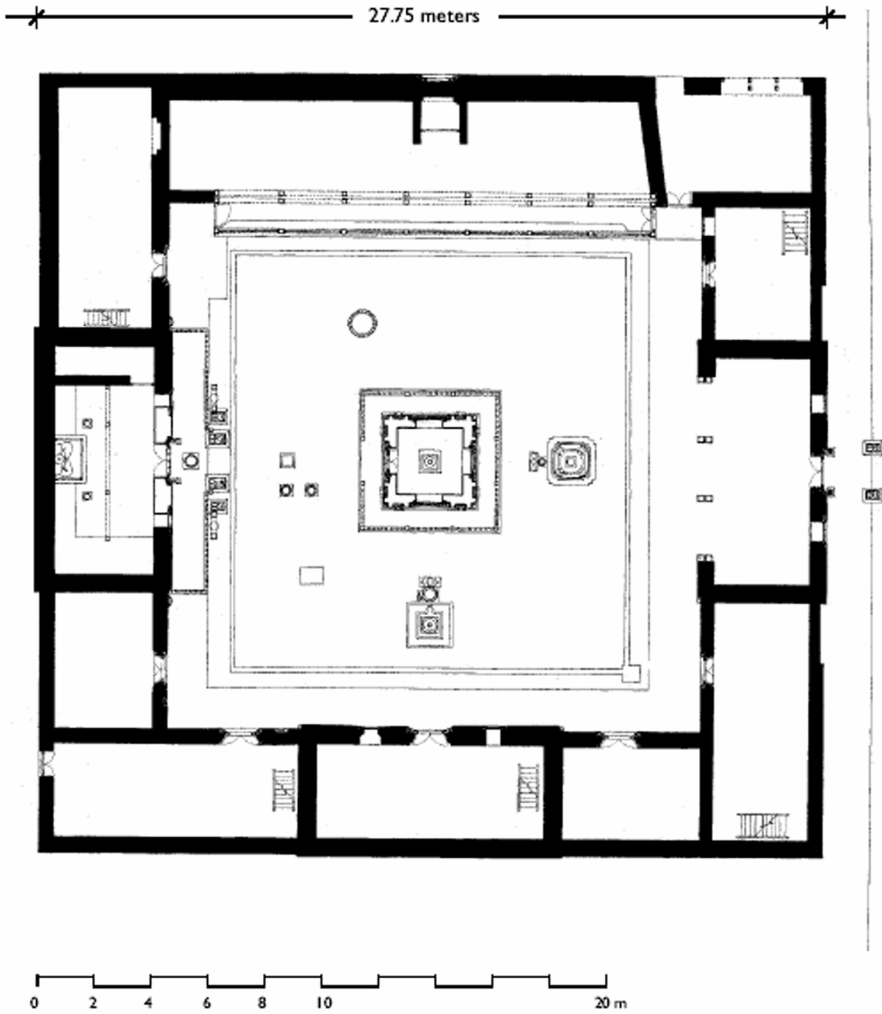
Figure 3. Floor Plan of Itum Baha

The outer dimension of the square quadrangle of Itum Baha is 27.75m. The typical bay width is 3.50m and wall thickness varies between 55 and 65cm. (**fig.3**)

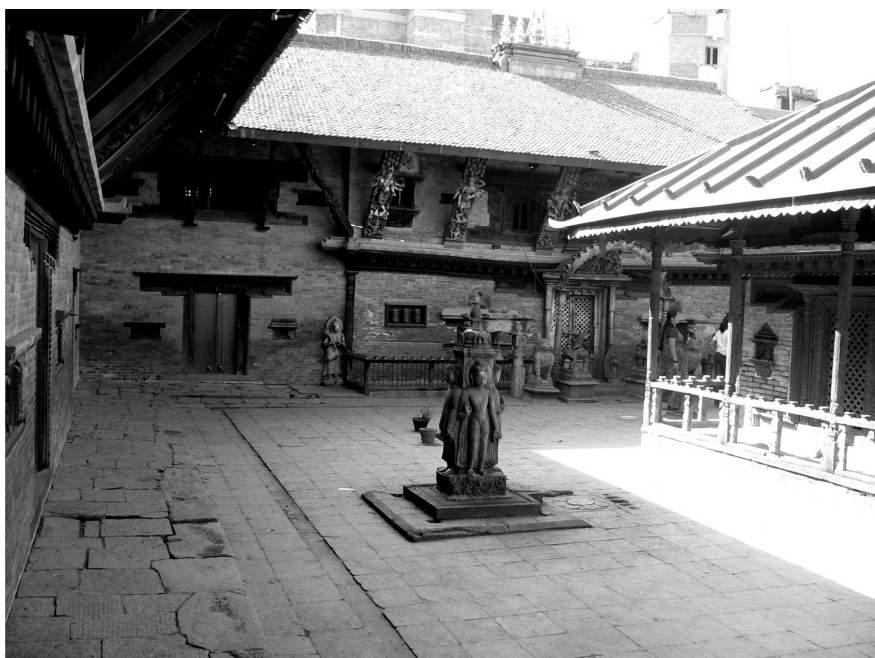
The damages at the west wing were minor in comparison to the south wing. At the courtyard façade some parts of the face bricks next to the shrine had been coated with cement plaster. At the rear of the west wing a parallel running wall had been added to stabilize the slanting bearing wall in the 1970s.

Figure 14. Restored west wing

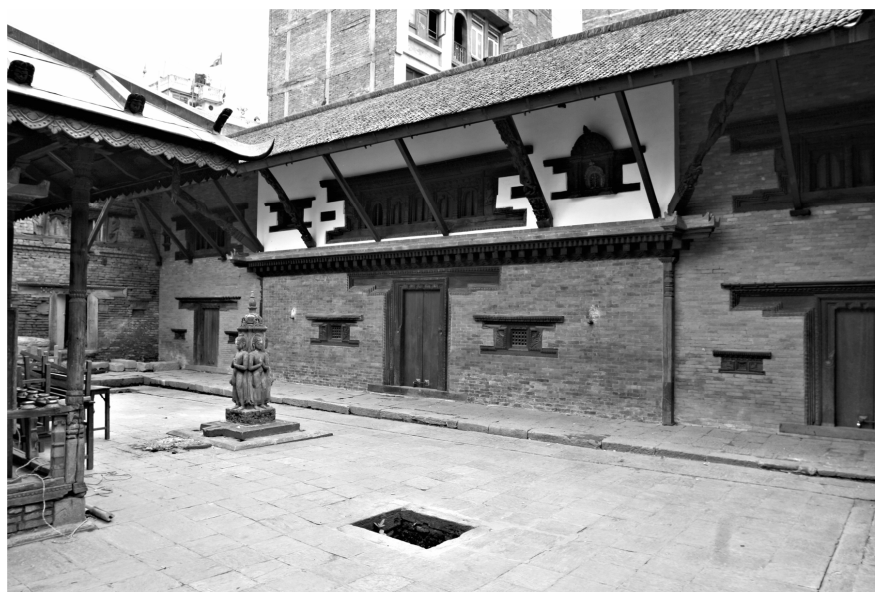
The restoration started with the south wing of the building, which was in an extremely bad state of repair (**fig.5**). A lack of maintenance had led to the partial collapse of the roof structure and the ingress of water had damaged beyond repair all the rafters and most of the joists. At the second floor level, many of the joists were rotten and severely affected by wet rot, fungus and insect infestation. Many of the timber windows on the second floor level showed boreholes caused by insects that had led to partial decomposition of the wood.

Figure 15. Restored south wing

The lack of authentic brickwork as well as the extremely poor condition of the structural fabric led the design team to the decision to dismantle some parts of the South wing and reconstruct them. To protect the masonry walls from rising water, and to increase the seismic shear resistance of the foundations, it was decided to incorporate a reinforced concrete ring beam just below grade level on top of the existing foundation walls (**fig.7**). The walls were rebuilt on top of the new ring beam in the traditional fashion with mud mortar, using both new and historic bricks. Instead of the typical three-layered wall construction with the rubble infill, a two layered cross section was used, with proper bonding between the face brick and the *ma apa* bricks behind. The new *ma apa* bricks were specially ordered to match the historic dimensions of 4 x 13.5 x 20cm. To this day bricks are still hand made using traditional wooden moulds and wood-fired kilns (**fig.8**).
