Nineteenth-Century Iron Suspension Footbridges in Flanders (Belgium)

Ine Wouters, Michael de Bouw and George G. Nieuwmeijer

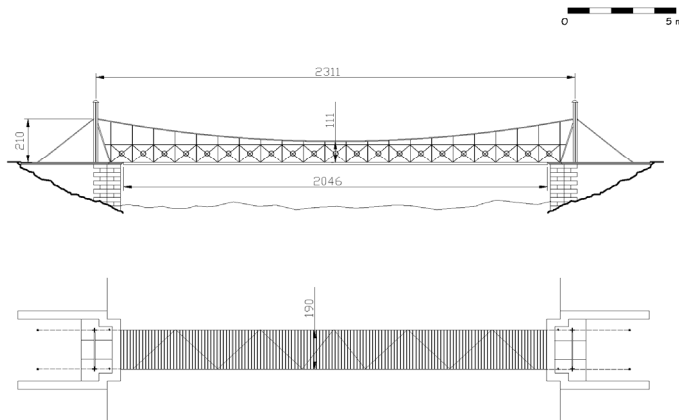
Figure 2. Plan and elevation. Iron suspension bridge in Wissekerke. 1824.

But times have changed. Since 1989, the council of Kruibeke rents the castle and the park to open them to the public. As a consequence, the bridge will have to undergo much higher loads. The discussion about the acceptable load-bearing capacity of the bridge has not yet been opened, since the bridge was in such a bad condition that it was closed to the public since 1990.

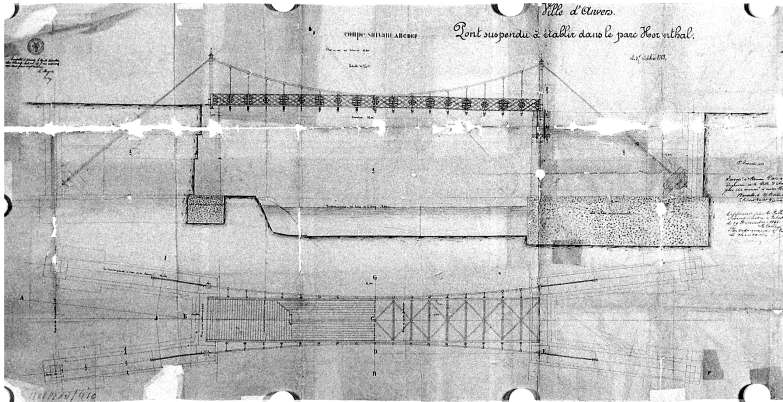
Figure 3. Original plan and elevation. Iron suspension bridge in the park at Antwerp. 1868. (Archive Antwerp).

The correspondence between engineer Van Bever and Cail et Halot reveals that the anchorages were dimensioned for a total tensile force in the cable of 400 kN. It is the construction of the masonry anchorage shaft that limits the load-bearing capacity of the bridge to a live load of 2.20 kN/m², because all the other elements (beams, hangers, main cable and columns) can stand live loads up to 5.00 kN/m².

In 1971, after a period of 100 years, the bridge was closed to the public because one of the main cables was corroded up to 50 %. Further inspection showed that there was severe corrosion on the cross beams and the railing too. The wooden deck had to be replaced. The council submitted a request for protection of the bridge as a historical monument and started the renovation. In 1976 the bridge was dismantled, the cable, railings and deck replaced.

still, the renovation tends more to a *rebuilding* of the bridge: the wire cable was replaced by a new steel cable (capacity 2500 kN), just like the hangers, wind bracing and anchorage bars; the double U-shaped cross beams (UPN180) changed into simple “I” shaped beams (DIN14). Only the columns and the truss in between those are still original parts.

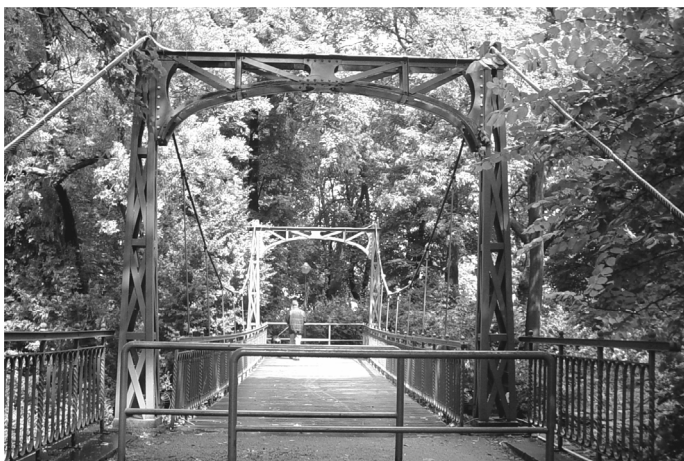
Figure 8. Front view. Iron suspension bridge in the public park of Vilvoorde, 1899.

The original cable was already replaced in the 1970s. In 2000 the bridge has undergone a thorough renovation. The “I” profiles of the deck were badly corroded, particularly where the wind bracing was connected to the main “I” profiles, since moisture and dirt accumulated onto the gusset plates. The abutments have subsided. At this moment, the railing, the truss between the columns, the

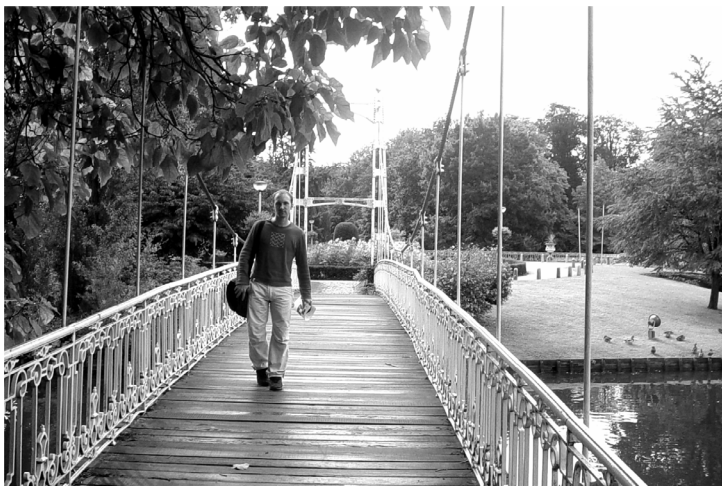
Figure 11. Front view of the iron suspension bridge in Beveren, near castle Cortewalle, 1900-05.

structural elements had to be replaced due to a lack of maintenance. In 1978, the deck of the bridge was renewed. In 1990, after one of the hangers was broken, the stability of the bridge was checked. The following renovation works were carried out: the columns were strengthened by welding new material onto them, the cable was replaced and the railing repaired. As the bridge is very lively and even one person can cause important oscillations, the railing endured serious deformations. The “design” problem of the detailing of the railing was not solved which results, today, in a deformed and buckled railing. Barriers are placed to avoid cars and motor vehicles from crossing the bridge.
