## From construction to maintenance. The history of the wooden chain encircling the dome of Santa Maria del Fiore

**Sofia Celli and Federica Ottoni**

Department of Engineering and Architecture, Università di Parma, Italy

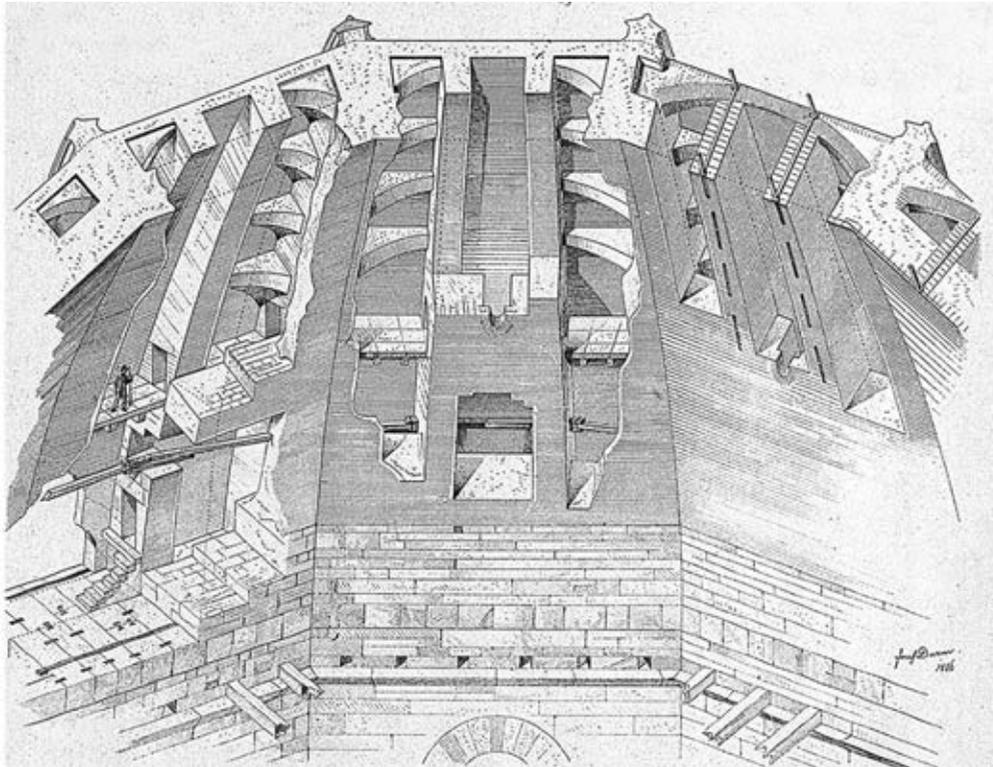
*Figure 1: The structural arrangement of Brunelleschi's dome with the one built wooden ring in Joseph Durm's representation (1887) [2].*

stone, iron and wooden rings. In particular, the wooden chains were initially meant to be four (one every 12 braccia, or 7 metres in height), but in the end, due to subsequent changes to the original plan [4], only one of them was actually realised (Fig. 1).

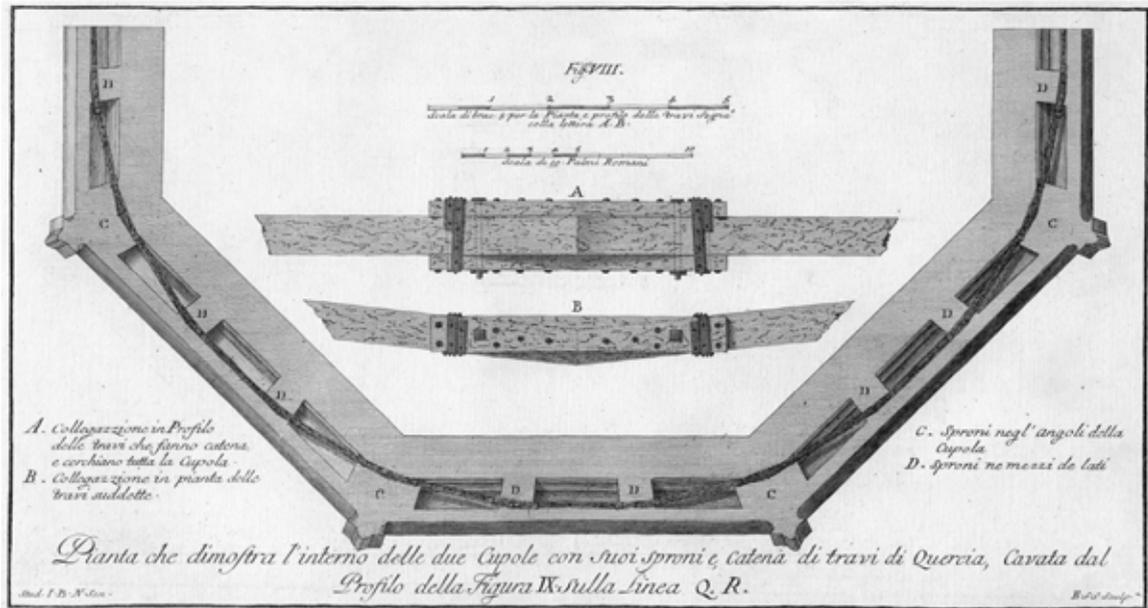
Figure 2: The joints of the chestnut chain according to Nelli's survey (1733) [17].

At the time, due to a quick worsening of the cracks of the cathedral's dome – possibly caused by an earthquake that occurred in the September of the same year [8] – the Florentine community was deeply concerned about the future of the structure. A committee, which included Nelli, was nominated to examine the situation and establish whether it was advisable to add a set of four hooping iron tie-rods to prevent the collapse of the building [9]. To that end, the committee gathered information on the wooden chain, both directly investigating the device and seeking suggestions from other fabric surveyors, such as those of the St. Peter's Basilica in Rome [10]. However, since the latter had never had any wooden rings, the most knowledge came from on-site observations. Nelli provides us with relevant data concerning both the state of repair of the chain – which, at the time, was rather poor [11] –, and with an approximate representation of the joints connecting the 24 beams [12] (Fig. 2).

The metallic joints named 'A', possibly the original ones (1423-1424), are by far the most common. They appear rather similar to the joints represented by Nelli in 1695 (Fig. 2), as they comprise an iron strap, an iron bolt and several nails (Fig. 4.A). The former is quite thin (1-1.5 cm thick) and is fastened to the beams through a variable number of irregularly disposed nails. The iron bolt has square section (average 3x3 cm) and is blocked on the lower end thanks to a hole and

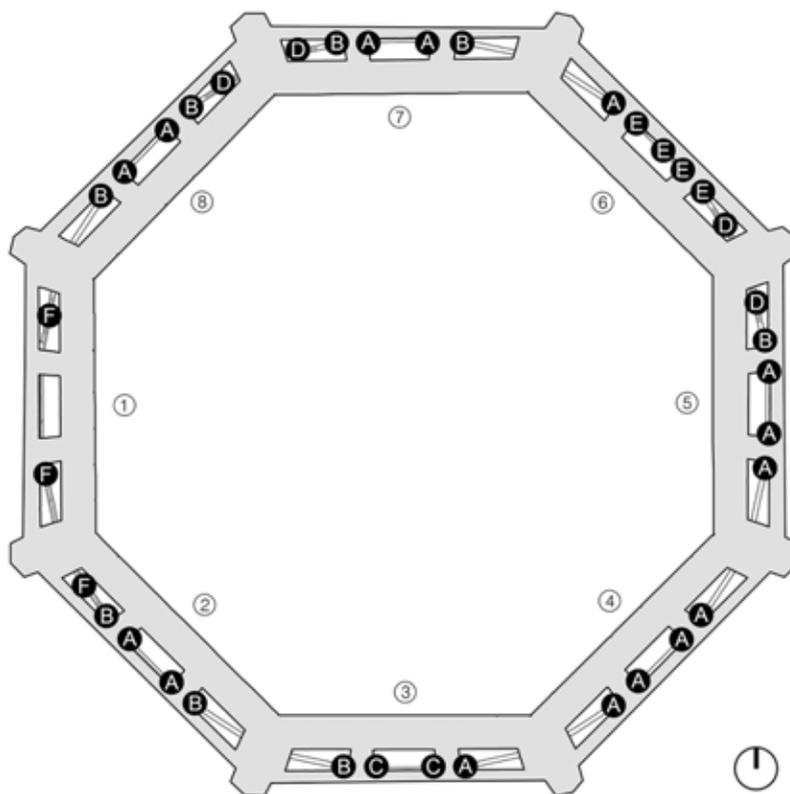
*Figure 3: Spatial distribution of the different types of joints along the wooden chain.*

Operationally, the first step was to identify, examine and classify the different kinds of metallic joints currently existing on the device. Overall, six types were detected, heterogeneously distributed along the wooden beams and tracing back to different epochs (Fig. 3). The comparison between the archival descriptions of the metallic components and the visible elements highlighted quite precise matches, allowing the establishment of a correspondence between the historical documents and the tangible artefact. The most plausible correspondences were subsequently verified through a dimensional crosschecking: the measurements indicated by the expense records, after opportune conversions [21], were compared to the dimensions obtained from laser scanning. While the comparison between linear measurements was quite immediate, weight measurements required a bit more effort. A geometrically regularized 3D model was created for each of the six metallic joints in order to easily obtain the rough volume, and, therefore, the possible weight. Undoubtedly, the approximations that were made – concerning both the geometry of the joints and the density of the iron alloys – entail a mediocre accuracy level. It should however be noted that the purpose of this comparison was not to ascertain a perfect coherence, but rather to verify whether the data could be considered compatible. In fact, even using the highest level of detail, the 3D model might not have provided overlapping results due to material decay, possible reductions in section, and lack of information about the alloy composition.

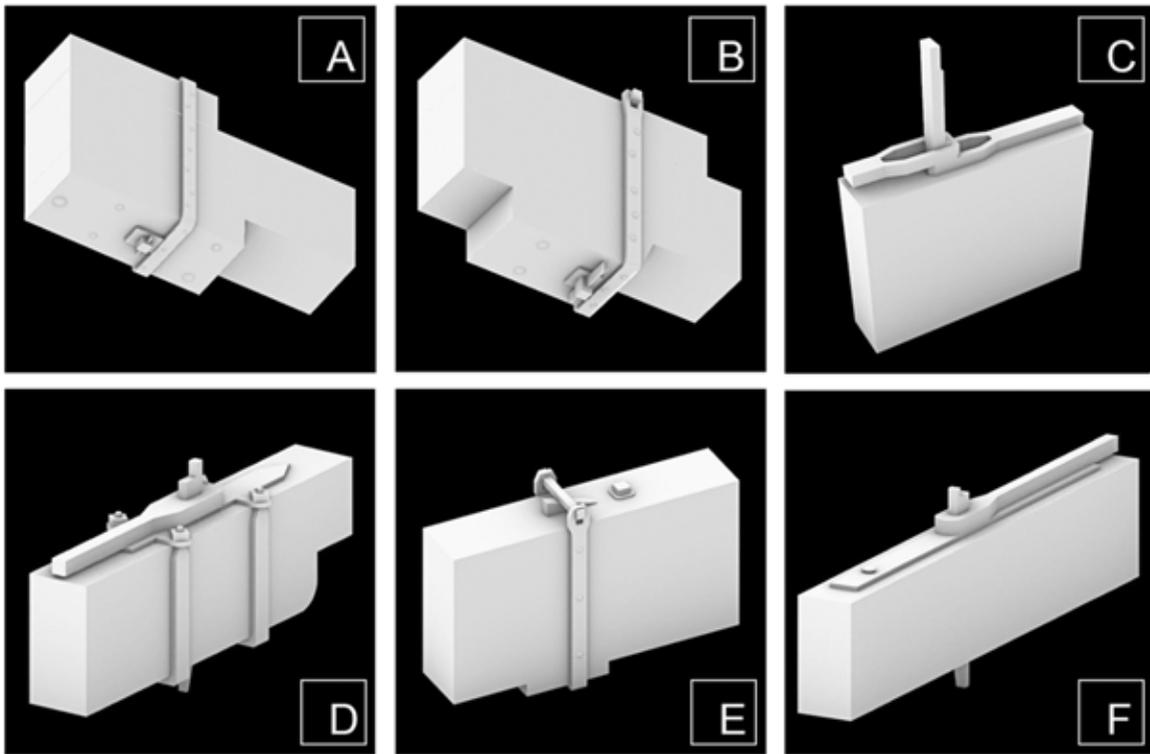
Figure 4: 3D representation of the six typologies of joints identified on the wooden chain.

The direct observation of the wooden chain, along with the possibility of accessing the dimensional data of the laser scan survey [22], allowed six different types of joints to be identified. Such joints differ from one another in terms of components, dimensions, workmanship and functioning (Fig. 4).

From what can be observed, the joint has a rather simple functioning and it is used to connect the added iron tie-rods both to one another and to the wooden beam (Fig. 4.C). The tie-rods are provided with a loop on both extremities; to join one arm with the next, the loops of adjacent tie-rods are aligned so that a vertical wedge can be inserted to lock them in position. By extending across the underlying beams, the wedge also guarantees the fastening of the metallic tie-rod to the wooden elements.

The metallic joints of type D are quite complex and comprise several elements (Fig. 4.D). On the one hand, there is a horizontal connection granted by an additional iron tie-rod located on top of the wooden beam; on the other a double u-shaped strap to vertically fasten the wooden and iron elements. Both the tie-rod and the straps are anchored to two iron plates nailed on the top and bottom surfaces of the beam. The former is blocked by a vertical wedge that passes through the tie-rod’s loop and continues downward, transversally crossing the iron plates and the wooden elements. The u-shaped straps, also nailed to the wooden beams, are provided with threaded ends locked by square nuts on the upper part.

This kind of joint is composed of two main elements: a u-shaped strap and a bolt, both working vertically (Fig. 4.E). The former is closed on the upper end thanks to an eyelet-stake system, tightened using metallic wedges; the latter has circular section (average  $\varnothing$  3 cm) and is locked with a square nut on bottom end.

The last type of joint is the most recent one and dates back to the repairs coordinated by Gaetano Baccani between 1845 and 1848 [27]. It consists of a metallic tie-rod (fastened to the underlying beam thanks to a vertical wedge), and two bolts locked on the bottom end with square nuts (Fig. 4.F). As in type D, the system also includes two iron plates that are nailed to the upper and lower surfaces of the beam to improve the anchoring of the added tie-rod.

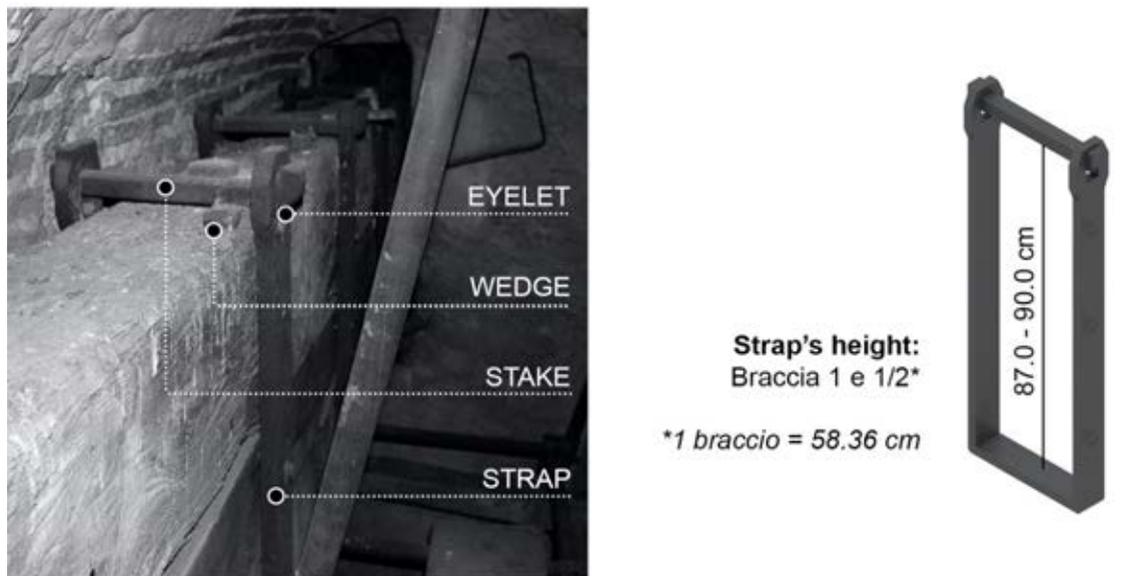
*Figure 5: The iron straps of E-type joints and their components. Photo by the authors (2018)*

On the other hand, the expense notes offer detailed descriptions of the wooden and metallic pieces produced by the craftsmen. In particular, the attentive reading of the blacksmith's words allowed one to preliminary match the elements mentioned in the archival paper with those that can currently be observed within sector six. The artisan refers to u-shaped straps whose features resembles the ones in sector six: they have eyelets on the upper ends to insert the closing stake, iron wedges to tighten the straps and, as suggested in the document, they enclose not one, but two overlapping wooden beams (Fig. 5).

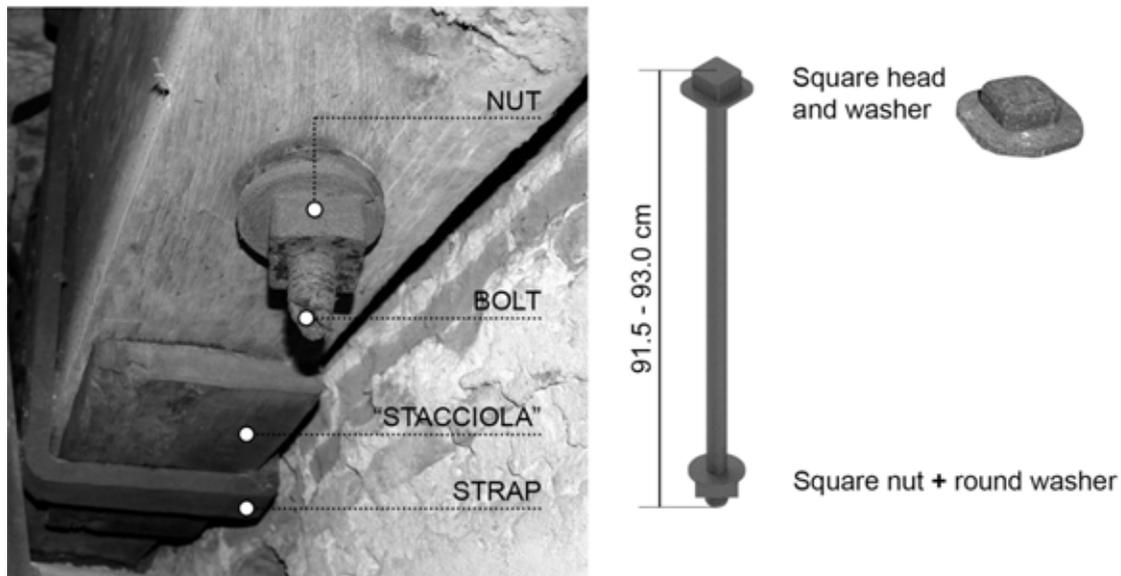
*Figure 6: E-type joint seen from below. Notice the lower end of the bolt and the wooden "stacciola". Photo by the authors (2018)*

The bolts description is rather fitting as well: there are three of them, they are at least partially threaded so that they lock with nuts and have washers both under the head and above the nut. Moreover, the expense note mentions that a square wrench was used to tighten the bolts' nuts, which testifies to the fact that the nuts installed in 1823 were square, just like the existing ones (Fig. 6).

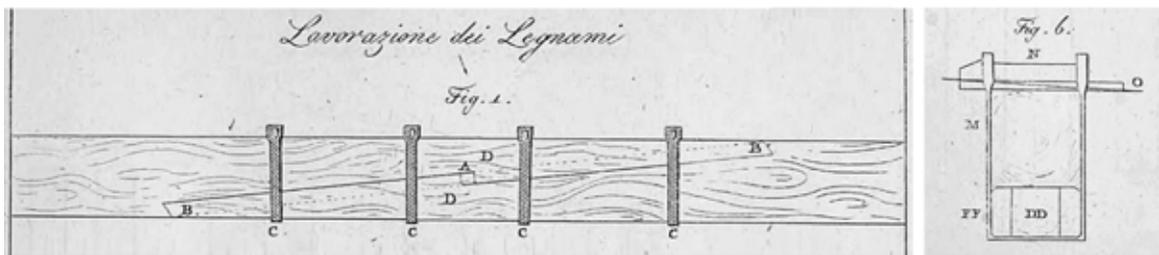
Figure 7: Possible use of U-shaped straps illustrated in Valadier’s treatise.. On the right, the mentioned wooden element (“*stacciola*”) to be inserted between the beam and the strap (DD)

The second measure in the note regards an element referred to as “*stacciola*”, which is not a very common term in literature and was not found in the main historical Italian vocabularies. It was however recorded by an Eighteenth-century Italian-French dictionary [29], where it is described as a straight edge or square, clearly suggesting the use of the “*stacciola*” as an aid to control orthogonality. Thanks to this new piece of information, it was possible to formulate the hypothesis that the term “*stacciola*” refers to the wooden plank positioned between the bottom surface of the beam and the iron strap (Fig. 6). Indeed, the blacksmith’s expense note reports that the “*stacciole*” were 29 cm wide, which is very close to reality since the three existing wooden planks measure 26 to 28 cm. No dimensions are provided with regard to the thickness or length of the planks. The hypothesis was finally validated thanks to Giuseppe Valadier’s architectural treatise [30]. When illustrating the possible ways to join two wooden beams together, he mentions the opportunity of positioning a wooden element between the beam and the strap to improve the adherence between them (Fig. 7).

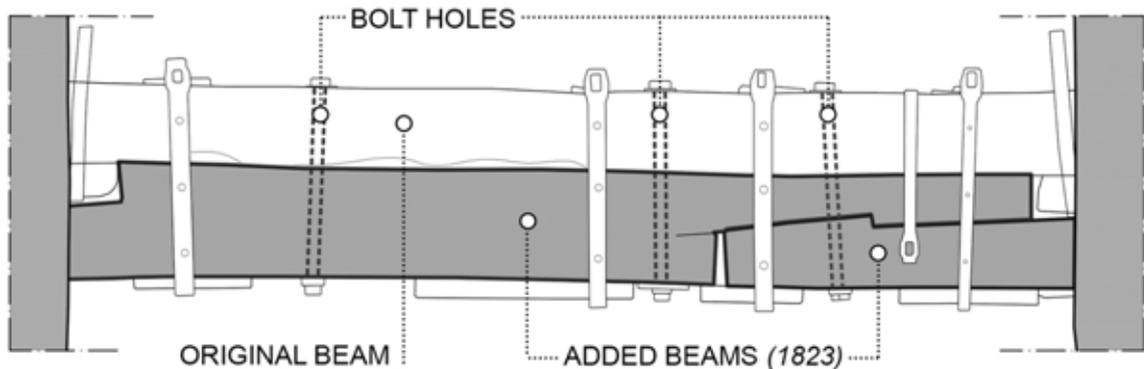
*Figure 8: The wooden elements currently existing in the central room of sector six. The darkened beams were supposedly added in 1823.*

A few considerations were finally made with regard to the carpenter's work (Fig. 8). In his brief expense note he explains installing two new wooden chains: the first one is 350 cm long, 35 cm tall and 29 cm wide and is said to "stay within the spur". The second one is 440 cm long, 48 cm high and 32 cm wide. The third and last item on the note concerns the three holes the wooden worker had to make in the mentioned beams to fit the iron bolts in. Given that the bolts were installed in the sixth sector of the dome, the best guess was to also find the "new" chains there. Indeed, when observing this portion of the wooden ring, we notice that the beam is actually composed of two overlapping beams: the one on the top appears to be the original one, while the one on the bottom is clearly a later addition. Moreover, the latter is a composed beam itself, as it comprises two different wooden elements connected by a stop-splayed scarf joint. The availability of dimensional data allowed a comparison to be made between the two wooden elements composing the lower, most recent beam and the chains supplied by the carpenter. It should be noted that, since it was not possible to survey the portion of the beams entering the spurs, the cross-checking was only made on the visible part.

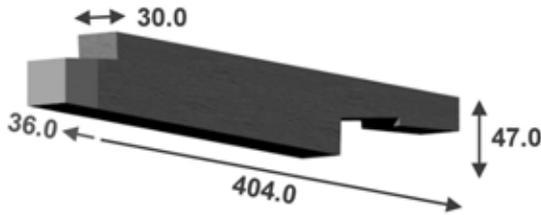
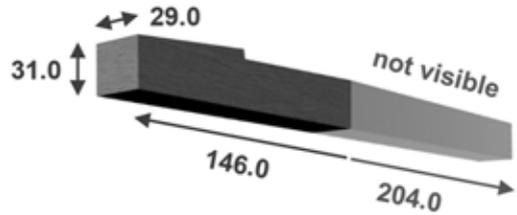
The lighter portion of the beam is not visible. Its length was hypothesized basing on the archival data:  $4.04 + 36.0 = 4.40$  m

1823 expense note	2018 survey
Length <i>braccia</i> 7 $\frac{1}{2}$ = 4.40 m	4.04 m ( <i>visibile</i> )
Height <i>braccia</i> 5/6 = 48 cm	47 cm
Width <i>soldi</i> 11 = 32 cm	30 cm

The length of the portion of beam that is not visible was hypothesized basing on the archival data:  $1.46 + 2.04 = 3.50$  m

1823 expense note	2018 survey
Length <i>braccia</i> 6 = 3.50 m	1.46 m ( <i>visibile</i> )
Height <i>soldi</i> 12 = 35 cm	31 cm
Width <i>soldi</i> 10 = 29 cm	29 cm

Figure 9: 3D model of the two wooden pieces composing sector six's lower beam and comparison between historical and current dimensions.

Even in this case, the level of compatibility appears to be quite high, especially for the longer segment (Fig. 9 left). Some discrepancies emerged with regard to the smaller beam, which, given the fact that the thickness of the spur is only 150 cm, about 70 cm shorter than the length indicated in the expense note (Fig. 9 right). It is however plausible that the chain was cut during assembling to better fit the designated space.
