## **“To Provide the Old Church with Good Foundations to Prevent Subsidence”: Builders’ Specifications in Amsterdam**

Gabri van Tussenbroek

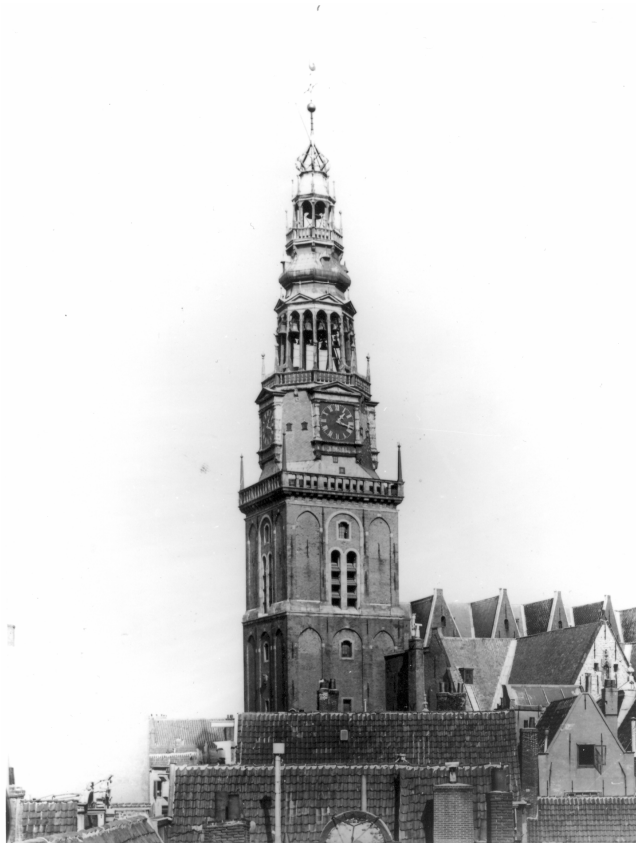
Figure 1. Tower of the Old Church, Amsterdam.

The tower of the Old Church was built in the fourteenth century and its height was increased substantially in the sixteenth century (**fig.1**). Given the weakness of the subsoil in Amsterdam and the shallowness of the fourteenth century foundations, this increase in the weight of the building materials was bound to cause problems. At the beginning of the eighteenth century the tower suffered visible subsidence (Wagenaar 1760, p. 735; Van Breen 1949, p. 605). The tower was built on peaty soil; one would have had to dig over 12 m down to find the first firm layer of sand in the city's sodden soil. Although the subsoil was taken into account when building the Old Church, and fascines were used, these did not reach the first layer of sand. From the fourteenth to the sixteenth century, the piles reached only about 5 to 7 m down into the ground (Janse 1993, pp. 5, 34-8). Leaning towers frequently needed to be restored, propped up or stabilised; several seventeenth-century examples are described in Janse (1999). But the method ultimately chosen for the Old Church tower differed from those adopted in the past. While most plans were confined to consolidating the soil, installing piles at the sides and adding buttresses, in the case of the Old Church, it was decided to encase the entire tower in stone. The same system was used in Gouda almost twenty years later, in 1754, to stabilise the tower of the Church of Our Lady. An 80 cm thick shell was constructed around the north side of the tower as a counter-weight, after which a thinner brick casing was built around the entire structure and firmly anchored to the old tower (Glaudemans 1994. pp. 2-3).

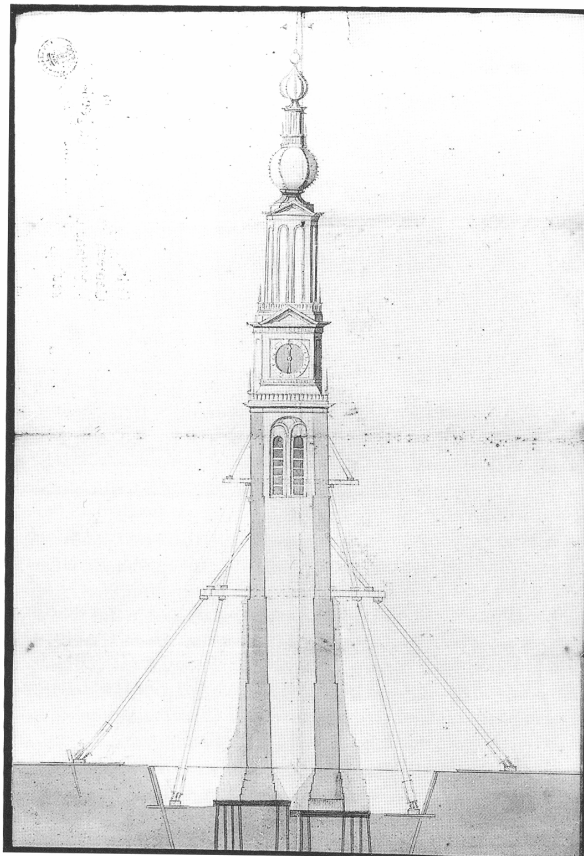
Figure 2. Façade/cross-section of the tower from the west with hoisting beams and struts, belonging to Sibout Bollard's plans.

Only one drawing of the Bollard plans has been preserved, with a view of the tower from the west. It shows the entire tower, together with a cross-section of the foundations. A ditch has been hollowed out around the tower. The drawing also shows how Bollard planned to straighten up the tower. The hoisting beams mentioned in the specifications, which supported the structure that had been attached about half way up the brickwork façade, rested on the ground far beyond the ditch. The struts that were to support the tower higher up, stood within the ditch. According to the plans, the foundation piles would be driven in against the old walls, which would have to be exposed down to the level of the foundations. The drawing shows how the south side of the foundations would be laid deeper than the north. Finally, the silhouette indicates how the brickwork of the planned mantle would be inserted up to the height of the first support beam. Carrying out Bollard's ambitious plans would obviously incur enormous expense: in total, he calculated that 45,500 guilders would be needed.

Once the foundations had been stabilised, they would have to be extended over the whole width of the new piles and renewed up to a height of about fifty feet, as indicated in the silhouette in the drawing (fig.2). (Similar solutions were adopted in other seventeenth-century tower support structures, including the tower of St Lawrence's Church in Rotterdam and the Boventoren in Kampen.) The plans referred to the structure surrounding the lower part of the Westerkerk tower, which likewise disguises all uneven places in the base.

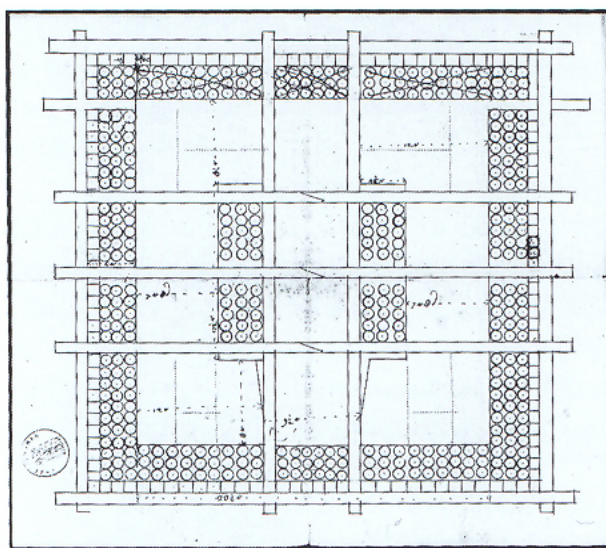
Figure 3. Pile-driving plans belonging to Willem van Diede's plans.

The first three pen-and-ink sketches were probably made by Van Diede himself. This conclusion is based on Van Diede's known handwriting, his style of lines, and the materials (paper and ink) he is known to have used. The first one shows the ground plan for the piles. It indicates the interior and exterior foundations with the beams extending right through the tower. Three sections are crossed out on the east side of the plan, probably because it became clear while the plans were being made that no piles could be sunk to support the tower underneath the organ.

More drawings of Van Diede's plans have been preserved than of Bollard's. Accompanying the builders' specifications is a set of seven drawings, which may be divided into three sketches and four elaborated drawings (**figs.3-9**).

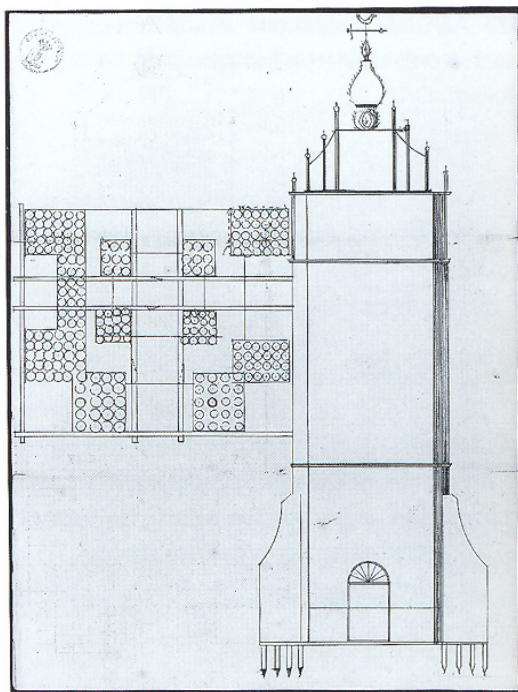
The second drawing, which also shows a ground plan of the piles, took this problem into account. In addition, the plan diverges slightly from the first one. In some sections, new piles would be sunk at different points. The same applies to the number of beams that were to support the tower along the north-south axis. The same drawing also gives a view of the tower from the west. On both sides heavy buttresses were to be added, reaching to a height of about 10 m. For the rest the tower is scarcely shown in detail.

Figure 4. Alternative pile-driving plans and view of the tower from the west, belonging to Willem van Diede's plans.

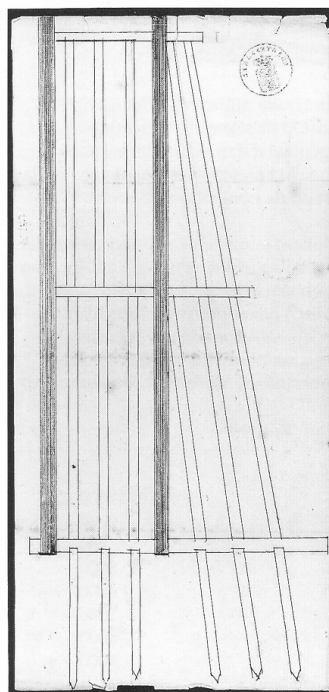
Figure 5. Plans for buttressing the tower during the pile-driving, belonging to Willem van Diede's plans.

The third and final drawing attributed to Van Diede is a sketch of the tower's vertical supports. The tower would be kept in balance while the piles were being driven in by using beams that pierced the structure together with diagonal struts.

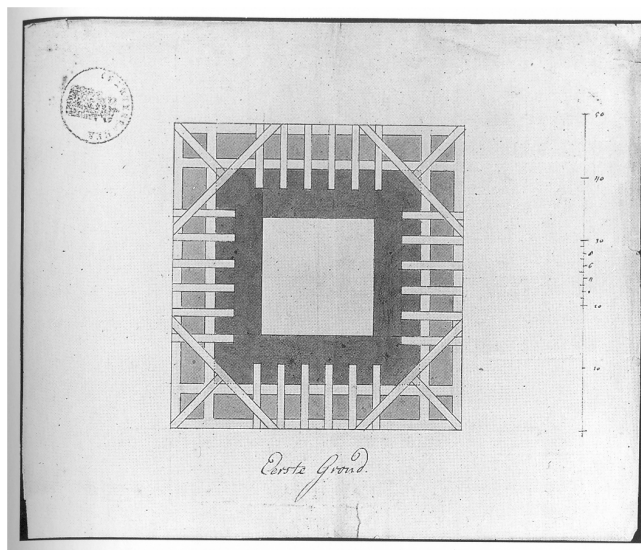
These plans were subsequently elaborated in four detailed drawings: two ground plans of the grillage, and a cross-section and external view of the tower, both from the west. The two ground plans of the grillage related to the first and second consolidating layers to be added during the work on the tower. The first layer was to be placed about three metres beneath the eighteenth century ground level. It consisted of a grillage with perpendicular and transverse beams and struts. The second layer, to be

Figure 6. Elaborated first ground plan, belonging to Willem van Diede's plans.

One of the authorities' main reasons for having Van Diede draft alternative plans was to save money. In his budget he refers to the drawings appended to his plans: he intended to make a grillage and pile system that called for a total of 568 masts. The grillage would extend 5 ft from the base on each side of the tower, and about 220 masts were to be erected under the walls, the number depending on the conditions encountered during the construction work. These masts would be placed 14.25 ins. apart, centre to centre. The planned grillage would have to be laid some 13 or 14 ins. lower on the south east than on the north west side.

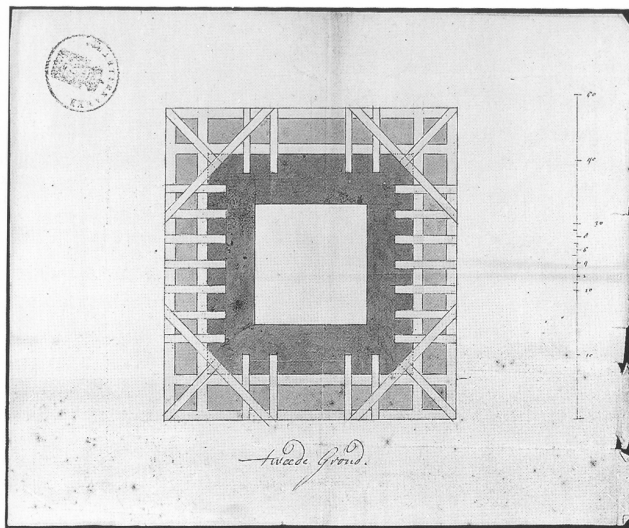
added just below ground level, was almost identical to the first. On the east and west sides, however, the access through the portal was taken into account, so no vertical beams were included here.

Figure 7. Elaborated second ground plan, belonging to Willem van Diede's plans.

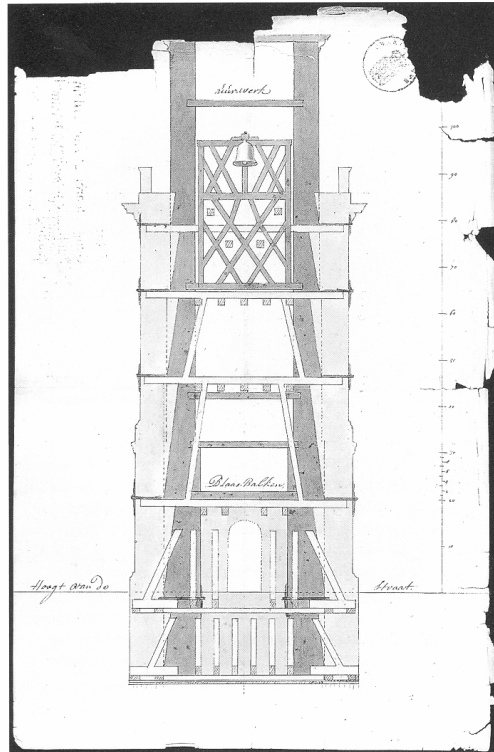
In the cross-section drawing, this plan was elaborated in more detail. Above the two ground plans, four horizontal beams were shown in the tower, the middle two supported by struts. The drawing also shows that the plan made provision for the addition of a mantle up to the height of the first three (present-day) sections, up to the belfry-arches. This mantle was attached to the old tower using sawtooth indentations.

Figure 8. Elaborated cross-section with reinforcements, belonging to Willem van Diede's plans.

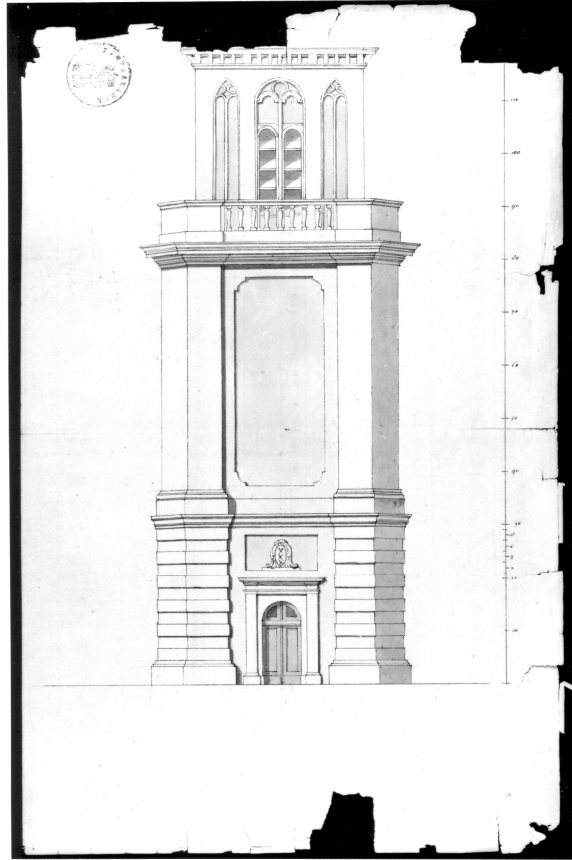
The fourth and last drawing shows the design for this mantle, which was to have wide bevelled corners and a gallery at the level of the (present-day) third section. At a height of about ten metres, the coarse bosse changed to smooth masonry.

Figure 9. Elaborated façade, belonging to Willem van Diede's plans.
