Saving the dome of St Peter's

Rowland Mainstone

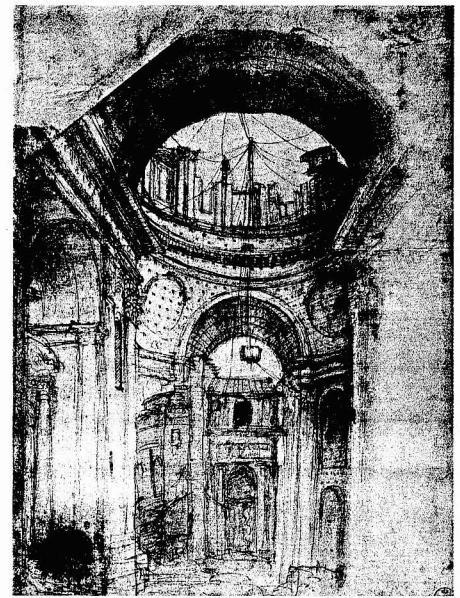
Figure 1. The drum under construction in the late 1550s, seen from the south. Below it, a temporary structure incorporating the original apse of the Constantinian church protects the saint's shrine (drawing by Dosio).

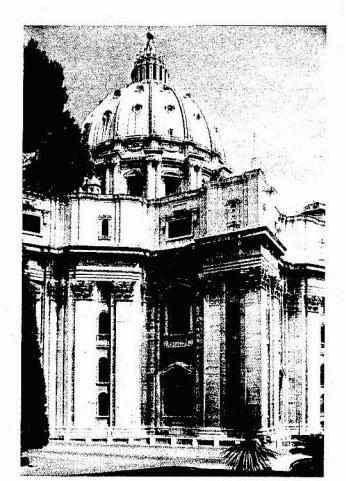
Figure 2. The south-west exterior of the church seen from the Vatican gardens (author)

Construction of a completely new church to replace Constantine's early 4th century timber-roofed one had begun in 1506 under the architect Bramante¹ The piers and linking arches destined to carry a vast central Pantheon-like dome were built in some haste over the next few years. But there followed almost a century of stop-go construction with repeated changes in design of both the church as a whole and the dome. Sangallo reinforced the piers to carry an even heavier dome as part of a more grandiose design. Michelangelo scaled this design back in a masterly manner and had the arches further reinforced before the drum that was to carry his dome was built in the late 1550s (Fig. 1). After another lengthy hiatus after his death an attic was added to this drum by della Porta and, between 1589 and 1590, he also built the dome itself to a slightly higher profile than Michelangelo had intended (Fig. 2).

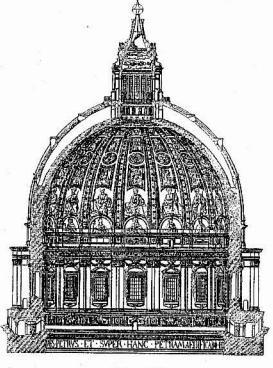
Figure 3. Elevation of the dome interior sectioned through the main supporting arches and plans at drum level and the level at which the shells divide (from Letarouilly, *Basilique de Saint Pierre*, Paris, 1882, plates 7 and 24).

Like that of Florence Cathedral the dome is double shelled over much of its height with internal meridional ribs (Fig. 3). It

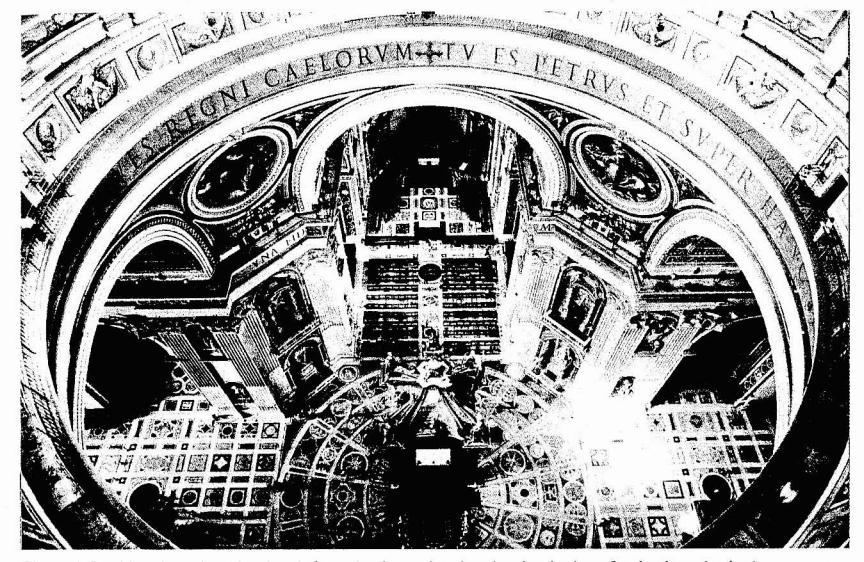
Figure 4. Looking down into the church from the dome showing the circular base for the drum (author).

differs in being circular rather than octagonal (Fig. 4) and, probably to speed construction, in having been built on centring, although this circularity would have made construction without centring much easier than it was in Florence.²

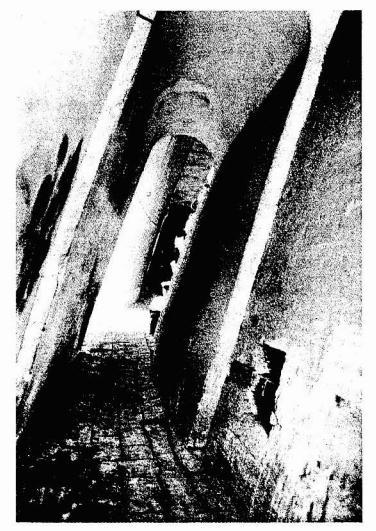
Figure 5. Interior detail of the dome between the two shells at the level at which they divide. A short length of the original upper circumferential tie is exposed at the lower right a little beneath the surface of the inner shell. The slight thickenings of the shells just beyond this point and again in the distance mark the entrances to passageways through two of the ribs (author).

Over part of its height, the drum consists only of 16 piers separated by windows and linked by spur walls to coupled columns acting with these walls as outer buttresses. The piers are bridged above the windows by a bold entablature that projects forwards over the buttresses, and above this by the continuous ring of the attic and the lowest part of the dome. When the dome divides into two shells, the ribs effectively continue the piers upwards until they terminate in another continuous ring at the crown, which is surmounted by a lantern. Construction of the drum and buttresses is of stone with rubble fills and with spiral stairs inserted in four of the drum piers for access to the dome. This masonry gives way to brickwork in the dome. Two circumferential wrought iron eye-bar chains of about 75 cm² total cross section were built into the lower half of the dome as construction proceeded (Fig. 5 and lettered L,L in Fig. 8 and P,P in Fig. 9 and n,u in Fig.13).

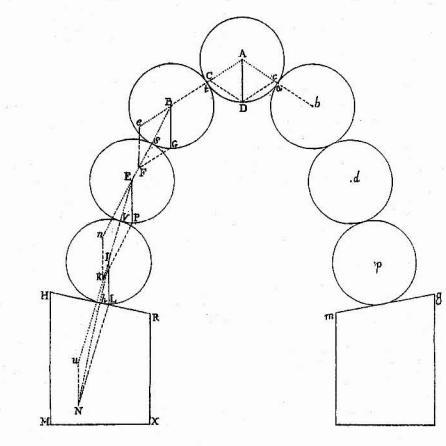
Figure 6. Stirling's model of the arch as engraved for Poleni's *Memorie istoriche* (from plate D).

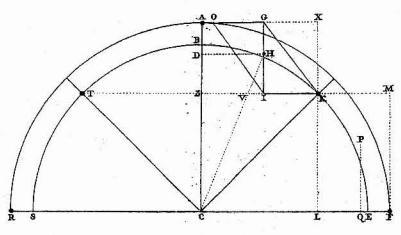
Figure 7. Couplet's model of the arch with base hinges at R and F, a crown hinge at A, and hinges in the haunches at T and K (from *Mémoires de l'Académie Royale des Sciences*, 1730)

directly the forces at the hinges and the balance of moments acting on the supports (Fig.7).

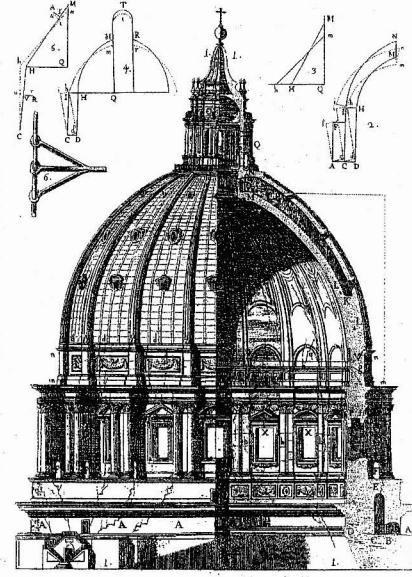
CVPOLA DI S. PIETRO Figure 8. External and internal part elevations of the dome, the latter sectioned through the pendentives, showing cracks observed by the three mathematicians (from *Parere di tre mattematici*).

In order to construct an appropriate model as a basis for analysis they sought first, by repeated detailed inspection, to learn as much as possible about the present state of the dome and all that it could disclose. They itemised and depicted on the best available drawings the damage they observed.15 This depiction must have served as the basis for fig.1 (the principal figure) of the plate appended to their report (here Fig. 8), though the cracking shown through the thickness at V near the springing level could only have been surmised from what they could see on the exterior. For comparison, Fig. 9 shows corresponding views and a partial plan from a slightly later much more comprehensive and precise survey.¹⁶ In the plan the crack that extends upwards from the crown of the annular vault of the access ramps and is lettered E in Fig. 8 is seen circling around the walkway above the vault.

They treated the crown ring of the dome in the same way as the crown voussoir of an arch.
In the absence of visible evidence of hinging in the dome above its springing level, they assumed a single hinge at this level (H in their small fig. 2 of the present Fig. 8).

Without the splitting they also ignored the evidence of hinging at other levels in the drum and considered all hinging of the unified support provided by attic, drum and buttresses to occur at A in their fig. 1 "or a little higher".

sills (a in their fig. 1), again ignoring the evidence of hinging at other levels in the drum piers. They also made further assumptions that they described as allowing for the high compressions, but that are better seen as making some allowance for the actual hinging at higher levels in the drum. The principal one was that the hinge H would not rise as the support rotated under the thrust but would be displaced horizontally. Clearly this was intended to apply to the estimated movement of the centre of gravity of the dome. But it is less clear how it was assumed to affect the movements of the centres of gravity of the drum and buttresses and outer base. In relation to the contribution of the buttresses and outer base, they merely mention a "small addition" without specifying it.²⁰

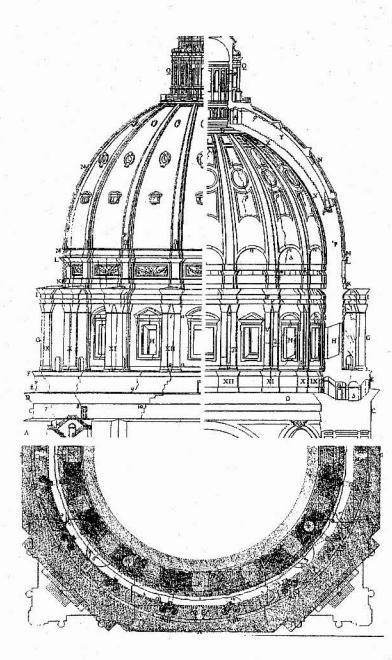
Figure 9. Similar part elevations to those in Fig. 8 with the internal one now sectioned through a main arch and a part plan at the level of the foot of the drum (from Vanvitelli's survey of the state of the dome in 1743 as engraved, somewhat simplified, for Poleni's *Memorie istoriche*, Stato de' difetti, plates II, XI and XVI).

On receipt of these *Riflessioni*, he was invited to Rome to see the situation for himself. This he did, apparently accompanied by Vanvitelli who had already embarked on the major new survey referred to earlier (Fig. 9).

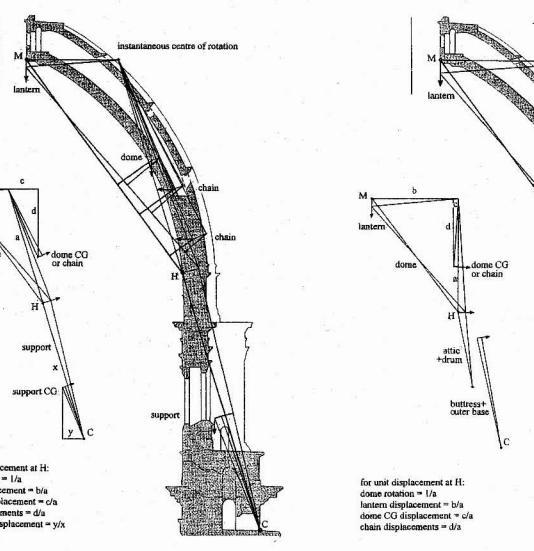
Figure 10. Reconstructed virtual-work analysis by the three mathematicians assuming no separation

of buttresses and drum (author).

The present Figs. 10 and 11 are therefore only tentative reconstructions, incomplete in Fig. 11 because of the greater uncertainties there about some of their estimates and assumptions.²⁵ Since they did not fully specify their assumed hinge positions, numerous similar analyses were made for other possible positions. Those reproduced are the ones that led to the best overall agreement with the displacements implied by their estimated forces. These displacements cannot have been scaled directly from large-scale plots of finite displacements.²⁶ They could have been arrived at only as the ratios of two measurements. It was therefore assumed that the actual measurements were those lettered a, b, c, d and x, y in the smaller explanatory drawings for rotations about the relevant instantaneous centres of rotation. If this assumption is correct, it was probably the first major occasion when the idea of the instantaneous centre was put to practical use.²⁷

part of the base, the forces in M libbre (1 libbra = 3.3N) for a unit displacement at the central hinge were:²⁸

the two chains	2.674919 stabilising
the rising attic, drum, buttresses and base	18.373475 stabilising
the falling lantern	1.853235 destabilising

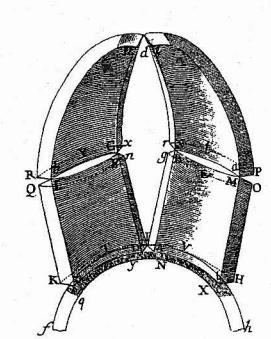
Figure 12. Poleni's small model of

of his Riflessioni as redrawn for

plate H of his Memorie istoriche).

the collapse mode visualised by the three mathematicians (from Fig. 1

the ribs could behave as one with the intervening webs.³⁵ To test their model's behaviour, he made his own small physical model of the whole dome and drum and cut it radially into four sections and each section into two at the springing level (Fig. 12). He found that in this model the rotations assumed by the three mathematicians about the intermediate and base hinges could not occur without large openings which would lead to very high local stresses at the points of contact in the real structure. Ignoring the fact that there was a vast difference between splitting into four sections (as in his model) and into a far greater number, he saw this as a further reason for rejecting the three mathematicians' model.³⁶

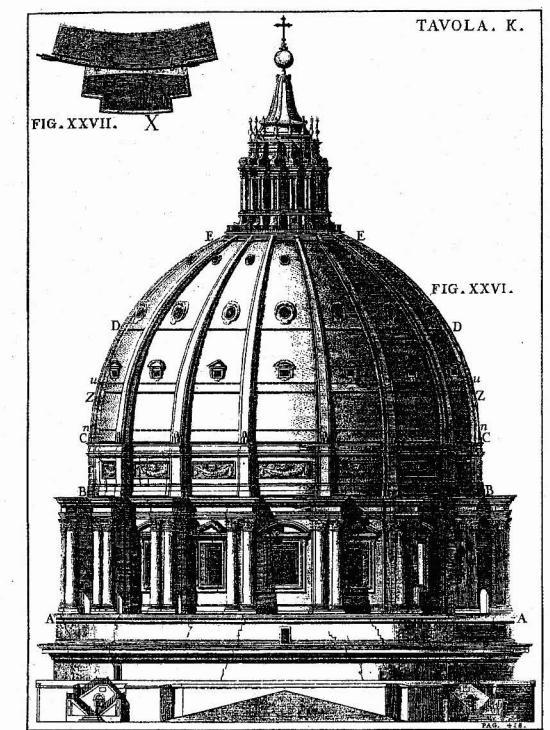
Figure 13. Positions of the original circumferential chains (n and u) and added chains (A to E and Z). The manner of installation of the added ones is shown in the detail (from *Memoric istoriche* plate K).

It was these recommendations that were finally accepted, apparently without further reference to the three mathematicians. Vanvitelli was entrusted with installing the chains and with other desirable works. Chain installation was completed in 1744 while work continued on making good earlier damage, and included that of an additional one at the base of the lantern (at E in Fig.13) after further lightning damage.⁴² When, four years later, it was found that the upper original chain was broken, another one was added a little below it at Z in Fig. 13. This largely completed the restoration.⁴³

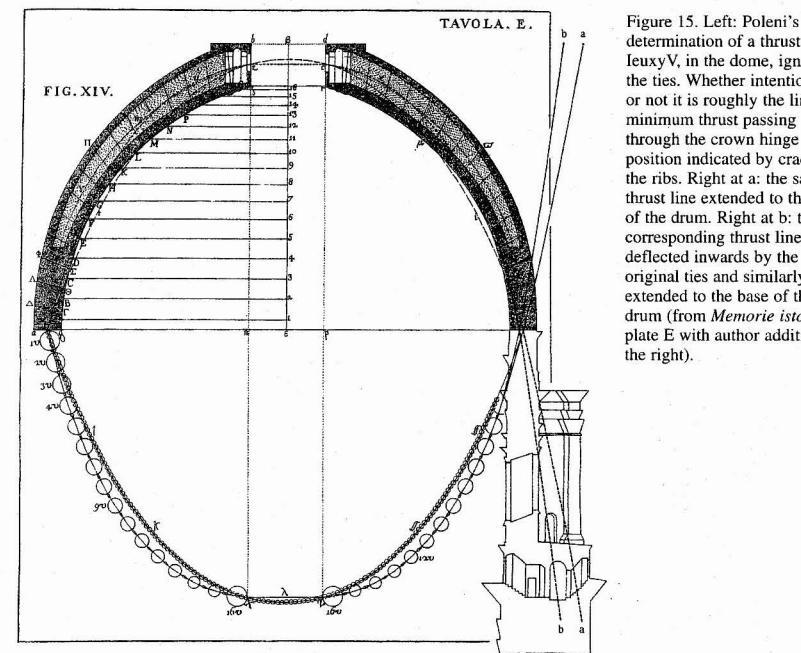
determination of a thrust line. IeuxyV, in the dome, ignoring the ties. Whether intentionally or not it is roughly the line for minimum thrust passing through the crown hinge position indicated by cracks in the ribs. Right at a: the same thrust line extended to the base of the drum. Right at b: the corresponding thrust line deflected inwards by the original ties and similarly extended to the base of the drum (from Memorie istoriche plate E with author additions on the right).

If only he had further developed it by extending the chain up to a point corresponding to the base of the drum he could have obtained a complete thrust line down to the base (Fig. 15 right a). Better still, he could have included the tie chains, representing their inward actions by attaching suitably weighted horizontal cords. This would have provided an alternative basis (Fig. 15 right b) for an overall assessment. Or he could, by similar experiment, have explored a wider range of tying possibilities. Judgement would still have been called for in deciding how close the thrust could safely approach the boundaries of the chosen representative cross section. In one sense it would have been more clear-cut than that called for by the three mathematicians' approach. But this would be so only if other implied judgements about such things as the validity taking this cross section as a basis were not made explicit.
