Masonry Construction in Olympia, Greece, during the Roman Imperial Period – Mapping, Classification and Dating

Anne Haseley

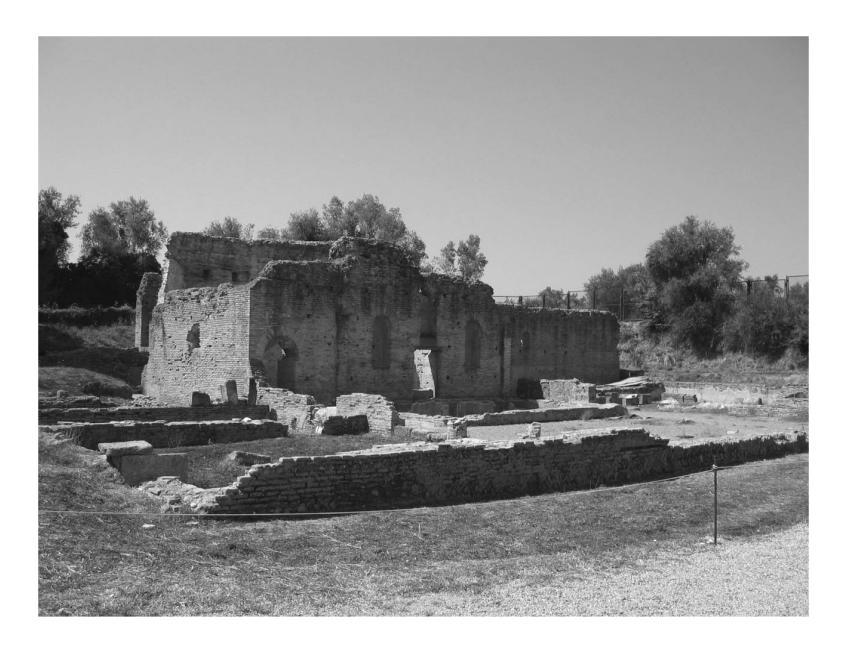
Figure 1. Olympia, South-West Baths. General view

The South-West Baths in Olympia were part of the extensive imperial construction activities during the 1st century A.D. and were studied as part of the "*Olympia in the Roman Imperial Period and in Late Antiquity*" research project led by Prof. U. Sinn. The documentation and analysis of brickwork represents an important dating indicator: using this technique four construction phases could be defined: The first one consists of a well constructed *opus mixtum*, i. e. a *reticulatum* (7.4 cm side length) of local limestone, combined with a *testaceum*, for which no similar quality is documented in Olympia nor in its surrounding areas. (Medri 1995 (2001)) Stratigraphic evidence involving ceramics, glass, lamps and tools allow this construction phase to be dated to the Neronic period. (Martin 1995 (2001).

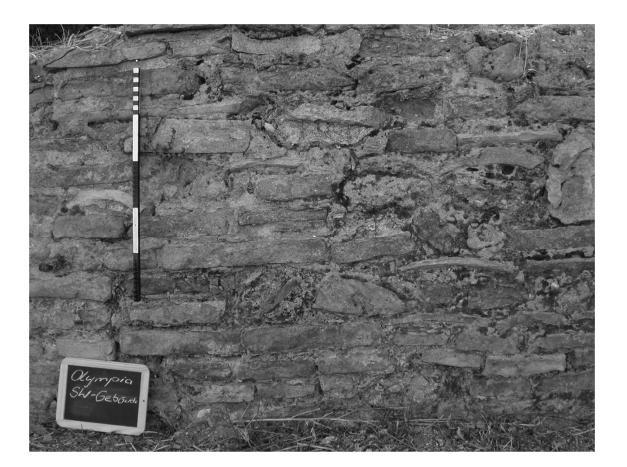
Figure 3. Olympia, South-West Baths, phase 2 (Haseley)

Other construction phases (the central part of the building, the service sections and the latrine) have been dated to the end of the 1st century AD and consist of a simple *opus testaceum*.

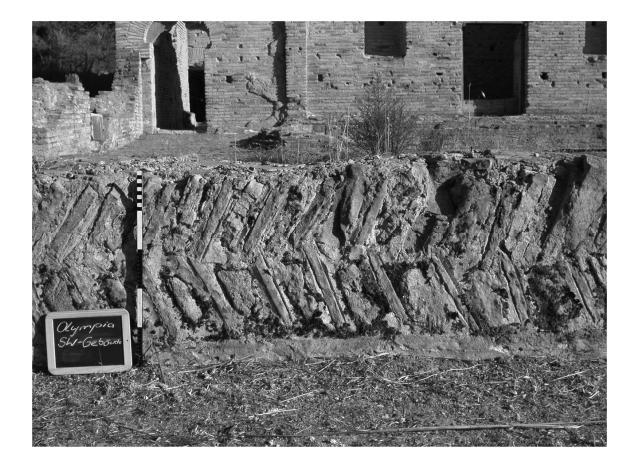
Figure 4. Olympia, South-West Baths. Phase 2, opus spicatum

While the above is relatively easy to classify, the dating and categorisation of masonry types in the courtyard is more difficult due to the large variations in construction techniques. The northern flight of rooms consists of *opus spicatum* and can be dated to the second construction period. The bond consists of fieldstones, which are framed by bricks in a rhomboid fashion whereby corners and the inner faces of doors are made of *testaceum*. Other masonry belonging to this construction phase includes an *opus incertum*, which is only used sporadically within the walls. A peculiarity is the use of different types of masonry in the opposite faces of a wall: on one side, an *opus spicatum* (see **fig. 3**) may be seen, while the opposite side consists of an *opus testaceum*. Mortar analysis allowed dating to the second phase (the third phase is characterized by highly sandy mortars, while mortars in the second phase consist of very hard mortars with high lime content).

Adjustments are already observable starting with the second construction phase. The bricks are only partly broken into triangular bricks, while the majority are just broken in half, which indicates local workgroups. Furthermore, the section of the peristyl is built with a mixture of fieldstone and rubble stone. The use of rubble as a filling material was much cheaper than the construction of reticulat, particular since the typical material for reticult - tuff (which is also easy to cut) - was not locally available. The use of different masonry types (testaceum and mixed masonry) followed a certain pattern: where the construction requirement arose (vaults and technical sections) *opus testaceum* was applied and in less critical situations a simple mixed masonry type (light roofing and residential sections of the building) was used. It was irrelevant whether the bricks used for the testaceum were derived from a homogenous production line (Kladeos Bath, South-West Bath, Octogon) or whether the bricks were reused (South Bath, North Bath). The use of different masonry types within a building complex contributes to different degrees of degradation that are still present. The sections of *testaceum* are much better preserved than those carried out in the simple quasi *spicatum* technique.

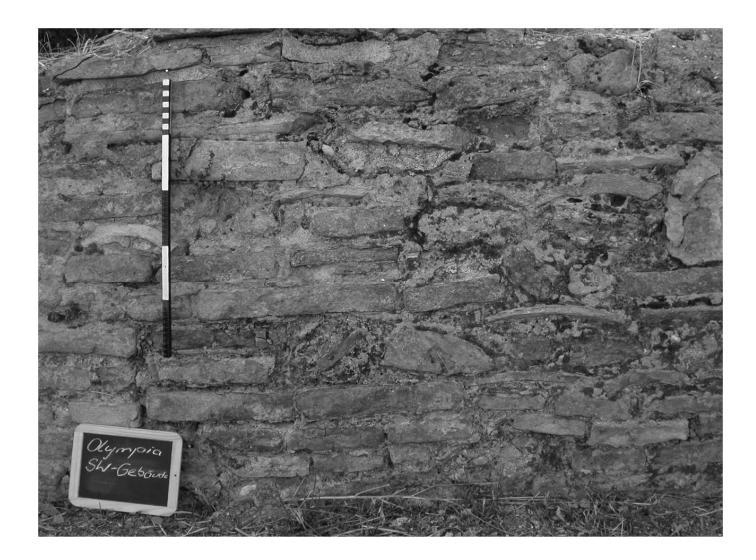
Figure 5. Olympia, South-West Baths, phase 3

The third construction phase probably occurs after a destructive earthquake at the beginning of the 3^{rd} century A.D. since brickwork in this period has a layer of debris which lay at the bottom of the latrine space and had shifted at its margins towards the lateral part of the latrine canals (Martin 1996).

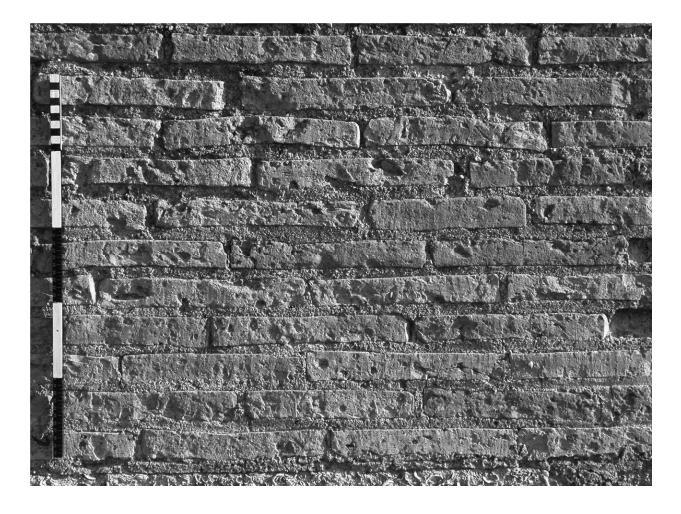
Figure 6. Olympia, Leonidaion, testaceum of the dividing walls

The study refers to the renovation phase during the 2nd Century A. D., whereby two sections can be distinguished: the outer and divisional walls as well as the central water basin. The masonry of the dividing walls is relatively good work in *opus testaceum*, which is apparently the result of uniform brick production. This masonry is among the few examples of breaking bricks into triangular sections in Olympia, as this was not a local tradition.

The masonry sections adjoining the decorative basin were carried out in different techniques and quality. The wall of the outer ring consists of a mixed masonry of blocks of *muschelkalk* and brick layers (*opus vittatum*). These alternate in bands, each of which are four layers thick. The interior wall uses these materials more irregularly. The relatively large areas of *opus testaceum* give a more irregular impression than that of the divisional walls. In a smaller section of the outer ring, *opus reticulatum* was used.

The outer wall of the inner ring consists of triangular bricks, whereby the breaking of the bricks does not necessarily follow the markings on them. The courses are less carefully worked than in the outer ring. In some areas bricks are mixed with blocks of *muschelkalk* of highly variable sizes. The inner wall consists of a uniform *opus testaceum*, which

contains hardly any triangular bricks (approximately 10). The breaking of bricks followed here the typical pattern of Olympia, i.e. along the middle section.

Outer and divisional walls: height 3.5-4.0cm, triangular bricks; Basin – outer ring: height 4-4.5cm (*Vittatum* 9-11cm, *Reticulat* 7-8cm, irregular), triangular bricks Basin – Inner ring: 4.0cm, half bricks

Outer and divisional walls: 1.5cm, joint-marks slightly towards bottom part, solid mortar. Basin – Outer ring - 1.5-2.0cm, Joint-marks slightly towards bottom part Basin – Inner ring – 2.0cm, Joint-marks slightly towards bottom part

Divisional and outer walls – 53.5-54.7cm Basin – Outer ring – 55.5-56cm Basin – Inner ring – 59-60cm

Starting with the Kladeos Bath, the use of brick masonry became the standard in Olympia and it was used within the entire building complex. The restoration of the Leonidaion is also mostly based on bricks. In the section of the basin other masonry (*quasi vittatum*) is used. The Leonidaion as a guest house for visitors of high status and civil servants is an example of the Hadrianic period (Specht 1996), where the walls are erected based on bricks broken into triangular pieces (which was

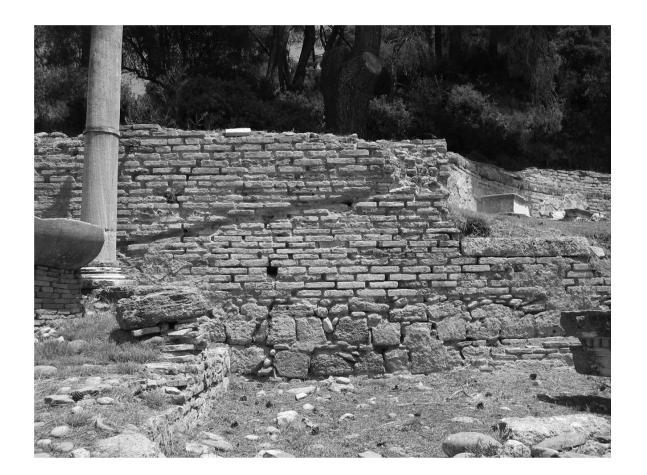
Figure 7. Olympia, Nymphaeum, Lower Basin

The nymphaeum consists of two basins, an upper one in a semi-circular shape and a lower one of oblong shape. The upper basin is set in a framework of niche architecture. The nymphaeum is mostly built in *opus testaceum* in high quality workmanship; the lower

basin section is remarkable for its higher prevalence of bricks of large formats. The wall between the two basins consists (in contrast to the remainder of the complex) of quasi *opus vittatum*

Lower basin - Height 4.0/6.5cm, Width 27.0/31.0cm, in exceptional cases 24.0cm, bricks broken in mid-section, no surface markings recognizable Upper basin – Height 4.7-5.0cm, Width 28.5cm

Lower basin - 1.6-2.2cm, Joint-marks in lower section Upper basin - 2.5-3.0cm

The Nymphaeum of Herodes Atticus employs increasingly large brick formats in the lower sections of the basin, but these are rapidly substituted in the upper sections with bricks of local production. However the lower basin section is carried out in a quasi vittatum.

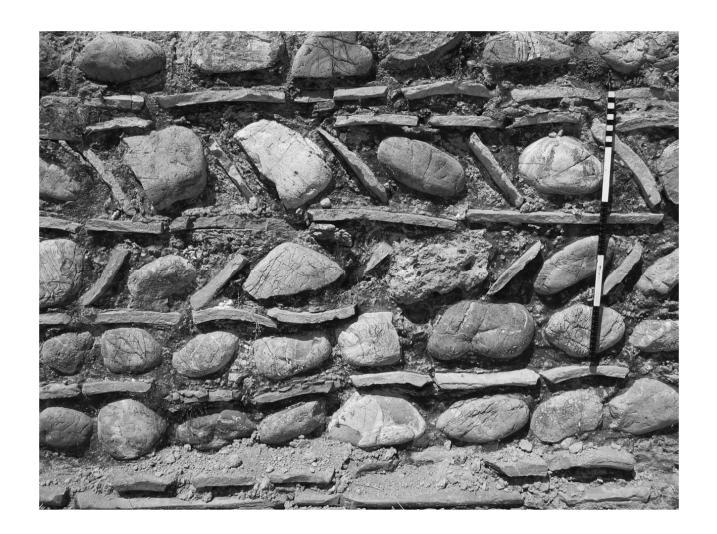
Figure 8. Olympia, Roman Guest Houses, quasi spicatum

The complex of the roman guest houses (I and II) lies to the south of the Kladeos Bath. The Guest House I was built around 170 A. D. and renovated during the construction of House II in approximately 220 A. D.. The entire complex consists of a quasi-*opus vittatum*, with the only exception being the remains of one wall (Room I.3) erected in a rather badly built *opus testaceum*. The corners are partly reinforced by poros blocks.

Room I.3 - Height - 3.5-4.0cm, Width 28-29cm, half-bricks

Room I.3 - 2.0-2.5cm, smooth joint-marks, mortar with high sand content

Room I.3 opus testaceum, otherwise quasi opus vittatum (fieldstone, tiles)

The reconstruction of Guest houses I and II next to the Kladeos Bath in the 3rd Century A.D. fall into the local tradition of Olympia. For this section it was unnecessary to build a solid testaceum. Instead, simple walls of *quasi spicatum* and *quasi vittatum* from fieldstone and brick rubble were erected. This masonry shows hardly any identifiable brick content.

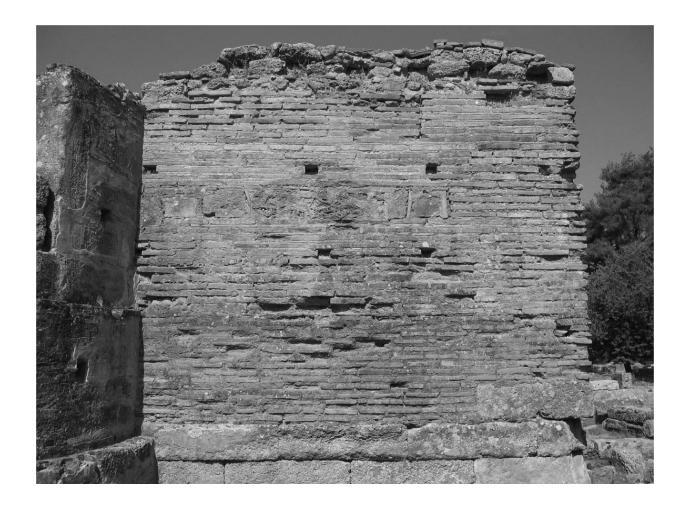
Figure 9. Olympia, Workshop of Pheidias

The workshop of Pheidias has a dimension of approximately 15 x 32 m and consists of masonry of different construction and use phases. The brick masonry visible today belongs to a second construction phase, which was never completed. It consists of a two-layered brick masonry with an inner core of *caementicium*. This was identified as two phases: the first phase reached up to the 14th layer of smaller brick formats (28-30cm) and the second, upper layer (cf. Olympia II, 99). According to Mallwitz, both layers belong to one construction period and are to be interpreted as working phases. He claims this is as the result of the horizontal end after bricks from one source running out. The second phase is interpreted as representing bricks delivered by a different brickyard. However,

closer inspection reveals that that different joint-marks appear simultaneously with the new phase. It appears likely that some time went by between the two phases. The section is approx. 96 cm high above the *orthostates*. The second phase of the brick masonry begins with the 15th layer and is set off towards the inside by approx. 2 cm.

1. layer - Height 3.2, 3.5, 4.0cm, Width 29.5cm, partly 30.5cm

2. layer – Height 4.2cm, Width 42.0 (approx. 86 % of bricks), yellow and red bricks, broken in half

1. layer - 3.5, joint-marks highly variable

2. layer – 2.0-2.5, double joint-marks in upper and lower section, smooth in mid-section, irregular joint system

opus testaceum, up to 50 cm high bands of *incertum* of fieldstone and small remainders of blocks (reused material)

The renovation of the Pheidias workshop at the end of the 3rd Century A. D. represents the last building in Olympia to be built with its own brick. The subsequently built South Bath marks the beginning of the reuse of brick material for the erection of new buildings, and even the wall heating is based on recycled materials (tiles). Even the structurally important sections of the barrel vaulted rooms were erected as *quasi testaceum*. Large bands of *quasi spicatum* stretch across large sections of the walls. Likewise the Leonidaion Bath built in the late 3rd Century A. D. was constructed using reused material which is apparent by the contrast between the central part of the building and the courtyard. The Leonidaion Bath was erected to a relatively high standard, demonstrating the entire spectrum of masonry from *testaceum*, quasi *spicatum* and a *reticulat* based on reused *tesserae*. During the later periods, the building techniques change drastically. The Christian settlement in the

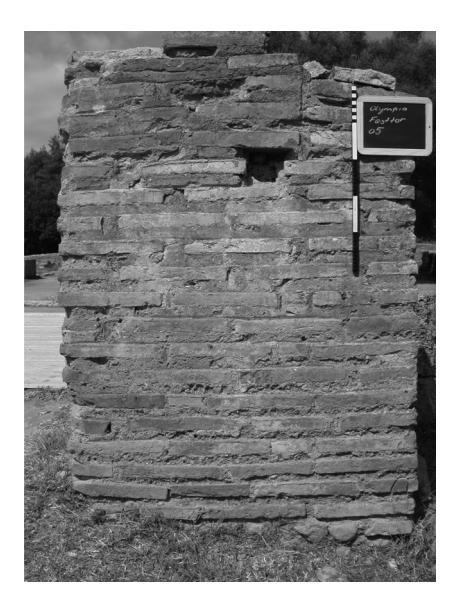
Figure 10. Olympia, South-West Gate

The festive gate is located in the immediate vicinity of the South Bath and demonstrates a uniform masonry.

Height 3.5cm, Width 29.5 -30.5 cm, consisting of half-bricks; no finger marks visible on the surface.

3.0cm, but also up to 3.3cm, joint widths with some variation with joint-marks towards the lower side. Tendency towards wider joints in the lower section of the masonry.

opus testaceum

10-layer-module 68.5 bis 70.5cm

The later buildings such as South-West Gate, North Building and Nymphaeum of Herodes Atticus continued to be erected in *opus testaceum*. None of these buildings employs triangular bricks. The North Building demonstrates irregularities through its increasing use of different recycled brick material. This is explicable in that it was erected directly over the site of a Hellenistic building, offering direct access to such material. This latter effect clearly demonstrates the difficulty of developing a chronology of Roman buildings – particularly in the case of baths which were frequently remodelled and adjusted in later periods. Also they were subject to conversion work (public as well as private) because of their good quality construction and general robustness.

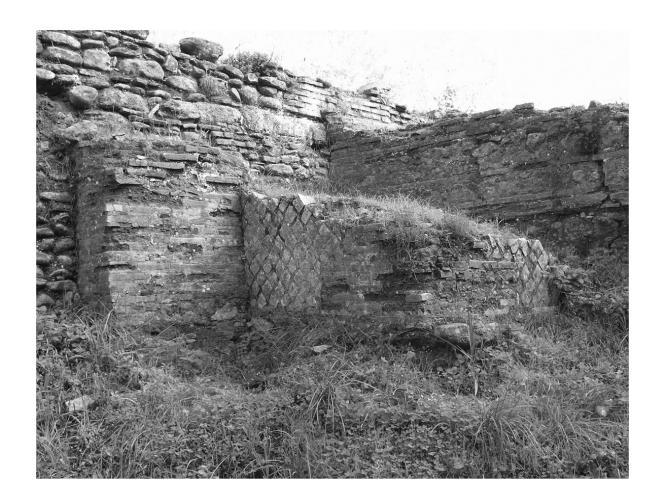
Figure 11. Olympia, Nero-House, south-east corne

The courtyard of the so-called *octagon* in the southeast of the sanctuary contains masonry of different phases, including remainders of masonry from the period of Nero. Large sections of the so-called Nero-house were demolished during the construction of the East Bath, resulting in scant evidence for the present period. In the south-east corner of the caldarium-basin (see fig. 9), remainders of *opus mixtum* were identified (even though Maura Medri could not address it in her publication, as the remaining parts were inaccessible). The type of joints does not coincide with the one identified in the South-West building from the same period. The quality of work of the *reticulat* is not particularly accurate. The triangular bricks and joints of the *testaceum* are in comparison to the South-West building relatively high and not properly developed. Likewise the building contains a mixture of masonry. Apart from the *opus mixtum*, the building contains other mixed types of quasi *opus vittatum*.

Height 3.0-3.5cm, largely based on tiles. Reticulat 8.5 x 9 or 8 x 9.8 (limestone)

1.3-2.0cm, joint-marks with a smooth surface with a little kerb in the lower part

opus mixtum, quasi opus vittatum

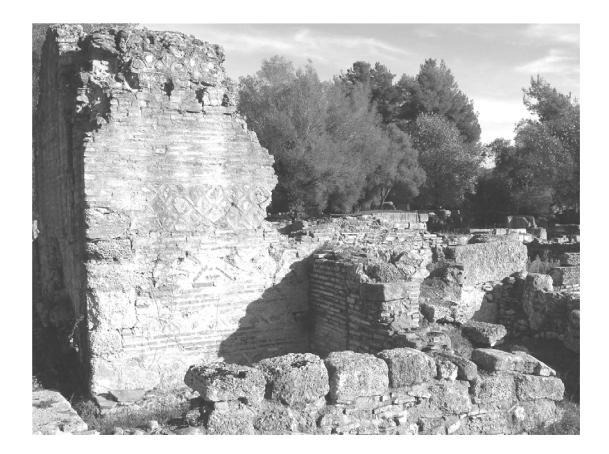
Figure 12. Olympia, South Bath, Caldarium

Based on the different types of masonry consisting completely of reused material (bricks and tiles), the complex can be divided into three large sections: the main building, the court area and the annexed latrine. The main building was covered by a barrel vault and based on bricks of different formats. The dominant format is, however, of a large format, which might have been taken from a predecessor building. The brick surface carries finger markings in form of a cross, indicating that these bricks are not reused material from the so-called Greek Hypocaust-Bath or from the Hellenistic Bath in the north of the sanctuary. Furthermore, the use of various brick formats indicate that material from several buildings was available during construction. The corners of the main building are reinforced not only with testaceum but occasionally also with blocks of muschelkalk. Just the section of the *piscina* represents brickwork which might be derived from a building with similarly homogenous appearance. On a number of occasions, the main building contains bands of a type of opus spicatum. The masonry is irregular and the execution is not very thorough, which indicates the overall declining technical abilities of the period. The courtyard area stands in contrast to the main building and is built mainly from rubble stone with little use of bricks. The latrine is based on opus testaceum and in sections opus incertum, whose bricks (frequently tiles) are reused.

large brick formats, height 4.5-5.5cm, 17 cm width; *Piscina*: height 3-3.5cm, width 28cm, Latrine: height 2.7-3.0cm, width 28.5cm

2.5-3.0cm, smooth joints

opus mixtum, in sections testaceum

Main building 83-84.5; *Piscina* 64.5-67.5; Latrine ca.73cm, dependig on the type of reused brick

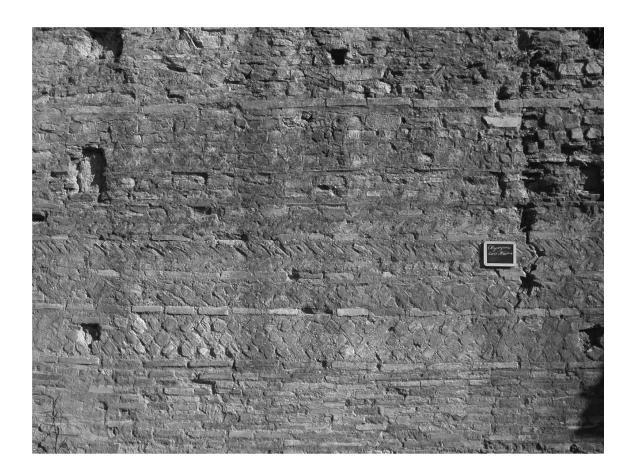
Figure 13. Olympia, Leonidaion Bath

The complex consists of a bath section and a courtyard, from which hardly any evidence has survived to the present day. The bath section has a large number of masonry techniques, which are worked much more carefully compared to the South Bath.

Brick Height- 3.5-5.0cm (Reticulat tesserae – 8x8cm, 7x8cm)

Joints 2.5-3.5cm (Reticulat1.7-2.5cm)

opus testaceum, quasi opus reticulatum, quasi opus spicatum

10-layer-module 60-61cm, 74.5-76.5cm,
