# The Working Space of the Medieval Master Mason: the Tracing Houses of York Minster and Wells Cathedral

## Alexander Holton

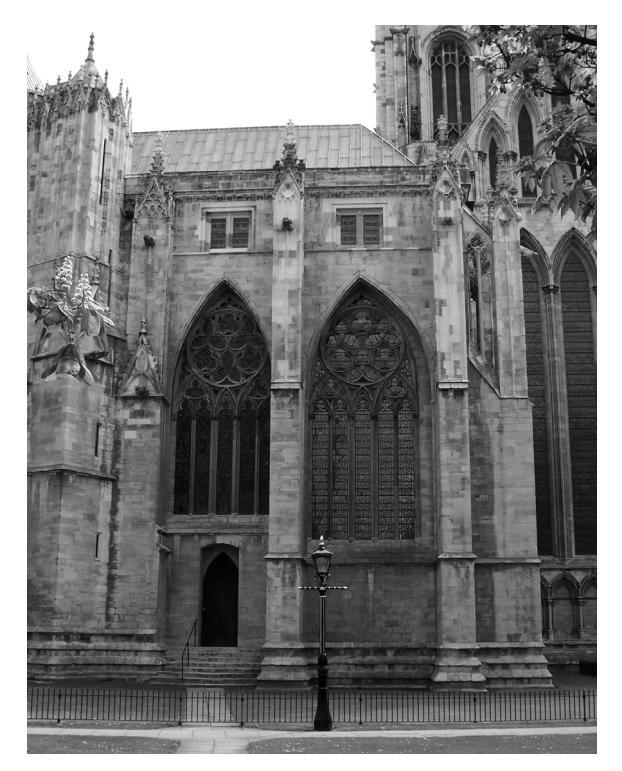
The tracing house at York, known as the masons' loft, is situated at first floor level above the vaulted passage-way of the chapter house vestibule (**fig. 1**). The vestibule is L-shape in plan and

Figure 1. York Minster, chapter house vestibule

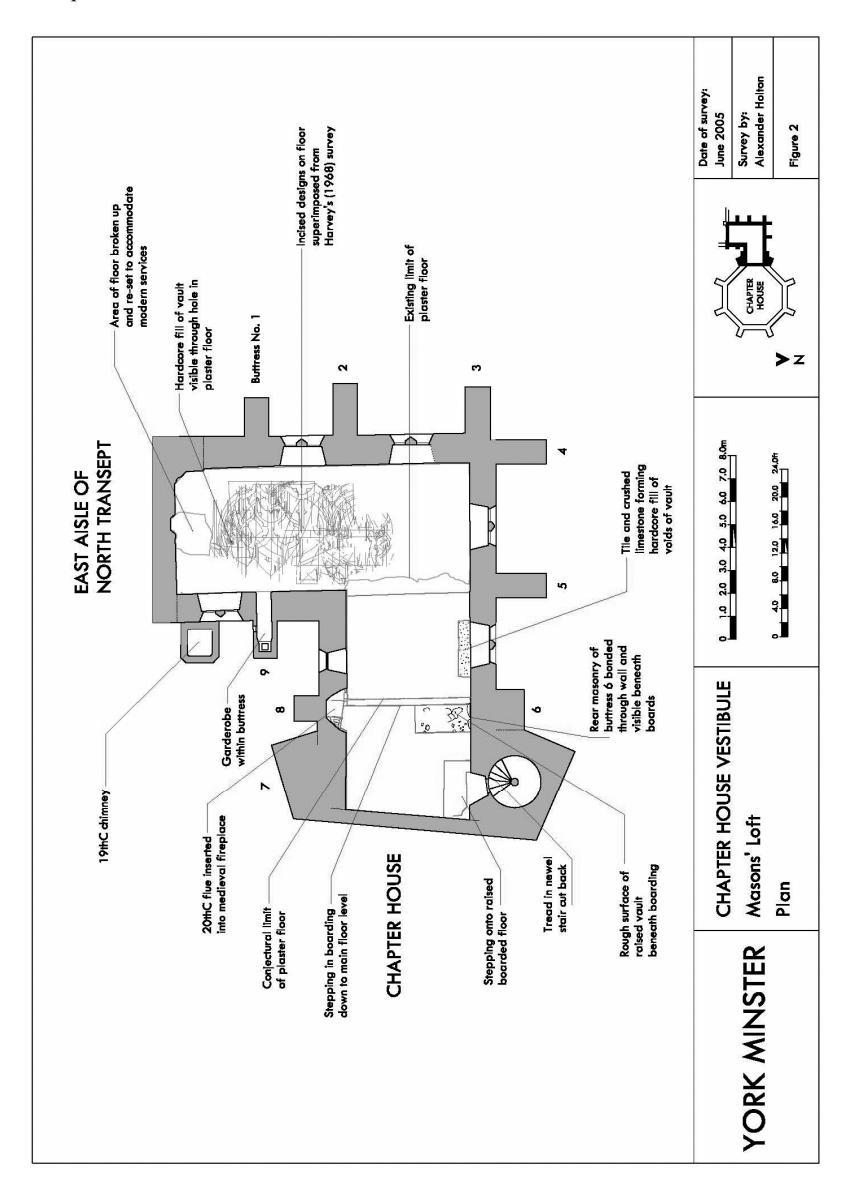
The interior of the masons' loft is composed of two ranges set at right-angles to form the L-shape plan (**fig. 2 and fig. 3**). The walls are built mostly of coursed, un-plastered magnesian limestone. Variations in geology appear in the south and east walls, including the use of Millstone Grit. The room is accessed from the chapter house stair turret in the north-east corner of the east-west range, most of which is used for storing the master mason's templates upon simple racks. The vertical mouldings of the turret are visible above the doorway within the masons' loft. The east-west range is currently boarded over and 'steps-up' towards the eastern end, while the plaster drawing floor, bearing its dense mesh of setting-out lines, survives along the north-south range. There is a fireplace in the south wall and a garderobe in the east wall; both are contemporary with the construction of the room. The north-south range abuts the north transept, of which the cornice, blocked windows

Figure 2. Masons' loft, plan

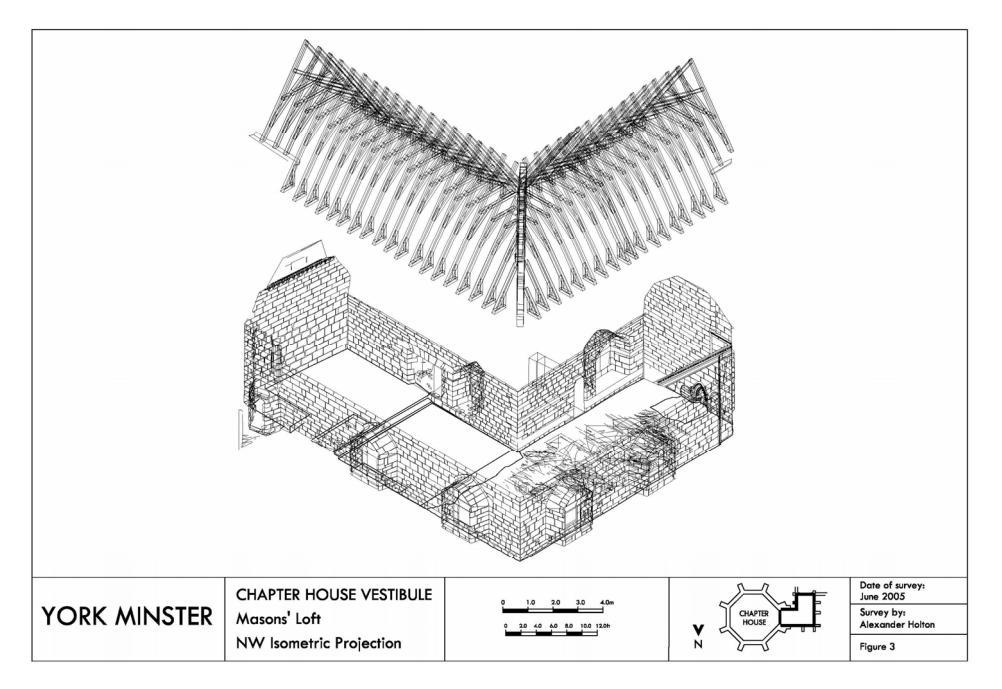
Figure 3. Masons' loft, isometric projection

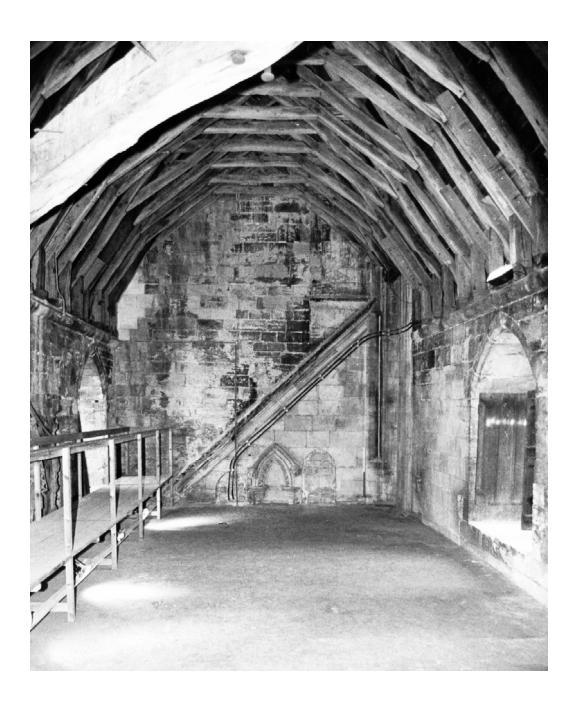
and stair turret are visible (**fig. 4**). The east-west range abuts the exterior of the chapter house, where the parapet moulding can be seen below the summit of the roof (**fig. 5**). The north, south, east and west walls contain a series of unused mortises approximately 0.40m above the floor level. The roof of the loft is of scissor-brace construction, with the trusses converging at the angle of the room by means of a substantial diagonal truss. Each truss rests upon continuous corbelling that circulates around the top of the north, south, east and west walls.

Figure 4. Masons' loft, north-south range (Photograph: J Rimmer)

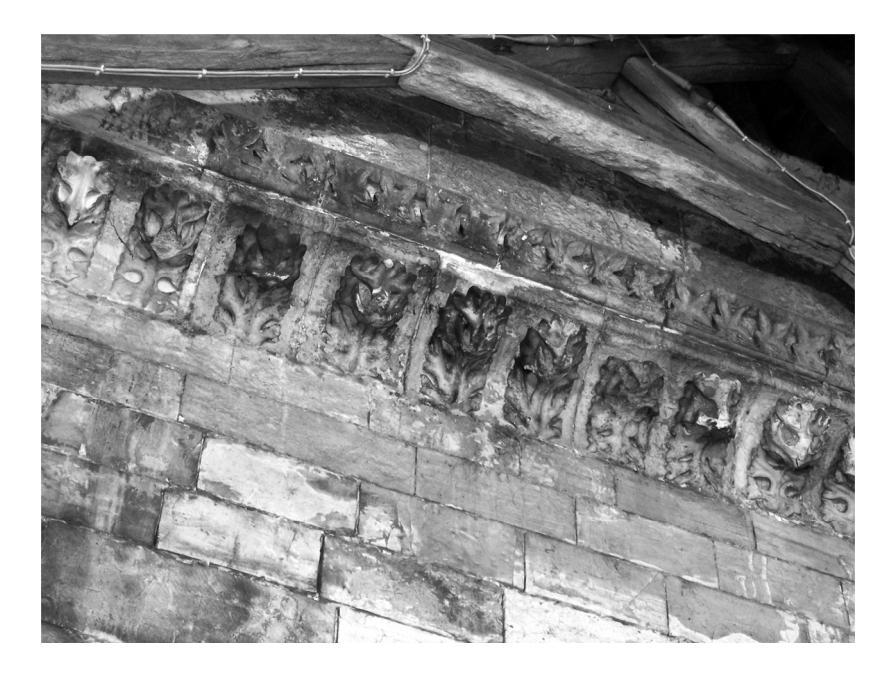
Figure 5. Masons' loft, chapter house cornice

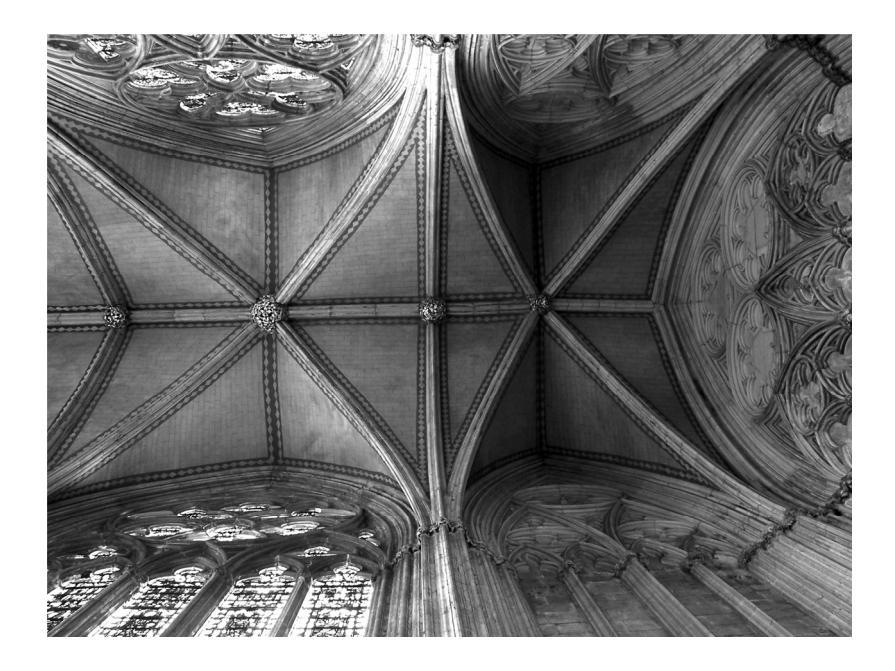
New observations of the evidence beneath the raised area of the boarded floor also shed new light on the understanding of the close sequence of construction between the vestibule and chapter house. By studying the vault of the vestibule at ground level it can be seen that within the final bay before the entrance to the chapter house, the vault rises subtly to avoid masking the blind window (fig. 6). This constitutes one of the many remedial features within the vestibule to enable a coherent visual passage from the north transept. It suggests that the chapter house entrance had been completed without reference to that of the transept, with the two subsequently married by the modified vault. This has implications within the loft, where the displacement of the vault is reflected directly in the raised area of the east-west range and is evident as an unfinished stone surface beneath the boarding. Significantly, this vault surface is bonded into the chapter-house wall and shows that the two projects were completed in relation to one another. The central components of the vault are likely to have been added after the construction of the chapter house and vestibule. However, it is likely that the features supporting the vault's connection to the chapter house were constructed early in the sequence, integrating the vault into the existing structure and thus enhancing its stability (Fitchen 1981, p.25). The close dating of the chapter house and vestibule proposed by Brown (2003, pp. 54-55) and Giles (2005a, p. 16) is evidenced by the fact that the western chapter house wall is built blind in its entirety. Furthermore, it was always envisaged that the roof of the vestibule would front this wall. To support this notion, this survey has drawn attention to that the fact that the apexes of the remaining exterior chapter house windows rise to just below the level of the cornice.

Figure 6. Chapter house vestibule, showing variation in vault construction adjacent to chapter house

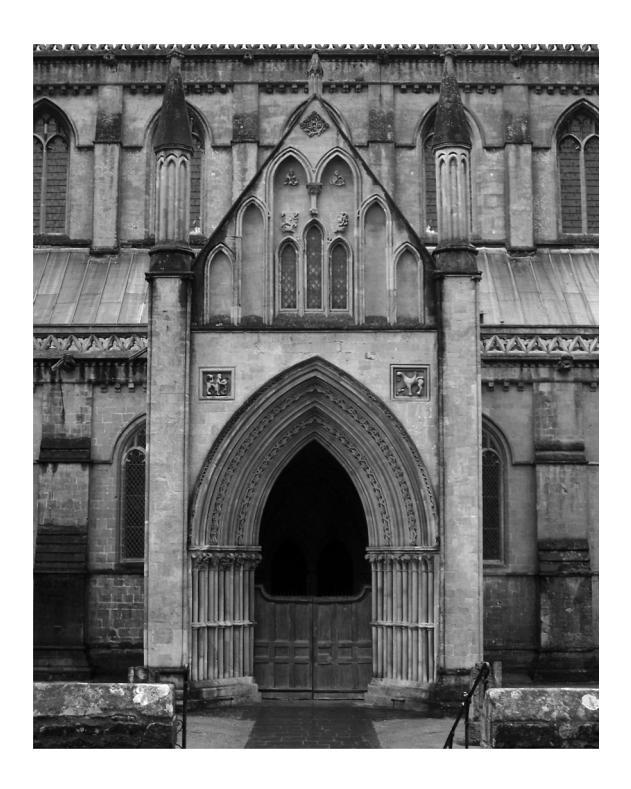
The tracing house at Wells Cathedral is located within the upper chamber of the north porch (**fig. 7 and fig. 8**). The porch is rectangular in plan and provides passage into the north aisle of the nave. The tracing room is presently accessed by taking the south-west tower stairs into the triforium where a small, squat entrance is found mid-way along in the north aisle wall. However, a staircase

Figure 7. Wells cathedral, north porch

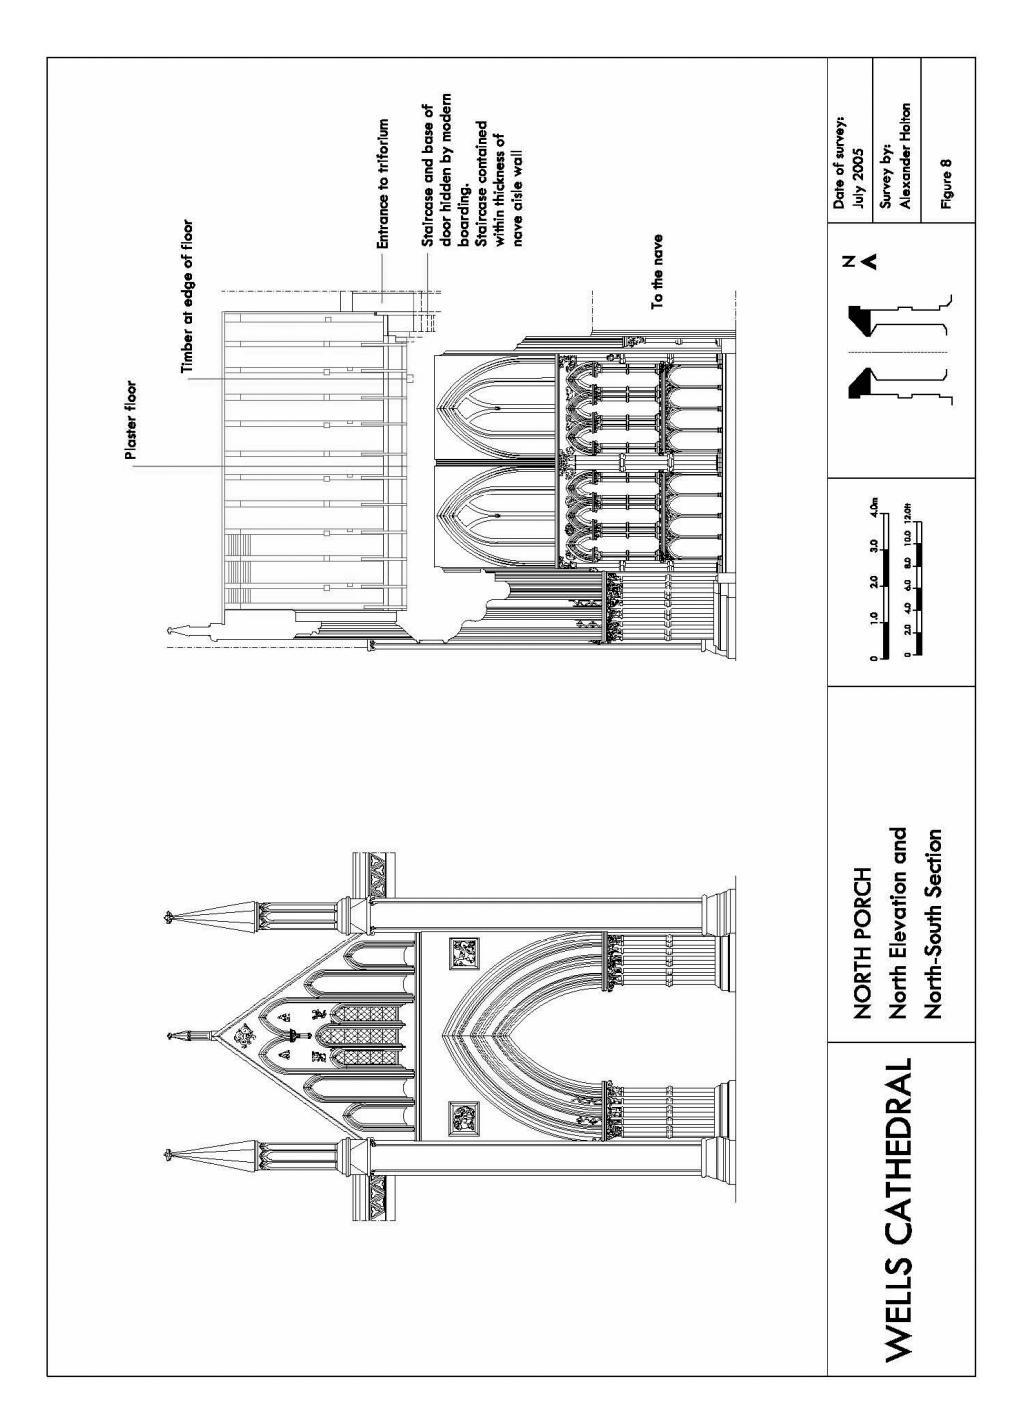
Figure 8. Wells Cathedral, north porch, elevation and section

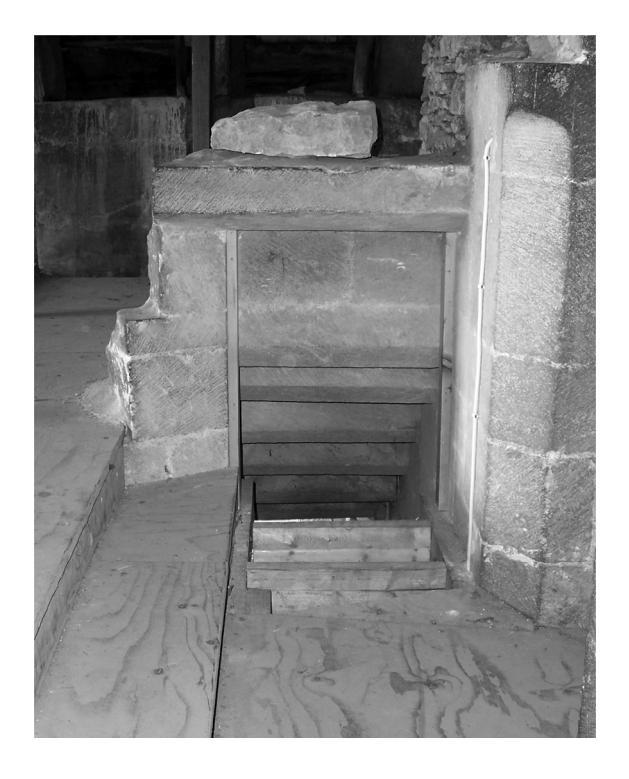
leading from a doorway to the east of the north aisle door originally facilitated immediate access from directly below the chamber (**fig. 9**). This staircase, contained within the thickness of the aisle wall, is now blocked at first floor level.

Figure 9. North porch, disused staircase from north aisle to tracing room

The transition of the ashlar work is subtle and well contrived, but the 'stepping up' of the string course above plinth level is clear. To the south of the break is the work of the nave, followed later by the porch to the north. Further observations add to this hypothesis. As described above, the staircase to the upper floor of the porch is contained within the north aisle wall. There is evidence to show that the north face of the staircase was meant to be visible on the exterior in the form of a window, now seriously reduced and masked by the abutment of the porch. This staircase would have provided self-contained access to the triforium level of the nave prior to the construction of the

porch. Subsequently, for the porch to be integrated into the north aisle at roof level, the face of the triforium wall, the staircase and the door had to be reduced in height and were roughly cut back. This also enabled the staircase to communicate with the upper chamber. The staircase rises through a newel to a diagonal flight and emerges in the middle of the room. This is due to the fact that if the entrance to the triforium were created directly above the newel it would have to emerge through one of the large inner flyers above the triforium, thus reducing structural stability.

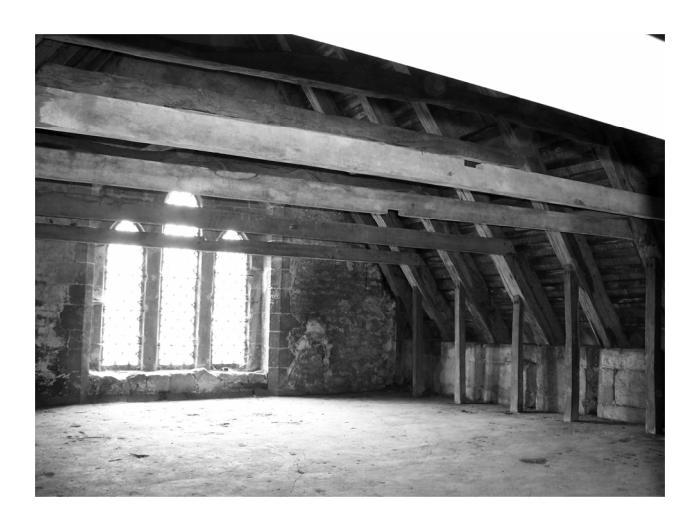
There is a striking contrast between the richly adorned, two-bay ground floor and the single-cell first floor of the porch (**fig. 10**). At this level, the surface of the south wall is unfinished, with only the rubble core in place. The adjacent wall to the north contains a simple tri-lancet arrangement with the remaining work plastered over. Upon the surface of the plaster are traces of lines drawn in charcoal. The timber roof is of a simple truss and tie arrangement, numbers of which have been subsequently strengthened with additional, lower tie beams. The roof rests directly upon the west and east walls without the use of a plate. These walls are set low at parapet level. The east wall is finished with ashlar masonry, while the west only consists of the roughly coursed core. The blocked staircase of the north aisle protrudes through the boarded floor at the entrance to the room and is blocked with a wooden panel. Both the head of the blocked staircase and the current entrance to the room have been cut back and reduced. The boarding continues into the room to where it meets a horizontal timber set in the floor. The plaster floor extends beyond this, abutting the north, east and west walls.

Figure 10. North porch, interior view of the tracing room

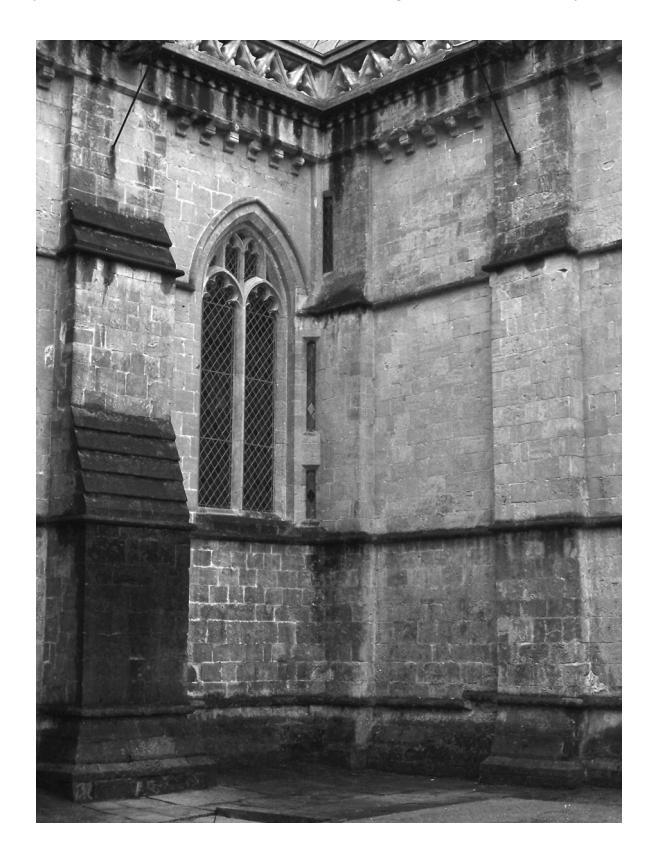
There can be little doubt that the north porch was the principle entrance to the cathedral (Pevsner and Metcalf 1985, p. 296). However, it was not the first. Studies by Rodwell (1996, p. 120) have shown that the liturgical quire was complete and ready for use by c.1196 and that it was around this time that the move from the earlier church took place. The principle access at this point was via a major processional door in the south transept. The focus of entry into the building shifted to the north aisle during the construction of the nave, probably brought about by the accommodation of the clergy to the north of the cathedral. However, the porch itself was not intended at first since a break in construction can be seen between the porch and the nave in **fig. 11**.

Figure 11. East wall of north porch, showing transition with the north aisle of the nave
