# Earth Constructions in the Marche Region (Italy): Building Techniques and Materials

# Enrico Quagliarini

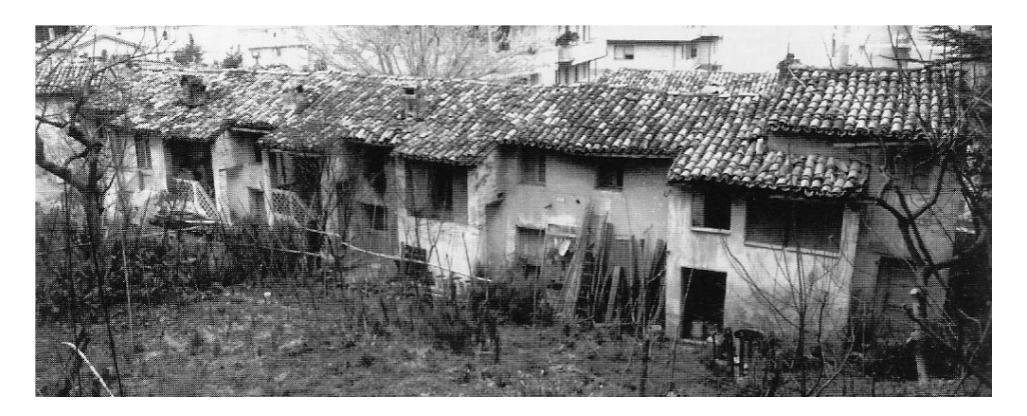
Figure 1. Panoramic view of some earth houses in Macerata (Italy)

Today only a small proportion of these buildings are left (**fig.1**), because of the gradual abandonment of the remainder and the consequent "cannibalisation" of their recyclable parts. It is imperative that the remaining examples be safeguarded. Unfortunately, the prejudice with which these buildings is regarded has resulted in a completely negative attitude to their restoration for residential purposes (**fig.2**). Given that these buildings are particularly subject to natural degradation (especially by atmospheric agents, since there are no protective elements such as guttering, and in some cases whole roof sections have collapsed, due to neglect) the prospects for their survival are not good. It has been estimated that, without maintenance, these buildings have a lifespan of some 60 years (Palombarini 1987), and possible uses have to be sought for these buildings that would promote their regular maintenance, thus enabling interests in the sector to develop.

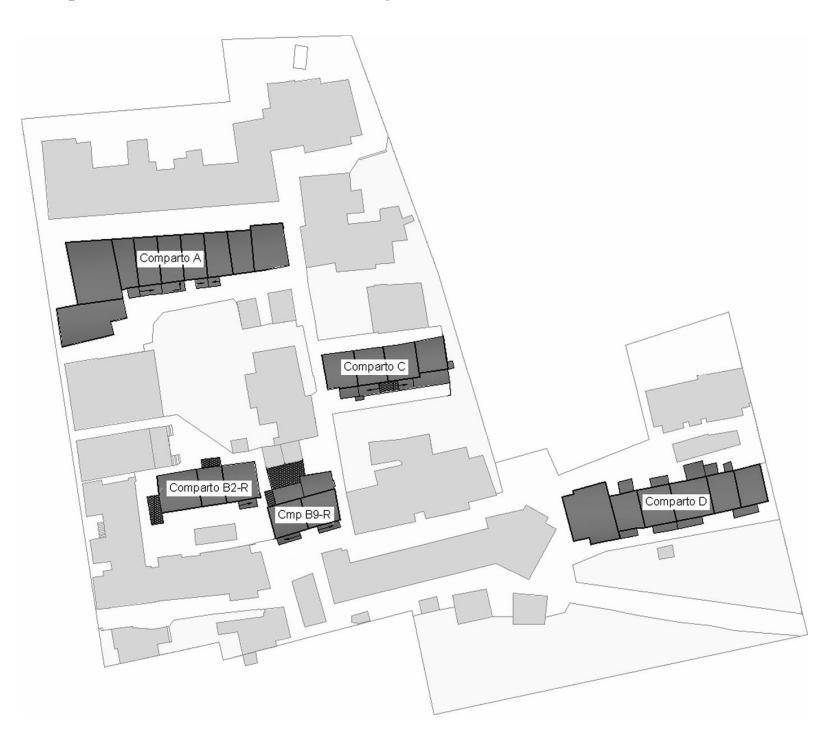
Figure 3. A plan of the quarter showing the location of the earth houses recorded

The earthen buildings of Macerata's "Quartiere Villa Ficana" (fig.3) are the case studies of this paper. "Villa Ficana" is a district in the northern neighbourhood of Macerata. It was built during the nineteenth century not far from the city centre and a lot of its houses have earthen walls. These are of a few examples of raw earth labourers' villages to have survived till now.

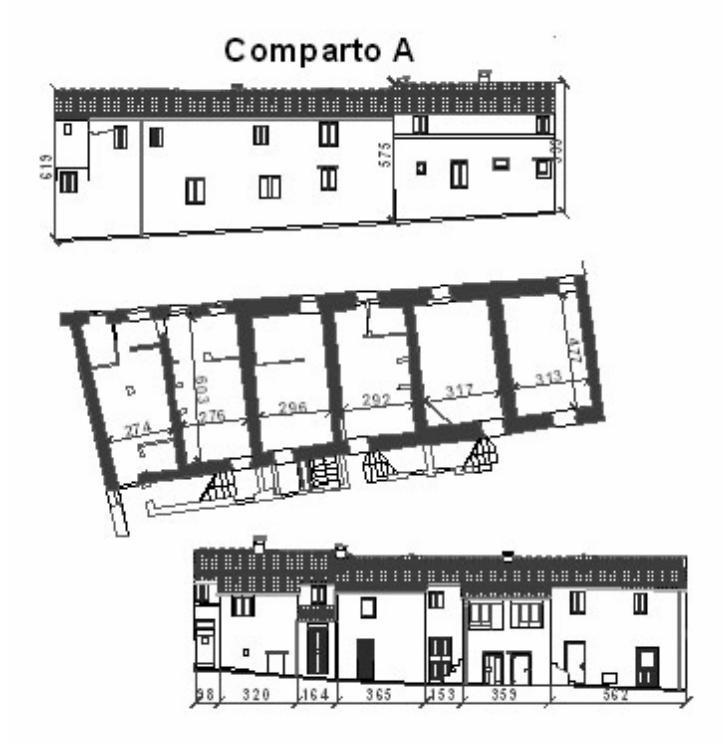
Figure 4. Plan and elevation of the earth houses in "Comparto A"

The common typology of the houses comprises two floors, generally with an external masonry stair (fig.4 and fig.5). The floor system is composed of a series of straight wooden beams and joists, overlaid with floor tiles (fig.6).

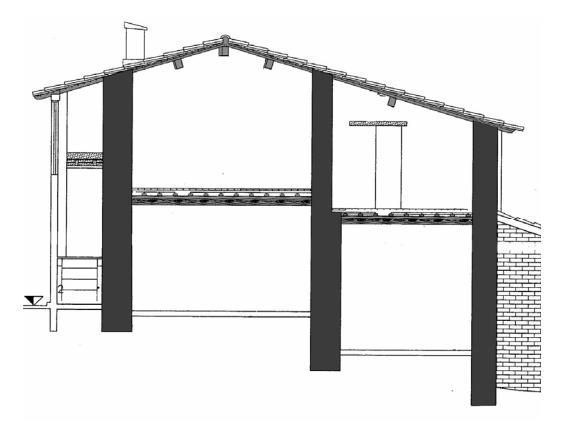
Figure 5. A typical section of a "Villa Ficana" earth house

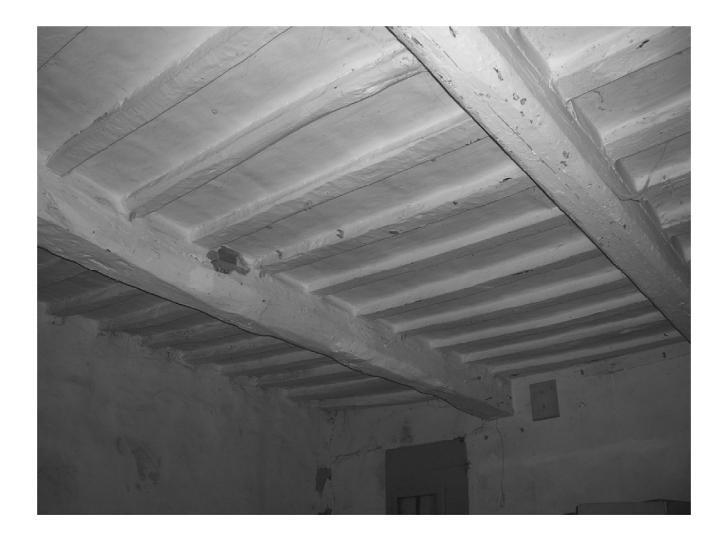
Figure 6. Interior showing the timber floor system.

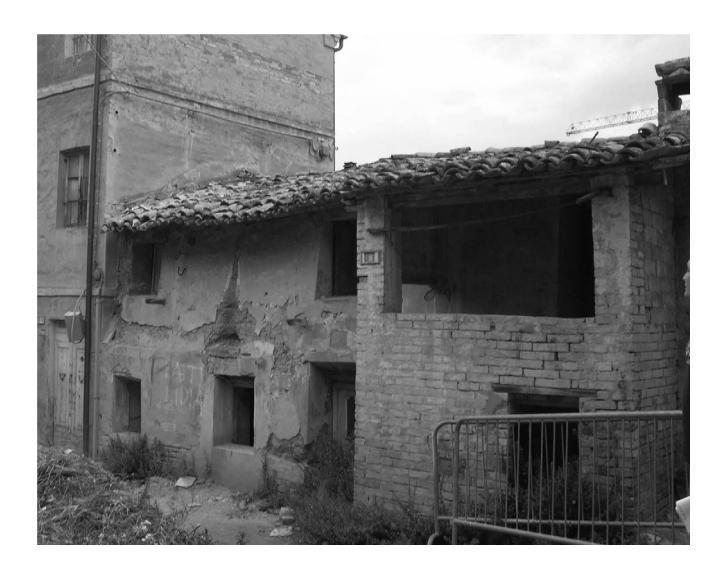
Figure 7. A masonry foundation is visible low on the left. Note also the external masonry stair to the right, the overhanging eave and the surface erosion on that part of the wall unprotected by the roof.

The thickness of the earthen walls is about 100-110 centimetres at the base and from 60 to 110 centimetres at first-floor level, the windows are small in order to reduce heat loss and water penetration. In some houses there are also walls made of common bricks. Several earthen walls have been erected upon a 40-50 centimetres high masonry base (fig.7). This reduces the earth-built wall's excessive vulnerability with respect to ground surface erosion and water absorption.

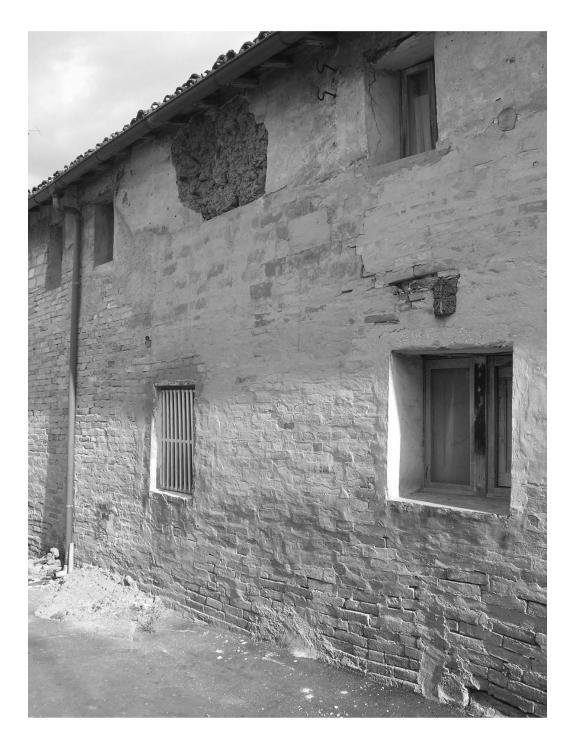
Figure 8. An external "skin" of common brick is often used to protect earth-built walls

The roof, covered by tiles, is sloping supported by a system of primary and secondary wooden beams. The eaves have an overhang of up to 40-50 centimetres to protect the walls from the rain. The earthen wall's external surface is sometimes protected by a 5-10 centimetres earth plaster, or an external layer of bricks (fig.8).

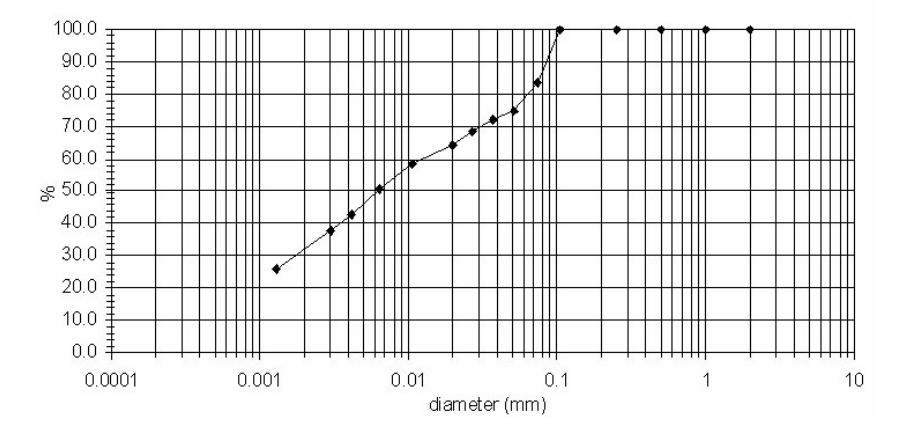
Figure 9. Analysis of the grain-size distribution of an earth sample

Comparing the results from soil composition and limits of consistency (Atterberg's limits) of earth samples taken from the buildings identified it emerged that the soil used as a construction material came directly from the construction site. It has the following texture: clay 30-35%; sand 15-18%; silt 50-55%, and the following limits of consistency (Atterberg's limits): LL (Liquid Limit) = 35-40%; PL (Plastic Limit) = 18-22% (figs. 9 and 10). Finally, it has a water (moisture) content of between 6% and 10%.

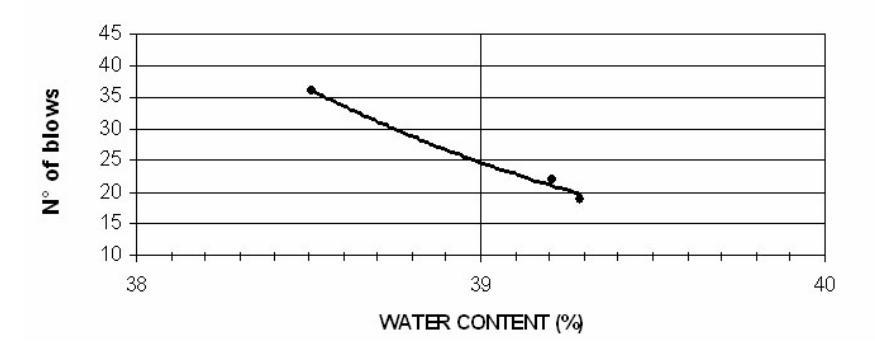
Figure 10. Measurements of Atterberg's limits of an earth sample

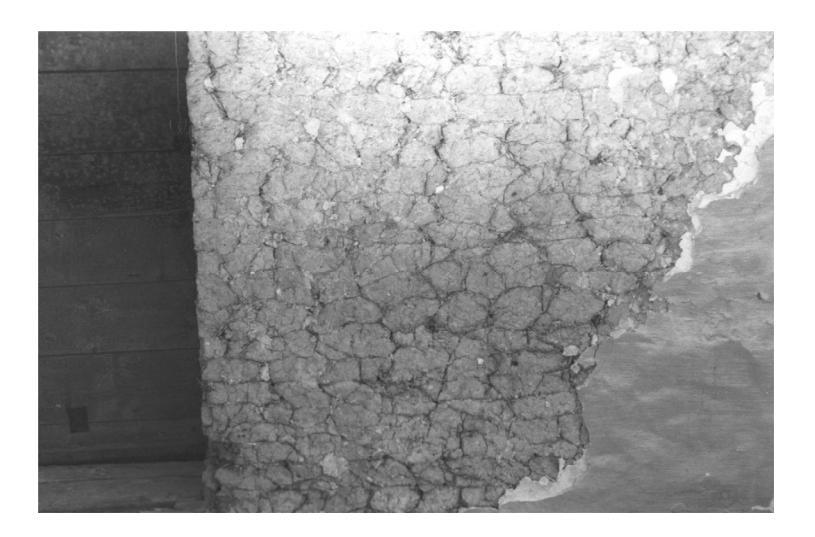
Figure 11. The material was first kneaded and then shaped into long cylinders, which were either piled or forcefully thrown onto the wall.

The mixture was probably moistened and trod by human feet in shallow pits. Subsequently, it was shaped into large cylinders 8 to 15 centimetres in diameter and 30-40 centimetres long. These were covered by straw and thrown up to the bricklayer who stands on a finished part of the wall and forms the new layer of cob by throwing the cylinders forcefully and rhythmically onto the wall up to a height of 50-70 centimetres. The wall under construction wall was then left to rest for some days for drying, after which the successive level could be constructed. No straw was found in the core of the samples taken. It was just put on the external surface, probably to limit the considerable

shrinkage of the material. In this way very thick walls (60 to 110 centimetres) consisting of several layers of monolithic appearance could be built (**fig.11**).

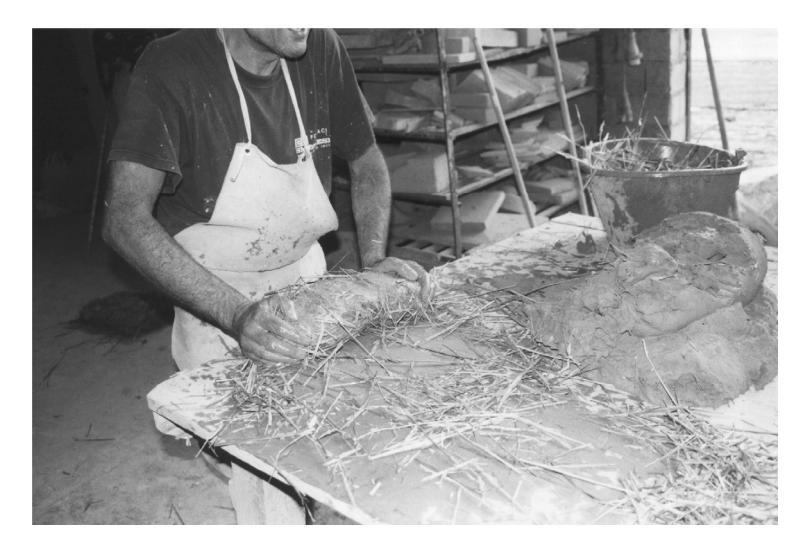
Figure 12. As the technique is no longer used we are trying to reproduce the old method to give a tool for future interventions

Cycles of experiments are currently under way. They are aimed at evaluating the prospects of reproducing the old technique, using first the in situ earth and then an earth of analogous composition, in order to regain control of the constructional aspects, namely the desired "workmanlike" practice or skill, and to identify a suitable type of soil for future use (fig.12). In fact, for the subsequent restoration designs to originate truly from an awareness of the real object being
